Service Bulletin

Bulletin No.: 22-NA-060

Subject: Information on Possible Tick or Rattle Noise Concern from Left and/or Right Side Rocker Cover

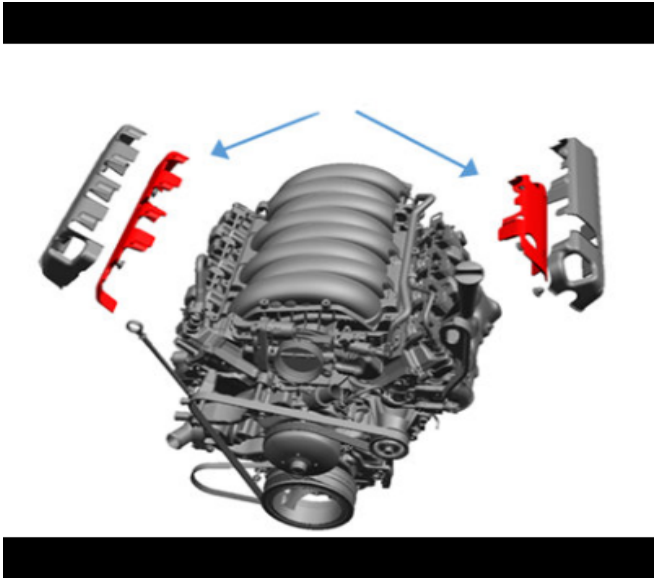
<p style="text-align: right;">6018737</p>
<p>Correction</p>	<p>If you encounter a vehicle with this condition and the noise is unacceptable to the customer, you can install a service cover which has the insulation attached to the insulator to help reduce the valvetrain noise.</p>

<p>Cause</p>	<p>This condition may be caused by the left or right side rocker cover insulator.</p> <ul style="list-style-type: none"> – For a short period of time the insulator was manufactured without the fiberglass insulation (as indicated in the graphic below) that is used to reduce the normal engine valvetrain noise. This was due to an unavoidable supply shortage issue. Without this fiberglass insulation an increase in valvetrain noise on that bank may be noticeable.
