Service Bulletin

Bulletin No.: 12-08-51-002O

Subject: Spray-in Bed Liner General Information and Repair Procedures

Models: 2013-2014 Chevrolet Silverado HD 2500/3500 Series
2014 Chevrolet Silverado 1500
2015-2023 Chevrolet Colorado, Silverado
2013-2014 GMC Sierra HD 2500/3500 Series
2014 GMC Sierra 1500
2015-2023 GMC Canyon, Sierra
2022-2023 GMC HUMMER EV
2020 Holden Colorado
Equipped with Spray-in Bed Liner (RPO CGN, PDL)

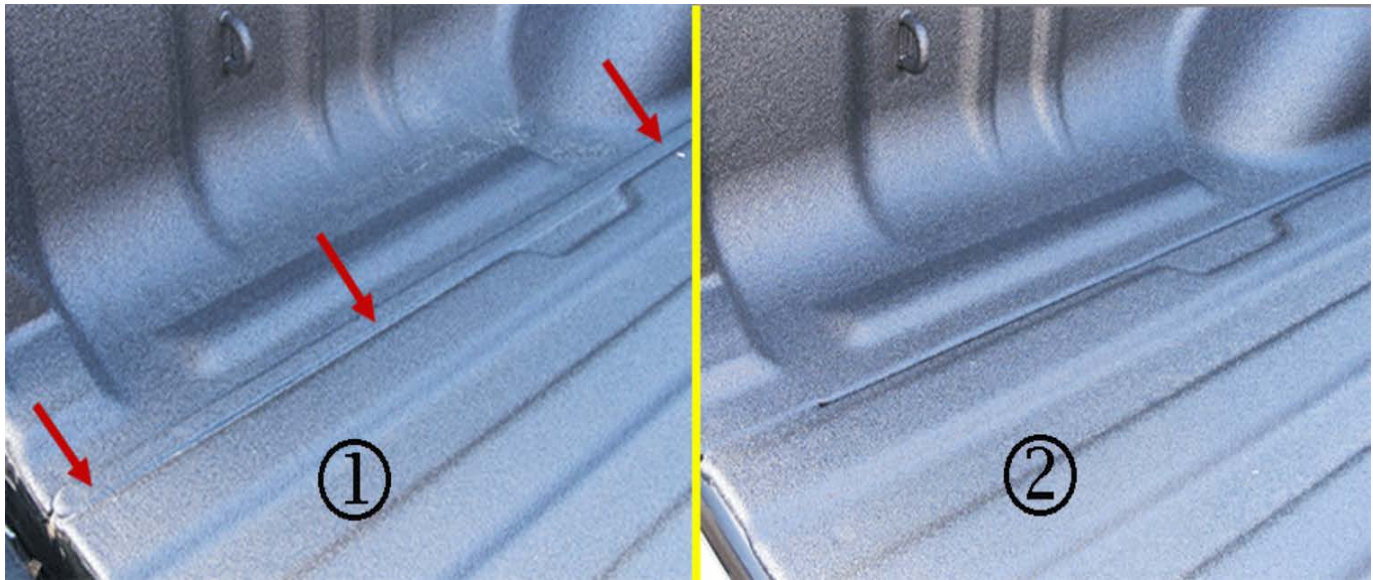
4244840

The photos below show the areas that are covered by the spray-in bed liner. These should be used as a guideline when making any repairs or answering customer questions concerning bed liner coverage areas.

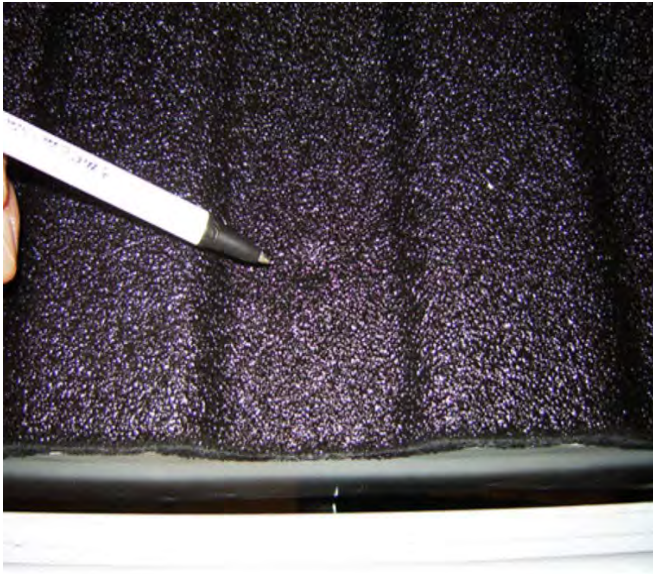
2968675

Because the bed liner material is sprayed on evenly, any variation in the bed such as seam sealer or spot welds in the sheet metal will show underneath the spray on coating. This is an expected condition. The coating does not completely fill in these variations.

Spot weld under bed liner example
