Service Bulletin

Bulletin No.: 22-NA-193

Subject: Information on Malfunction Indicator Lamp (MIL) Illuminated - DTC P219A and/or P219B Set

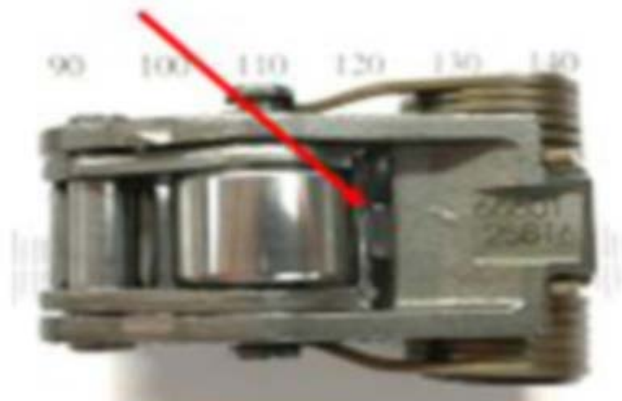
5924237

1. Remove the cam cover of the affected bank (A is Bank 1, B is Bank 2) to inspect for Switching Roller Finger Followers (SRFF) and dual function stationary hydraulic lash adjusters for cylinder 5 or cylinder 2.
 2. Inspect the SRFFs and rocker assemblies for any damage or dislodge.
⇒ While inspecting the rockers, it will be necessary to rotate the engine over by hand to ensure that the rockers are opening the valves.
- Note:** Camshaft carrier assembly removal will be necessary to fully inspect the rockers and SRFFs.
- ⇒ Below are pictures of possible SRFF failures. If any one of the SRFFs are damaged, it will be necessary to replace all four on the affected cylinder.
3. Replace the SHLA's and the damaged Switching Roller Finger Followers (SRFF) on the bank found to be the concern.

4. If any of the conditions listed above have been verified, refer to the Service Procedure listed in SI for replacement of the Switching Roller Finger Followers (SRFF) and dual function stationary hydraulic lash adjusters cylinder 5 or cylinder 2.
