Bulletin No.: PIC6476
Published date: 09/29/2022

PIC6476 Appearance of Surface Cracks on Rotors

Brand:	Model:	Model Years:	VIN:		Engine:	Transmissions:
			from	to		
Cadillac	CT5	2022 - 2023	All	All	All	All

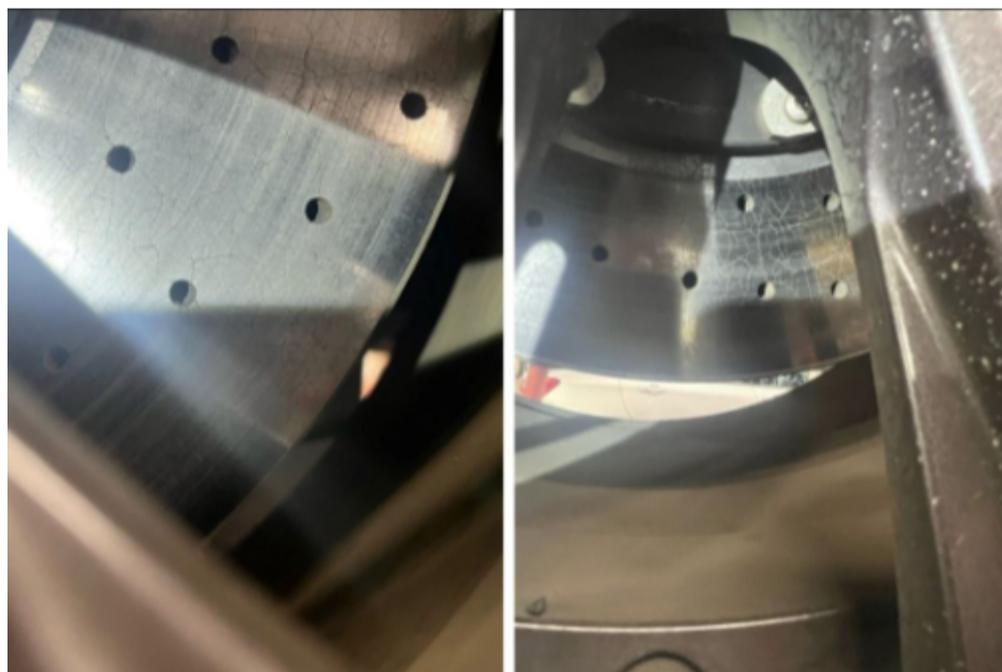
Involved Region or Country	North America
Additional Options (RPO)	J57 - Carbon Ceramic Rotors
Condition	A customer may comment that the carbon ceramic rotors on their vehicle appear to have cracks on the surface of the rotors.
Cause	This is a normal appearance and does not impact the performance or durability of the brake system.

None - The cracks are cosmetic only and no repair or replacement is required.
