TECHNICAL SERVICE BULLETIN

Soft Top Wear Above B-Pillar

22-2274

Ford 2021-2022 Bronco

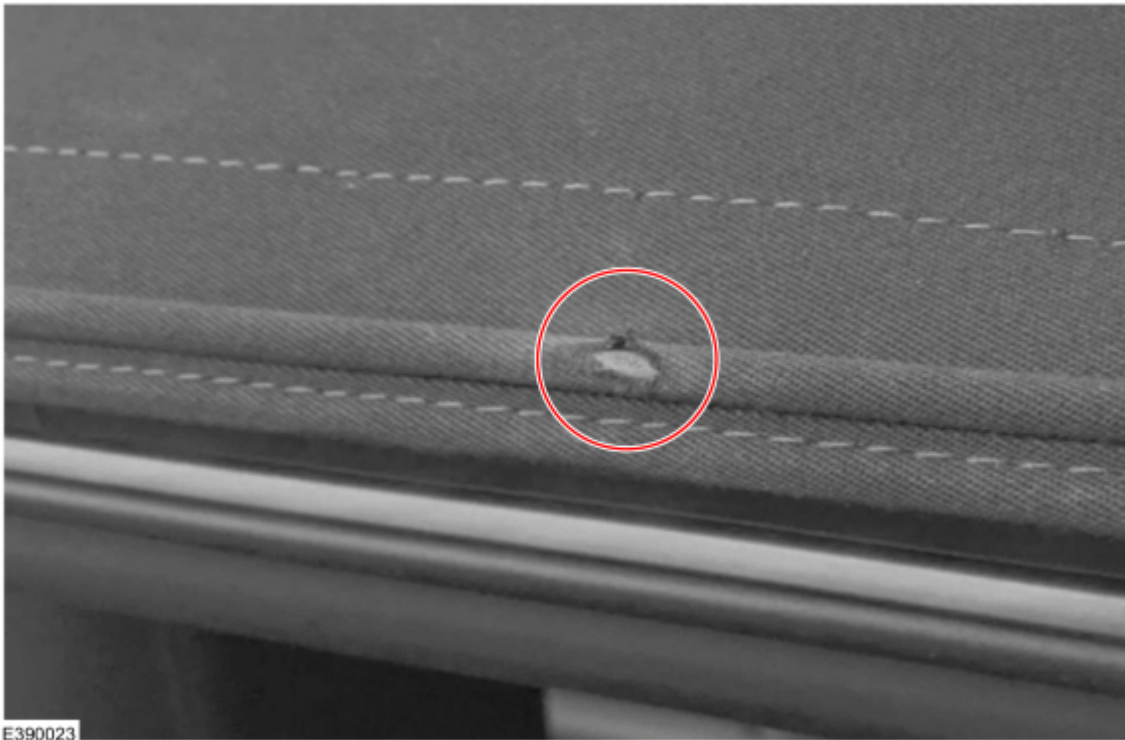
Figure 1

Issue: Some 2021-2022 Bronco vehicles equipped with a soft top may exhibit exterior wear on the sides of the top above the B-pillar. This may be due to contact and rubbing between the soft top frame and fabric. To correct the condition, follow the Service Procedure to replace both right and left deflectors attached to the soft top frame and soft top cover.

1. Does the soft top exhibit wear above the B-pillar similar to Figure 1?

(1). Yes - proceed to Step 2. Updated deflectors will be installed on both sides of the soft top frame assembly to prevent wear.

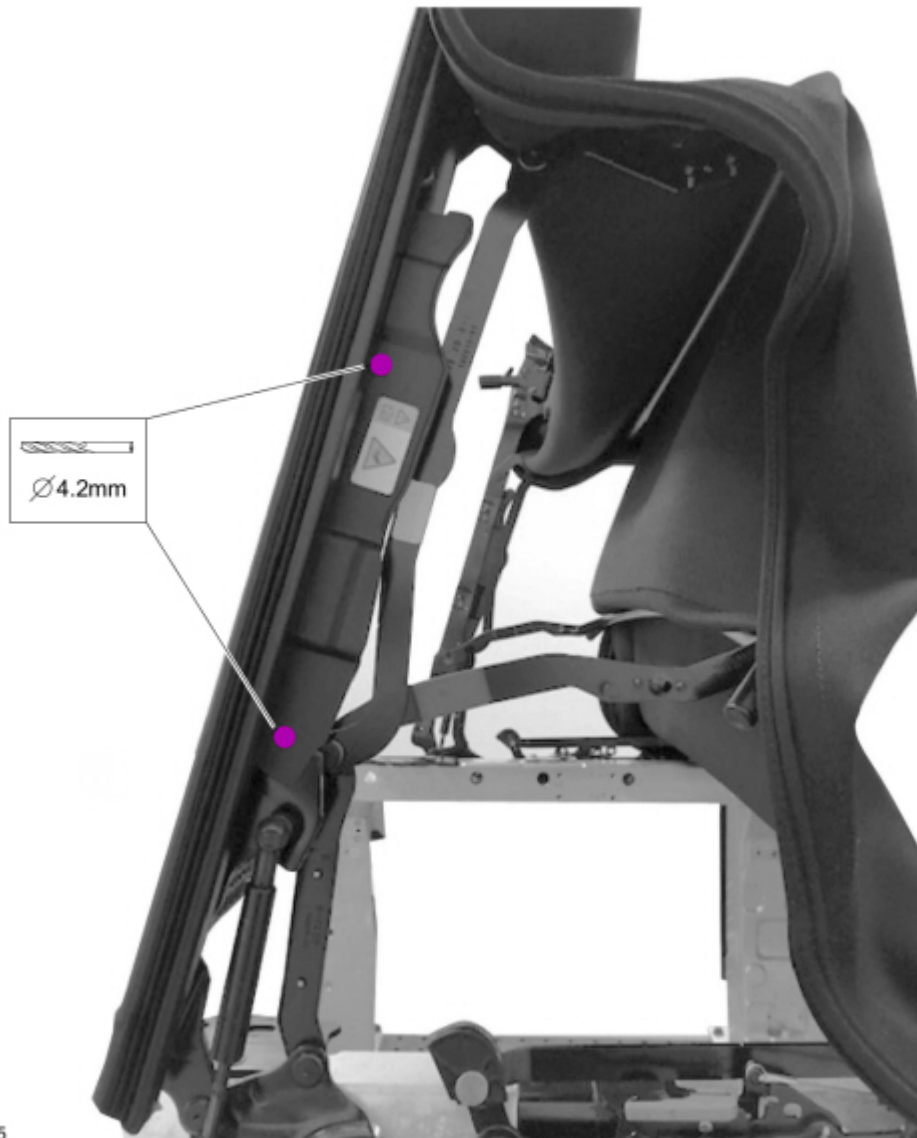
Figure 3

CAUTION: Do not drill through the linkage assembly. Only the head of the rivet should be drilled. Drilling through the linkage enlarges the hole where a new rivet will not fit to secure the linkage.

4. Locate each deflector on the right and left side of the frame assembly and drill out 2 rivets per deflector using a 4.2 mm (11/64 in) drill bit. (Figure 3)

5. Attach an updated deflector on each side of the frame using rivets, securing the new deflector to the frame assembly starting from the front moving to the rear.
6. Remove and replace the soft top cover. Refer to the Workshop Manual (WSM) Section 501-18A Soft Top > Removal and Installation > Soft Top Material.
