# Service Bulletin

Bulletin No.: 20-NA-219

**Subject: Gurgle or Sloshing Noise Heard Coming from Front Sunroof Drain Hose Areas**

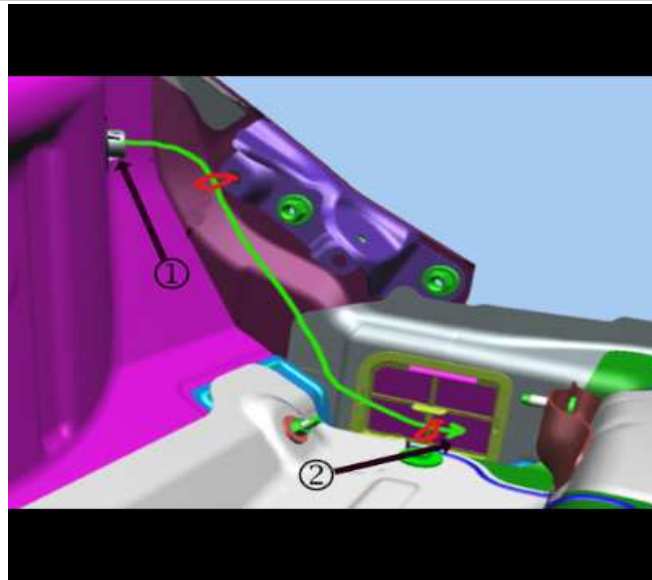
5677469

**Note:** An illustration of the driver side hose is shown in the graphic above.

Following the steps in the Service Procedure below, add drain hose extensions to both the right and left sides. These extension hoses will attach to the existing sunroof front drain hose grommets (1) in the plenum and then exit out the plenum drain valve (2), on that side of the vehicle.

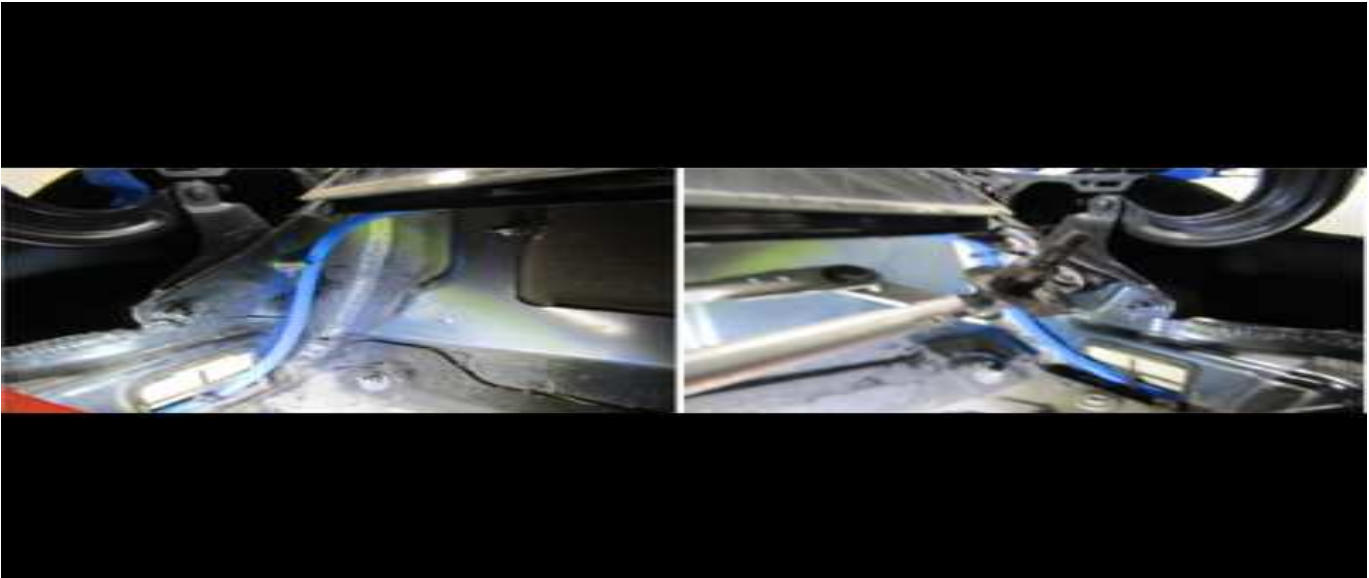
5677480

**Note:** The graphic above shows the hose installation completed on both the passenger and driver sides.
