Service Bulletin

Bulletin No.: 21-NA-192

Subject: Convertible Top May Not Lower Intermittently, DTC B19E4 SYM64 May be Stored in History

Brand:	Model:	Model Year:		Date Breakpoint:		Engine:	Transmission:
		from	to	from	to		
Chevrolet	Corvette	2020	2023	—	—	All	All

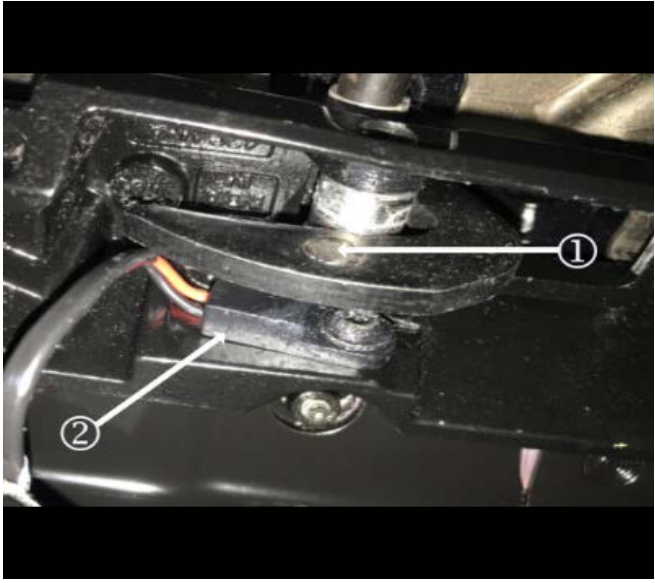
Involved Region or Country	North America, Middle East, Europe, Australia/New Zealand
Condition	Some customers may comment that the convertible top may not lower intermittently. Technicians may find DTC B19E4 SYM64 stored in history.
Cause

<p style="text-align: right; font-size: small;">5892481</p> <p>Note: This hall effect sensor (2) is looking for the roof to be fully latched at the header. We have seen cases where the hook is not extending far enough to reach the magnet (1). The cause of the condition may be that the hall effect sensor, in the right side folding top front latch striker, may be out of position.</p>
Correction	The simplest solution is to adjust the right side folding top front latch striker following the steps in the Service Procedure below.

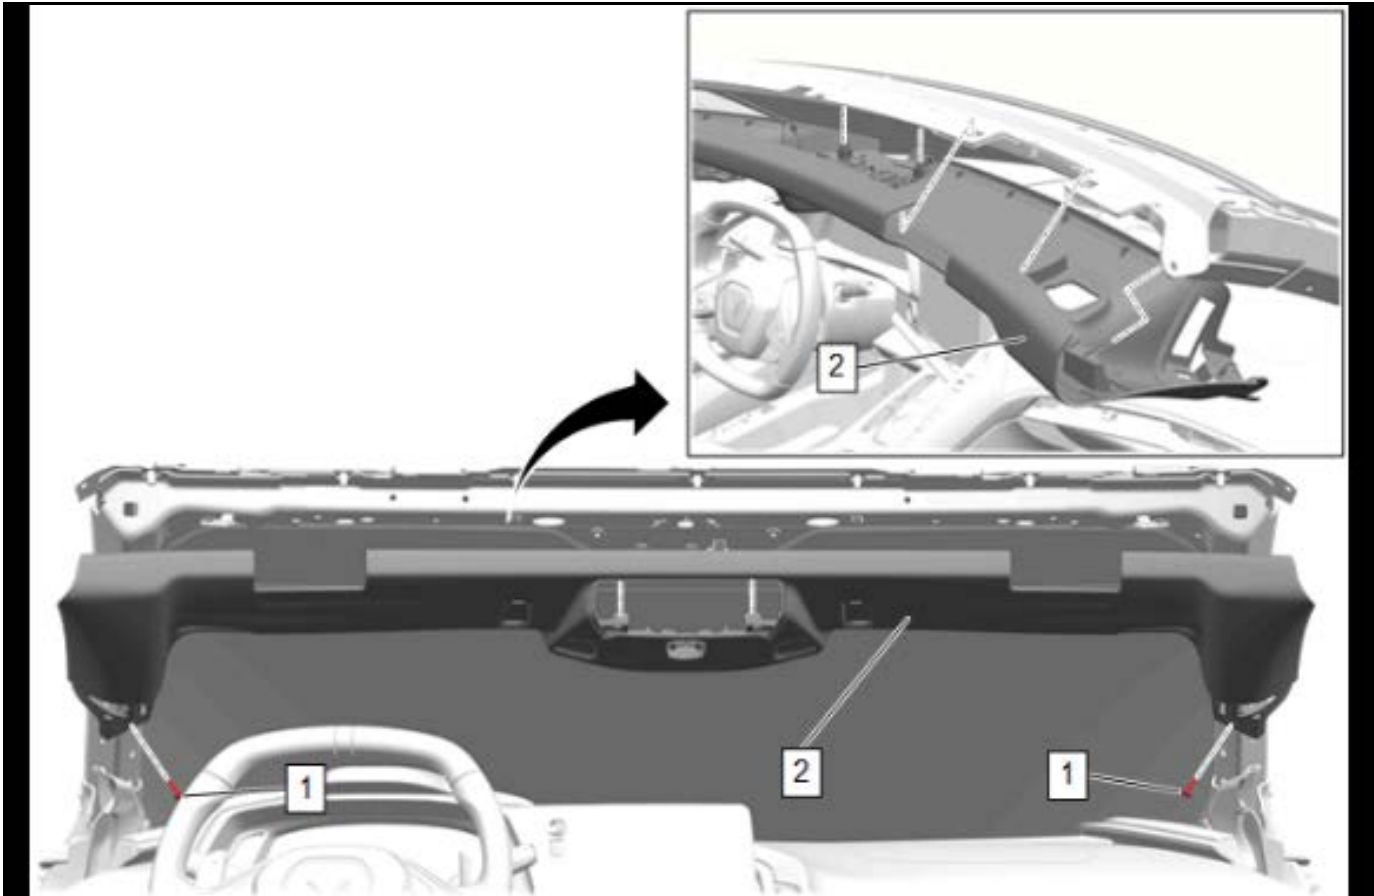
Note: The windshield upper garnish molding must be completely removed. Removing fasteners on only one side and flexing the molding, may damage the part. This type of damage due to not removing the complete molding should not be submitted under warranty.

1. Remove the windshield upper garnish molding (2). Refer to *Windshield Upper Garnish Molding Replacement (Convertible)* in SI.
