# Service Bulletin

Bulletin No.: 18-NA-069

**Subject:** Poor Engine Performance in Extremely Cold Weather Conditions for LFV Engines, Charge Air Cooler Icing - Malfunction Indicator Lamp (MIL) Illuminated - DTC P0299, P0234, P2227 and/or P00C7 Set

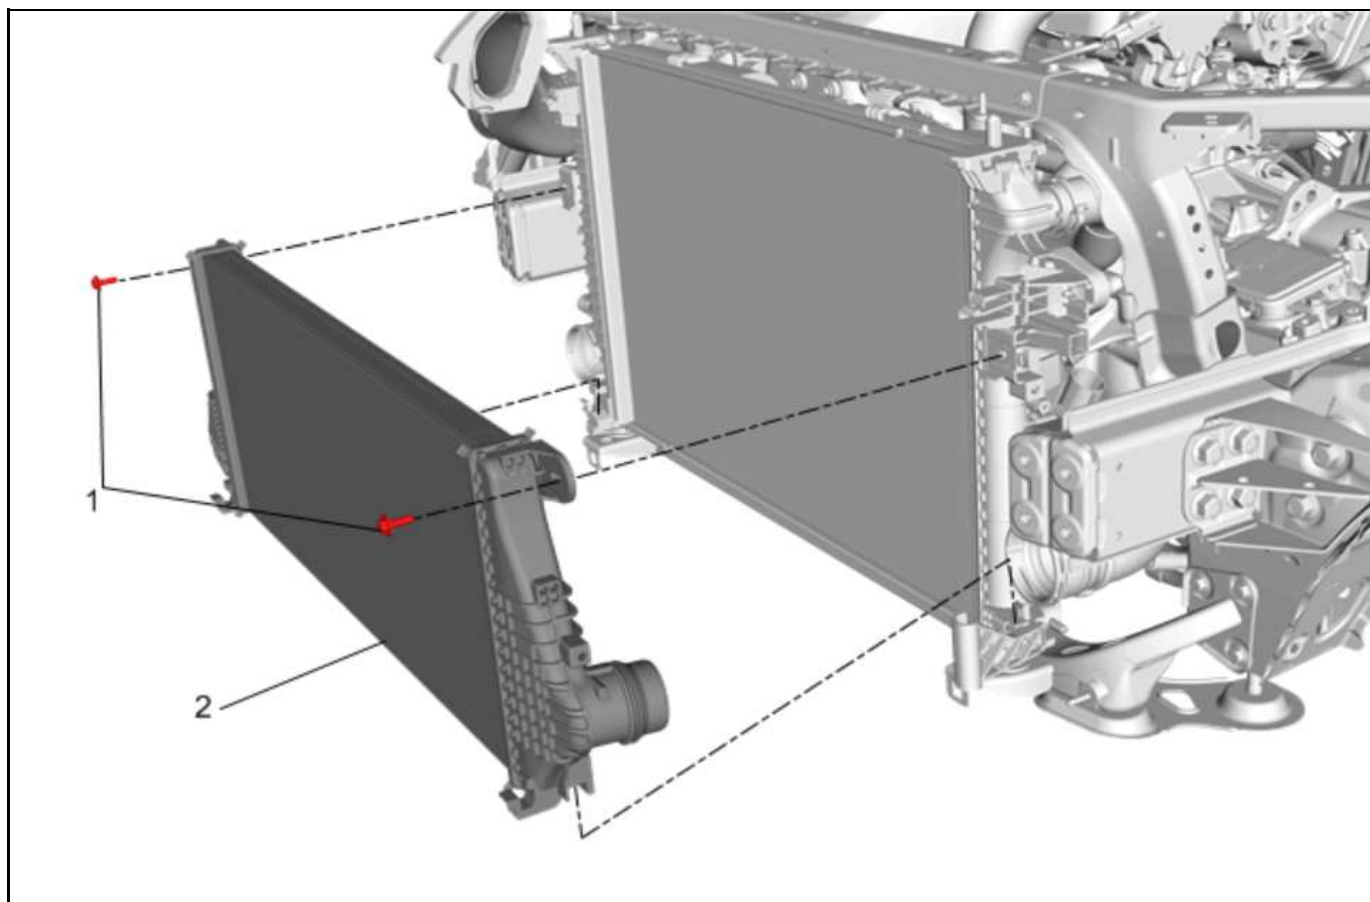
4241877

**Important:** Do Not replace the CAC ducts as part of this repair unless there is evidence of damage and/or a leak from the CAC ducts.

1. Install the CAC (2). Refer to *Charge Air Cooler Replacement* in SI.
