Service Bulletin

Bulletin No.: 21-NA-006

Subject: Diagnostic Tip to Diagnose Emission Reduction Fluid Tank Electrical Connector Inspection, Reduced Power Message, Service Emissions System, System Displayed on the Drivers Information Center (DIC) Malfunction Indicator Lamp (MIL) Illuminated - DTC P20C1, P21DD, P221C, P10D9, P10F3, P143C, P20B9, and/or P221E

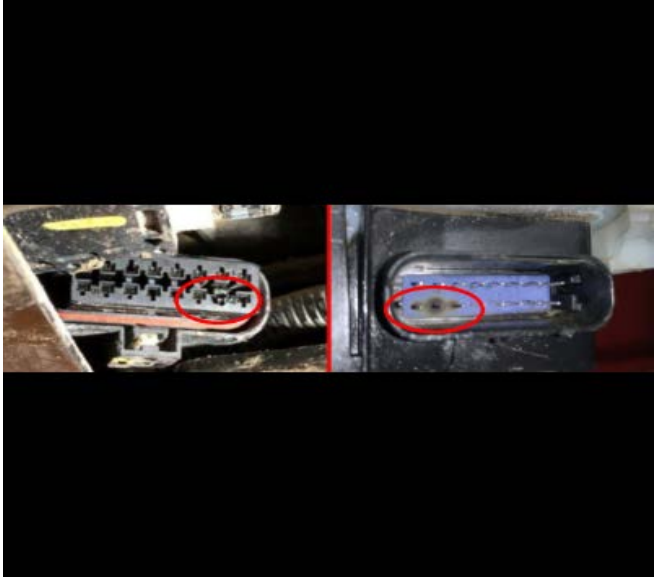
<p>Cause</p>	<p>This condition may be caused by a poor connection at the Emission Reduction Fluid Tank electrical connector.</p>
<p>Correction</p>	<div style="text-align: center;">

</div> <p style="text-align: right;">5708899</p> <p>Inspect the A38 - Reductant Pump and Sensor Assembly electrical connector for any signs of damage and repair as necessary.</p> <p>– If this condition is not found, refer to Service Information section.</p> <p>Note: If this condition is found on a Silverado HD or Sierra HD, check for an update to the Emissions Reductant Fluid Controller. Updating the controller will prevent this from happening again.</p>

On all vehicles, replace the *Emission Reduction Fluid Tank Replacement in SI*.
