# Service Bulletin

Bulletin No.: 22-NA-007

Date: October, 2022

**Subject: Poor Engine Performance in Extremely Cold Weather Conditions for LE2 Engines, Charge Air Cooler (CAC) Icing - Malfunction Indicator Lamp (MIL) Illuminated, DTC P0299, P0234, P0236, P2227, P00C7 Set**

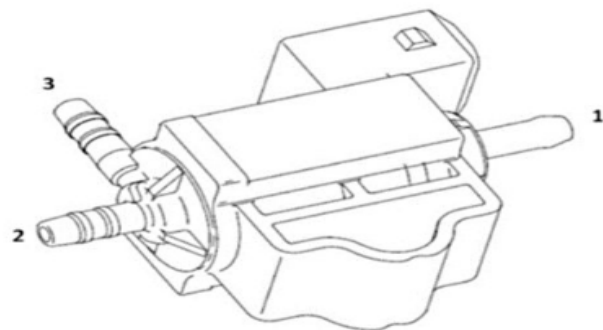
6055068

**Note:** Check port #2 to assure the spring gets lifted off the seat. This will be determined by the compressed air not dead heading when applied to port #2. When applying air to this port a small amount of air should be observed at port #3 and even less air will be noticed at port #1. If this does not happen, the TCV plunger may have hardened deposits from hot operating conditions which will impede TCV plunger movement, and the turbocharger wastegate regulator solenoid valve should be replaced.

3. Using clean shop air regulated to 80-100 PSI, blow through all three ports (1, 2 & 3) for 5 seconds each.

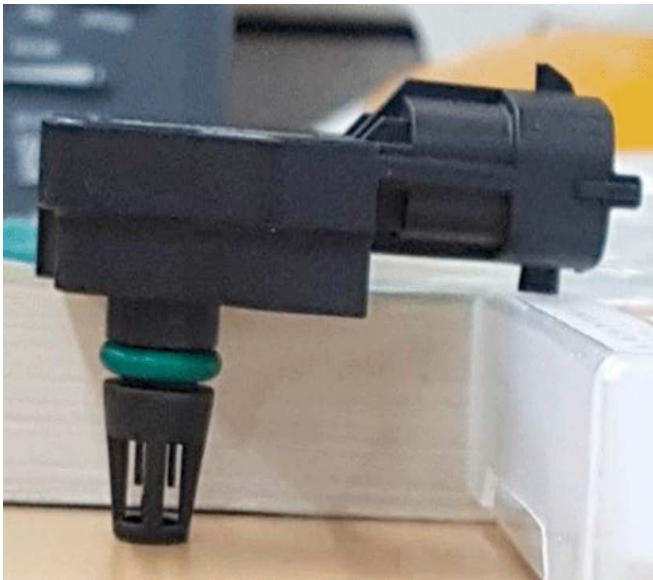
2. Inspect the sensor for any contaminants.

3. Allow time for any ice build-up to melt by placing the sensor port down.
4. Clean the sensor with a clean towel.
5. Install the sensor. Refer to *Turbocharger/Supercharger Boost Pressure Sensor Replacement* in SI.
