TECHNICAL SERVICE BULLETIN

Various Concerns With The Active Exhaust System

22-2282

Ford 2018-2022 Mustang	non-Shelby GT350
----------------------------------	------------------

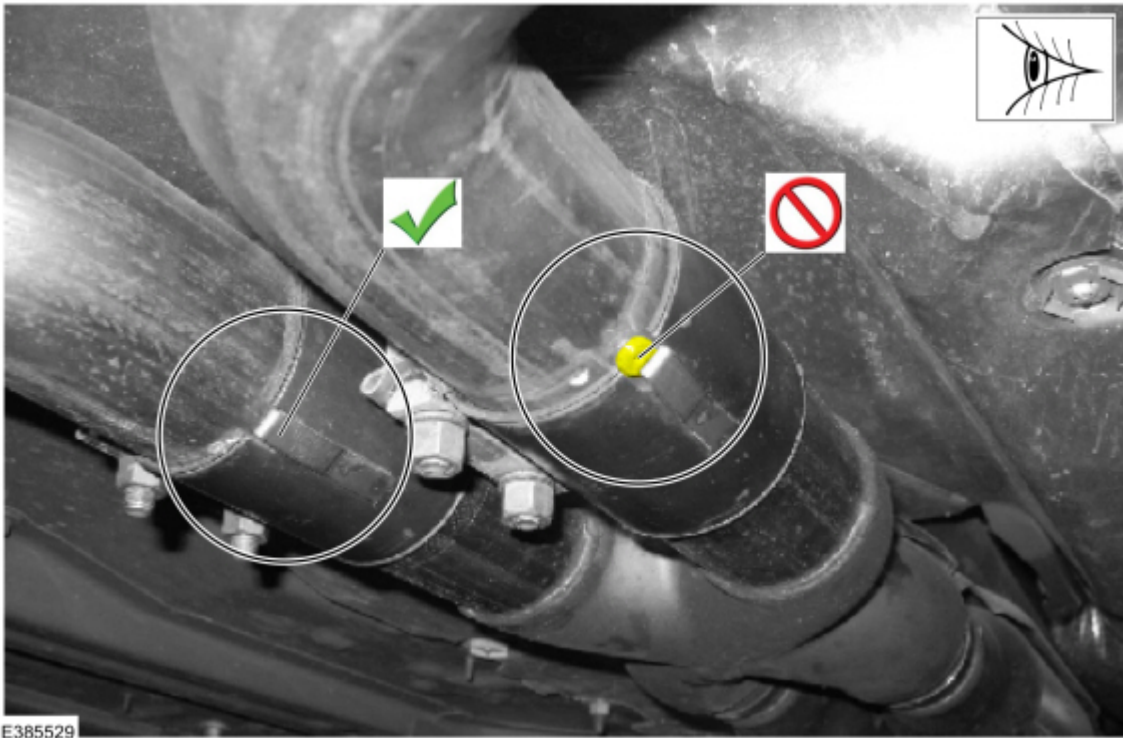
Figure 1 - Exhaust clamp locking tabs

- Is the concern still present?
 - Yes - proceed to Step 5.
 - No - repair is complete.
- Inspect the muffler and tailpipe assembly and both catalytic converters for proper positioning in the exhaust clamps which secure them together. Make sure the exhaust clamp locking tab is fully engaged to the catalytic converters (Refer to Figure 1). Make sure the knurled/ridge area of the muffler and tailpipe assembly are covered by the exhaust clamps (Refer to Figures 2-3). Adjustments can be made by loosening the exhaust clamps and repositioning the muffler and tailpipe assembly. (Figures 1-3)

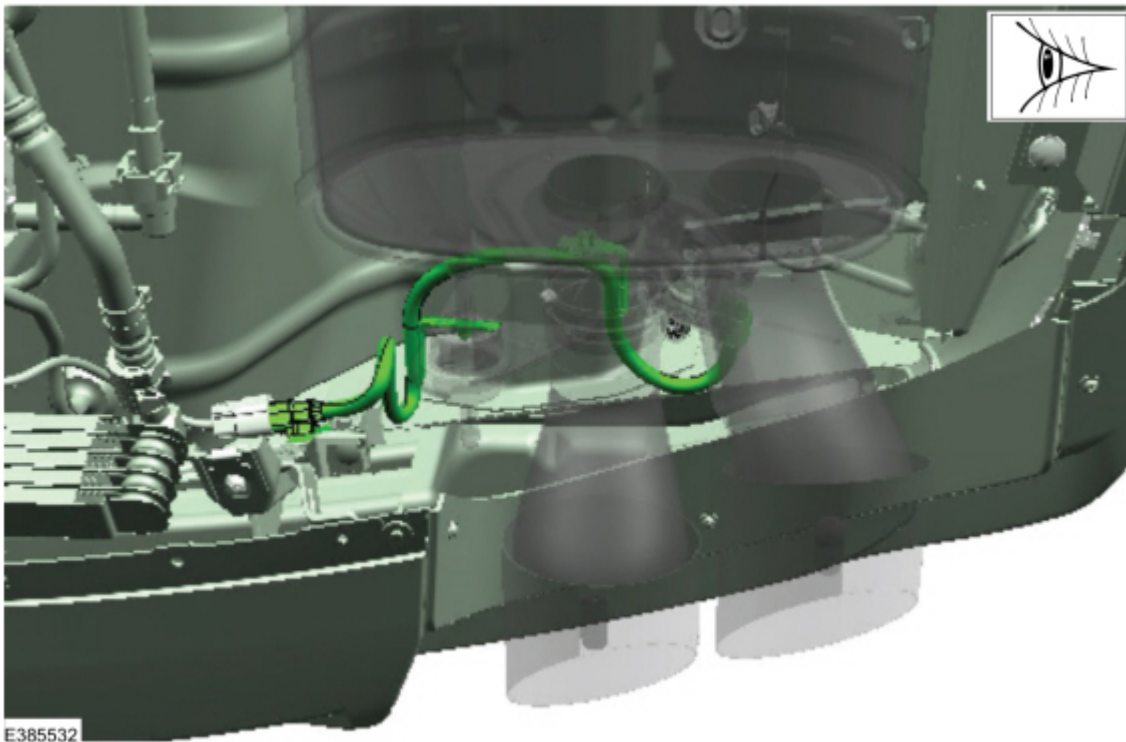
Figure 4 - GT500 shown, other vehicles similar

6. Inspect the exhaust actuator wiring harness for signs of damage. If damage is found, replace the exhaust actuator wiring harness (service base part number: 14A411). (Figure 4)
