TECHNICAL SERVICE BULLETIN

2.0L EcoBoost - Rattle Noise At The Transmission Bellhousing Area

22-2381

Ford 2015-2018 Fusion	Engine: 2.0L EcoBoost
Lincoln 2015-2018 MKZ	Engine: 2.0L EcoBoost

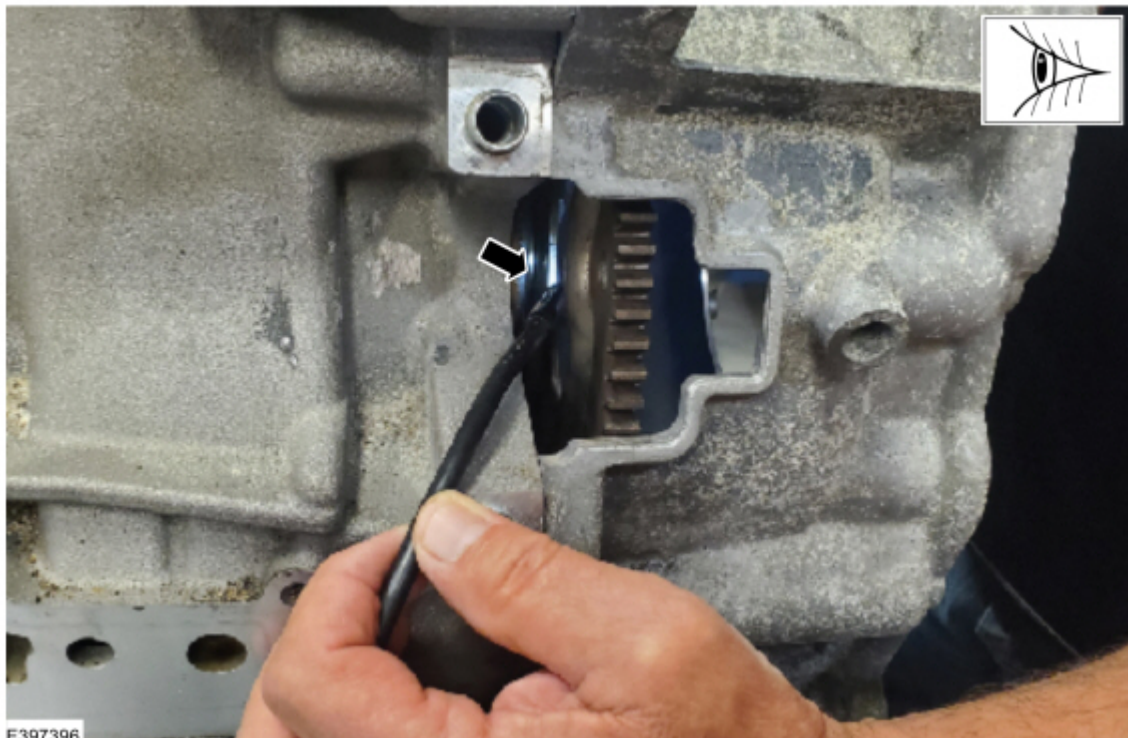
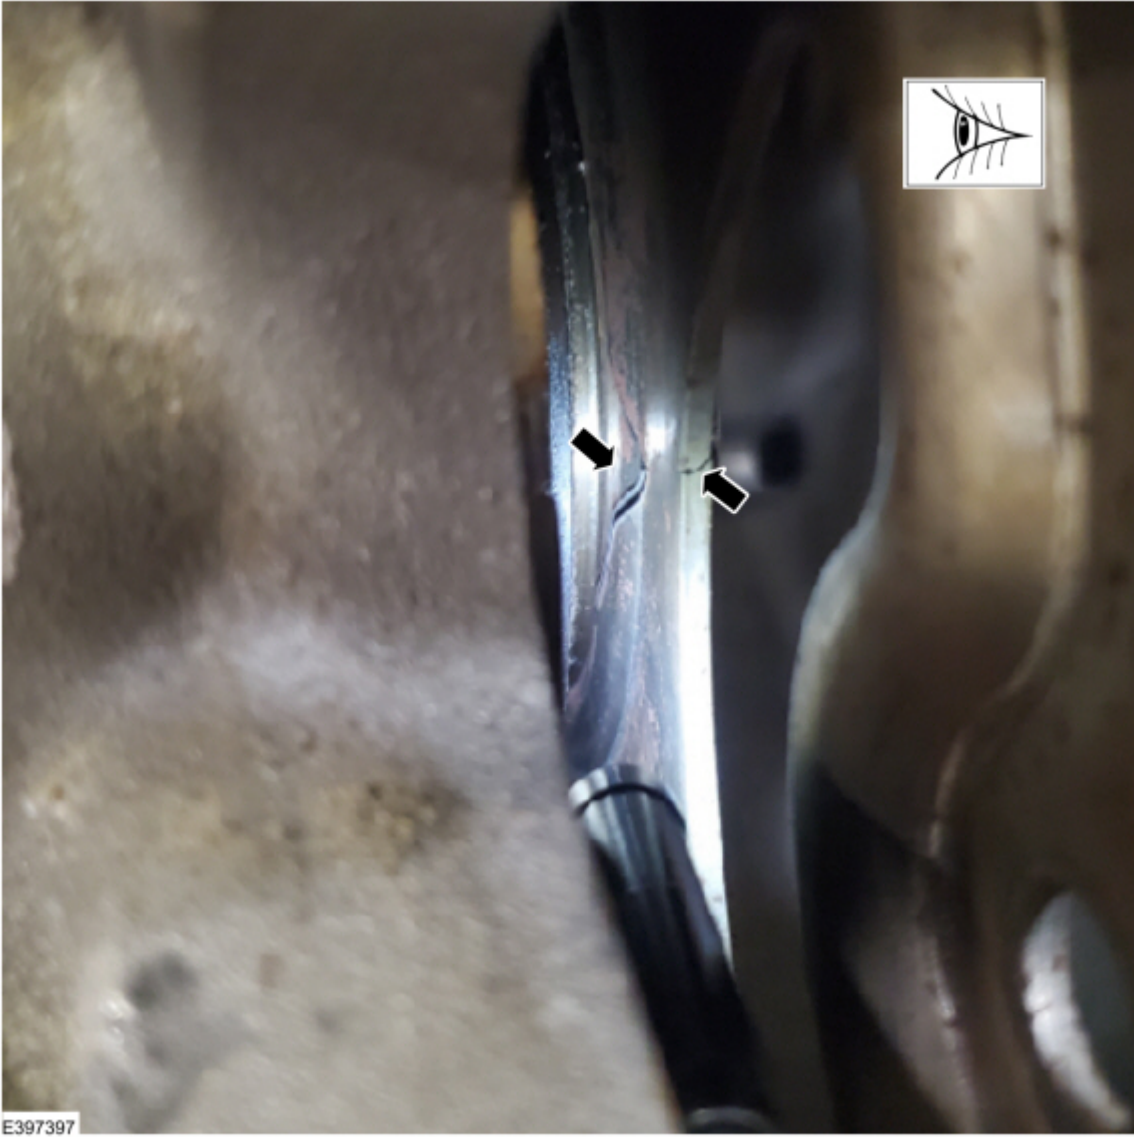
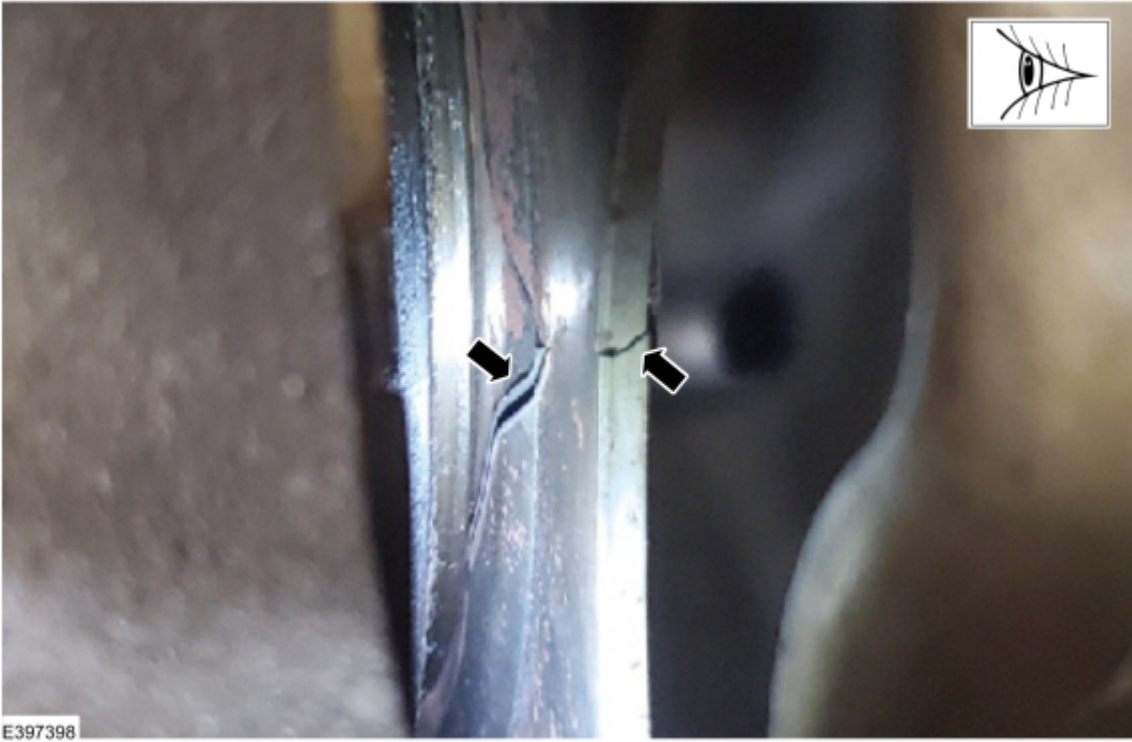
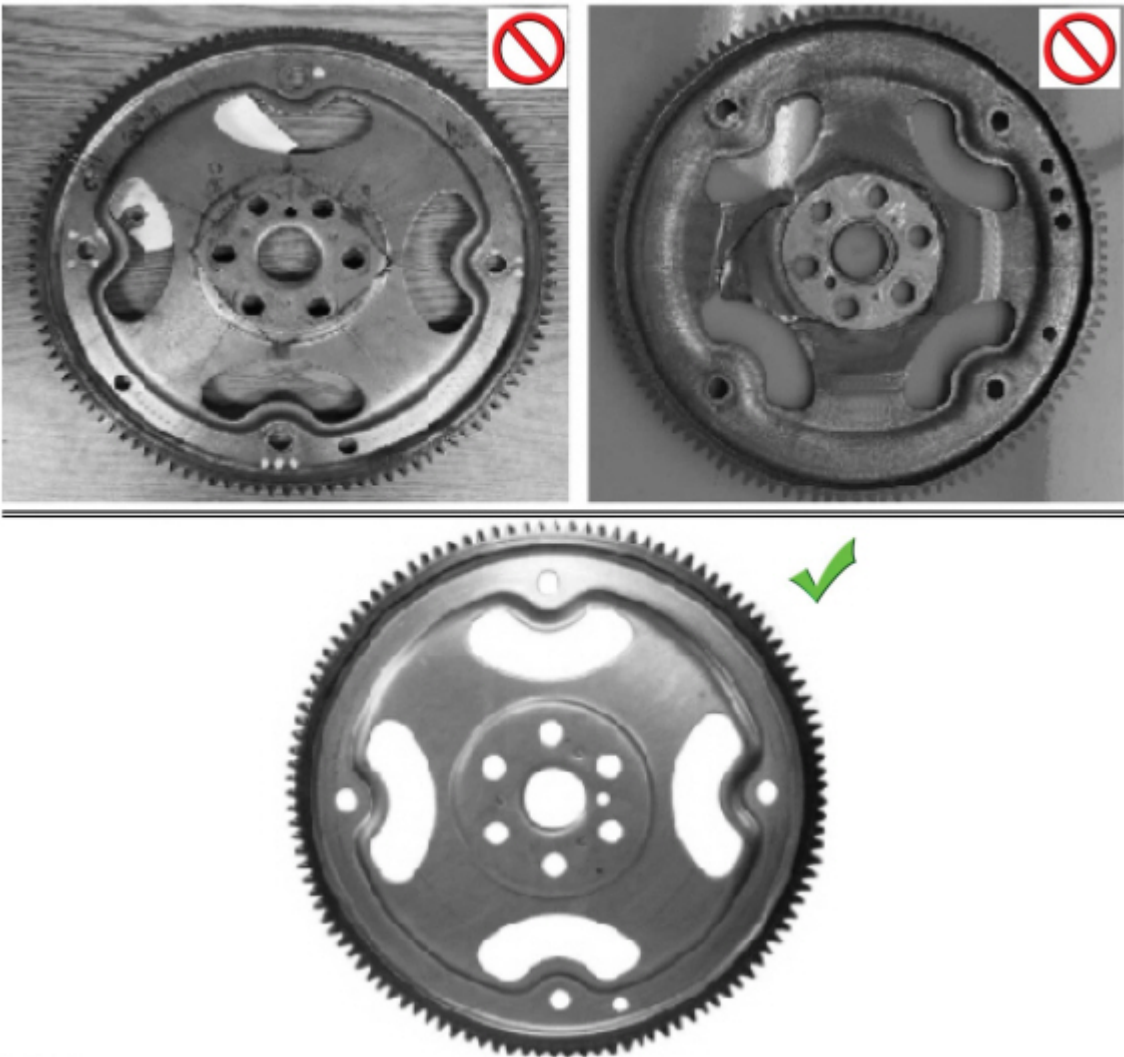
Issue: Some 2015-2018 Fusion/MKZ vehicles equipped with a 2.0L EcoBoost engine may exhibit a rattle noise from the transmission bellhousing area. This may be more noticeable at idle. This may be due to a flexplate crack around the mounting area. To correct the condition, follow the Service Procedure to replace the flexplate, transmission fluid pump, and torque converter.

4. Placing a borescope between the engine block and flexplate, inspect the flexplate for cracks near the crankshaft. Are there any cracks present in the flexplate? (Figures 1-4)

NOTE: It may be necessary to rotate the engine crank to find the cracks in the flexplate.

- (1). Yes - proceed to Step 5.
- (2). No - reinstall the starter motor. Refer to WSM, Section 303-06. For further diagnostics outside this article, refer to WSM, Section 100-04. Repair is complete.

6. Remove and replace the flexplate. Refer to WSM, Section 303-01B.
7. Remove and discard the torque converter.
8. Remove the torque converter housing from the transmission case. Refer to WSM, Section 307-01A. Steps 6 through 40 are not required.

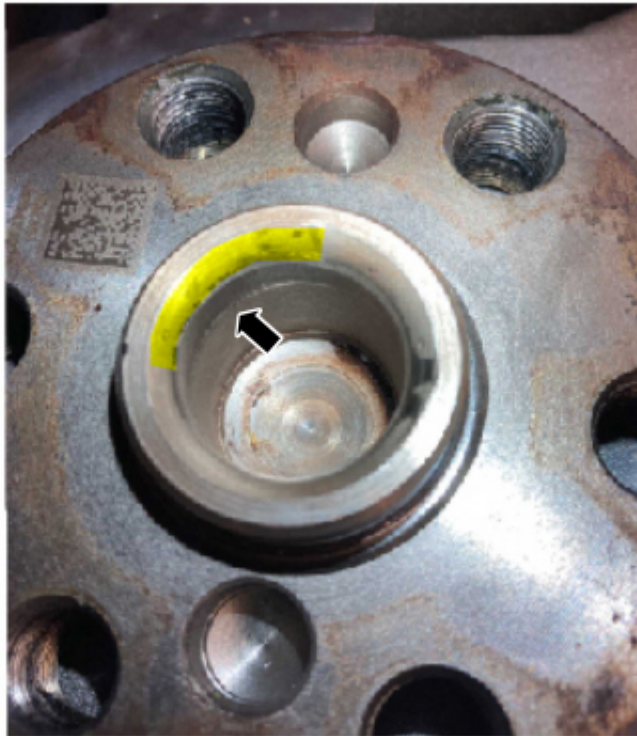
Figure 5

15. Inspect for damage on the crankshaft pilot bore. Is there damage? (Figure 5)

(1). Yes - rotate the stud hole nearest to the 12 O'clock upright position so that the damaged part of the crankshaft pilot bore is at the 12 O'clock position. This is important to endure minimal imbalance. Proceed to Step 16. (Figure 6)
