TECHNICAL SERVICE BULLETIN

Flutter/Rattle Noise In The Hood While Driving Above 80 MPH (129 KM/H)

22-2382

Ford 2022 Maverick	Built on or before 3-Aug-2022
------------------------------	-------------------------------

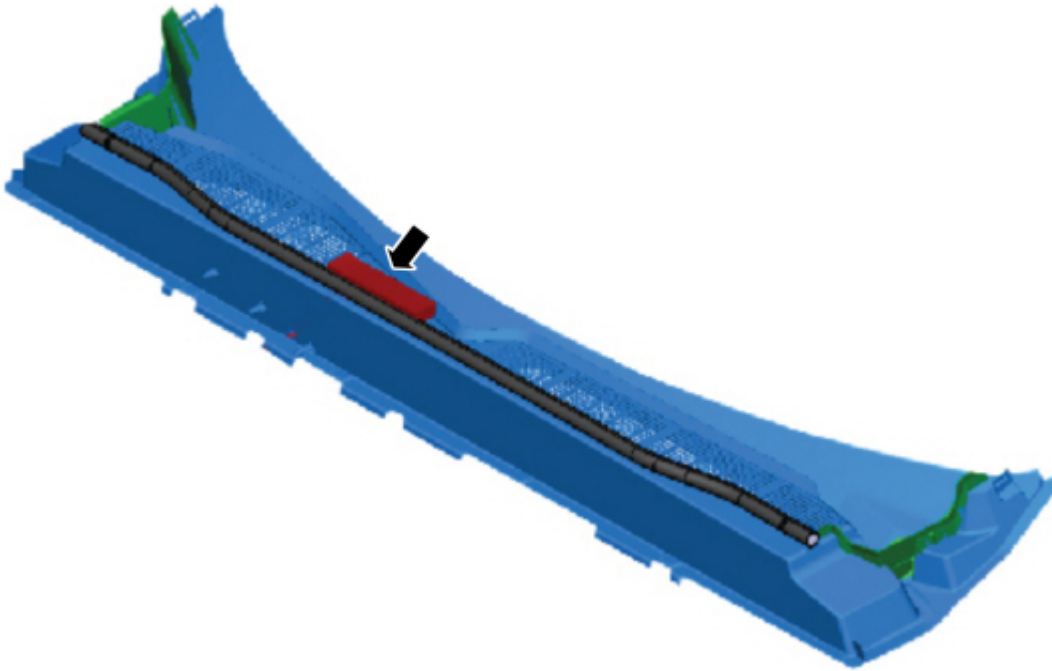
Figure 1

Issue: Some 2022 Maverick vehicles built on or before 3-Aug-2022 may exhibit a flutter or rattle noise in the hood while driving above 80 mph (129 km/h). This may be due to a gap between the hood and the weather strip located in the cowl panel grille. To correct this condition, follow the Service Procedure to diagnose and install a foam tape in the cowl panel grille.

1. Install a foam block tape in the right center section of the cowl panel grill. (Figure 1)
