TECHNICAL SERVICE BULLETIN Water Leak From The A-Pillars, Overhead Console/Upfitter Switches And/Or Sun Visors

22-2403 21 October

Ford 2021-2022 Bronco

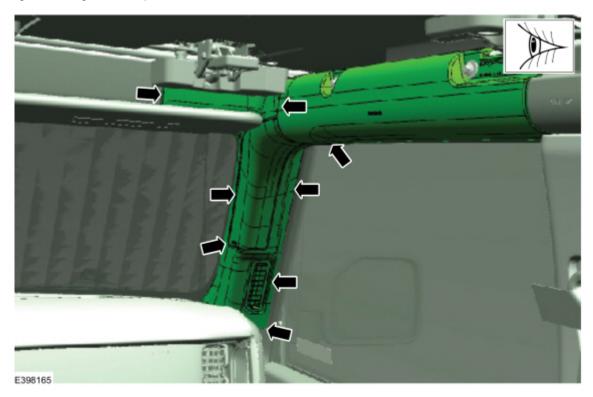
Figure 1 - Right side A-pillar shown, left side similar

1. Does the vehicle exhibit a water leak from any of the locations shown in Figure 1 and Figure 2?

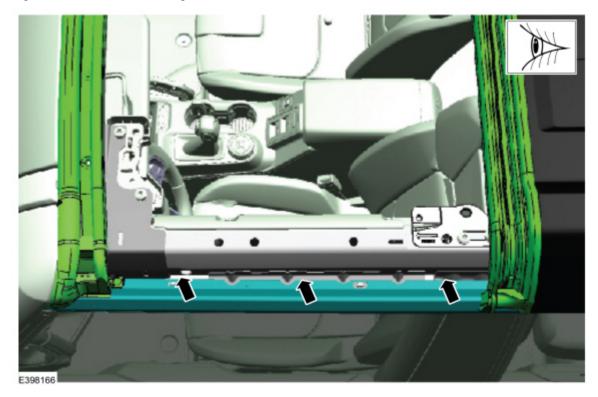
Figure 3 - Left side shown, right side similar

- 3. Is the vehicle equipped with a hard top roof?
 - (1). Yes proceed to Step 4.
 - (2). No proceed to Step 5.
- **4.** Inspect the side roof channels shown in Figure 3. Are there any signs of water in this area leading back to the hard top center panel and hard top rear cap?

- (1). Yes inspect the hard top center panel seal (3-door vehicle) and/or hard top rear cap seal (5-door vehicles) for proper sealing. Repair as necessary. Repair is complete.
- (2). No proceed to Step 5.
- **5.** Inspect the header seal locator pin which can be found to the left of the middle header seal bolt. Is the locator pin missing, broken and/or damaged? (Figure 4)

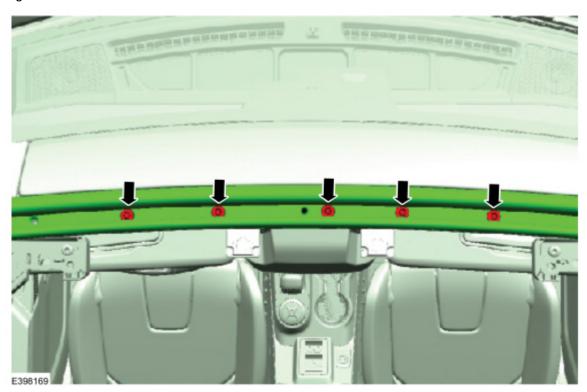
Figure 5

- (1). Yes proceed to Step 11
- (2). No proceed to Step 6.
- **6.** Inspect the five fasteners that secure the header seal to the body. Make sure these are tightened to 9 Nm (80 lb-in). The nuts that receive these bolts are not welded to the body will free spin with the bolt if they are loose. If a bolt spins freely during this check, temporarily remove the windshield header trim panel to gain access. Refer to Workshop Manual (WSM), Section 501-05. (Figure 5)

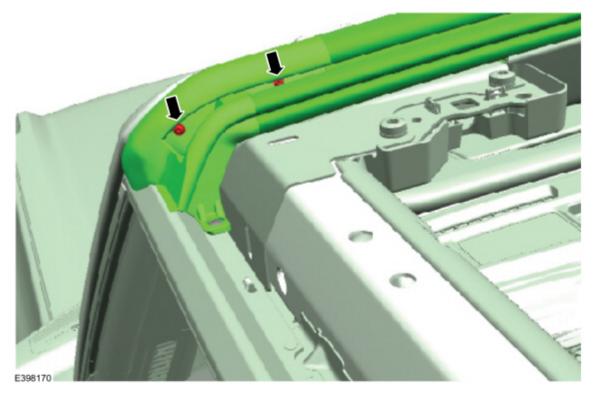
Figure 6 - Left side shown, right side similar

7. Inspect the 2 small bolts on both corners of the header seal. Make sure these are tightened to 3 Nm (26 lb-in). (Figure 6)

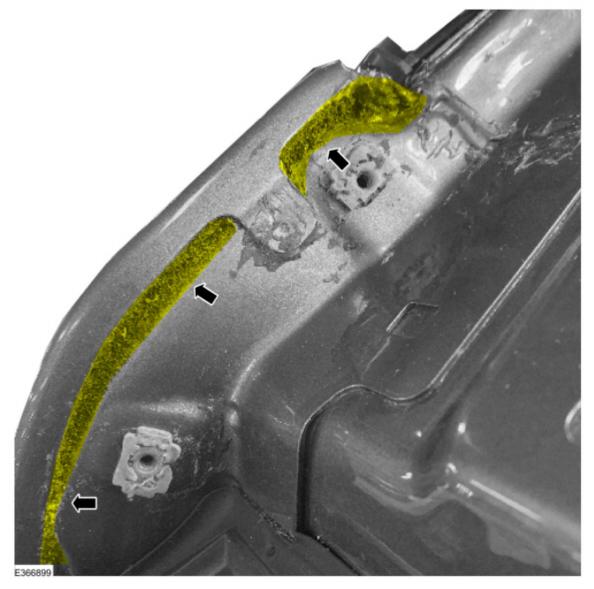
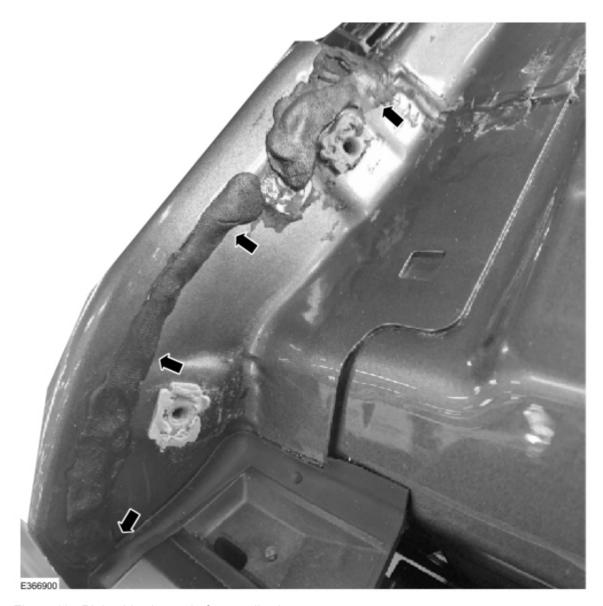
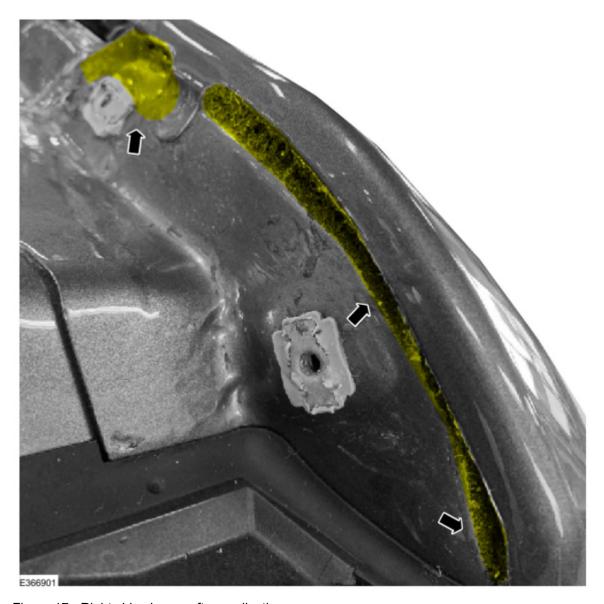
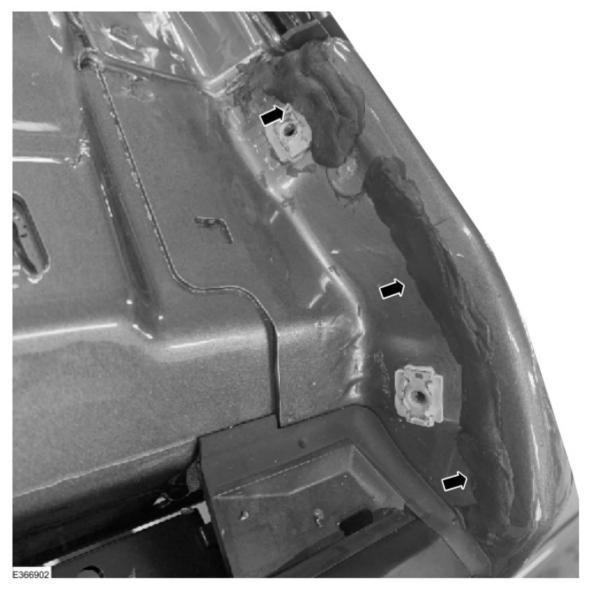
Figure 14 - Left side shown before application

Figure 15 - Left side shown, after application

Figure 16 - Right side shown, before application

Figure 17 - Right side shown, after application

19. Apply 3M[™] Strip-Calk to the exposed body seams starting at the roof rack trim cover area and ending at the corner seal where the body seam ends. Do not leave a gap between the edge of the caulk and the corner seal. (Figures 14-17)
