SERVICE INFORMATION BULLETIN

APPLICABILITY: 2020-2021MY Outback
2019-2021MY Forester
2019-2021MY Ascent

NUMBER: 07-199-21R

SUBJECT: Measurement of Dark Current
(Standby Current Draw)

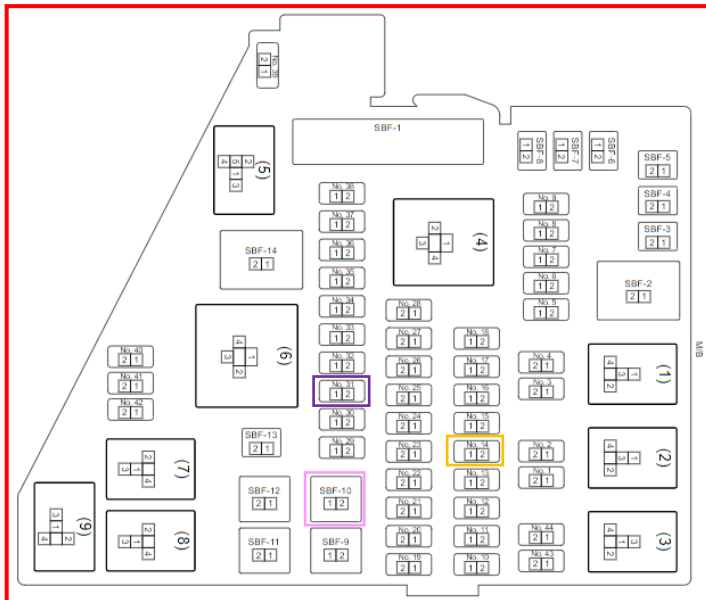
Ascent & Forester

VDC Fuse

Fuse No.31

SBF No.10

Power Rear Gate Fuse

Fuse No.14

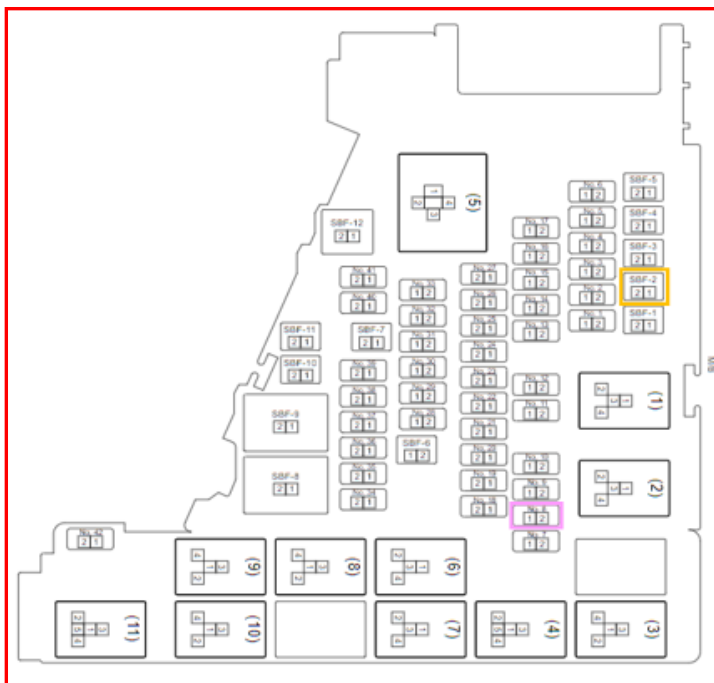
Outback

VDC Fuse

Fuse No.8

Power Rear Gate Fuse

SBF No.2

Fuse No.37

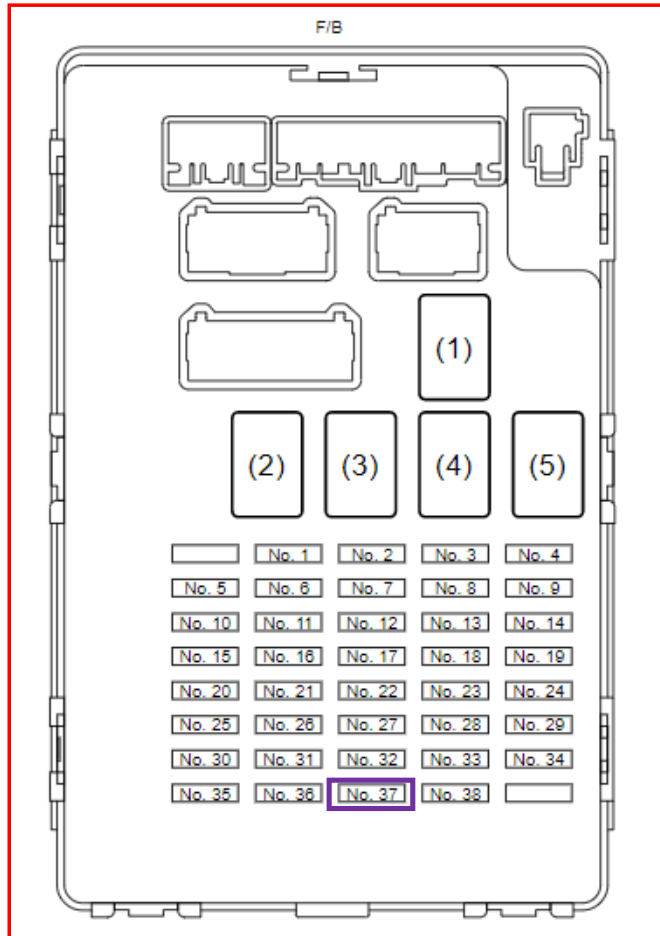
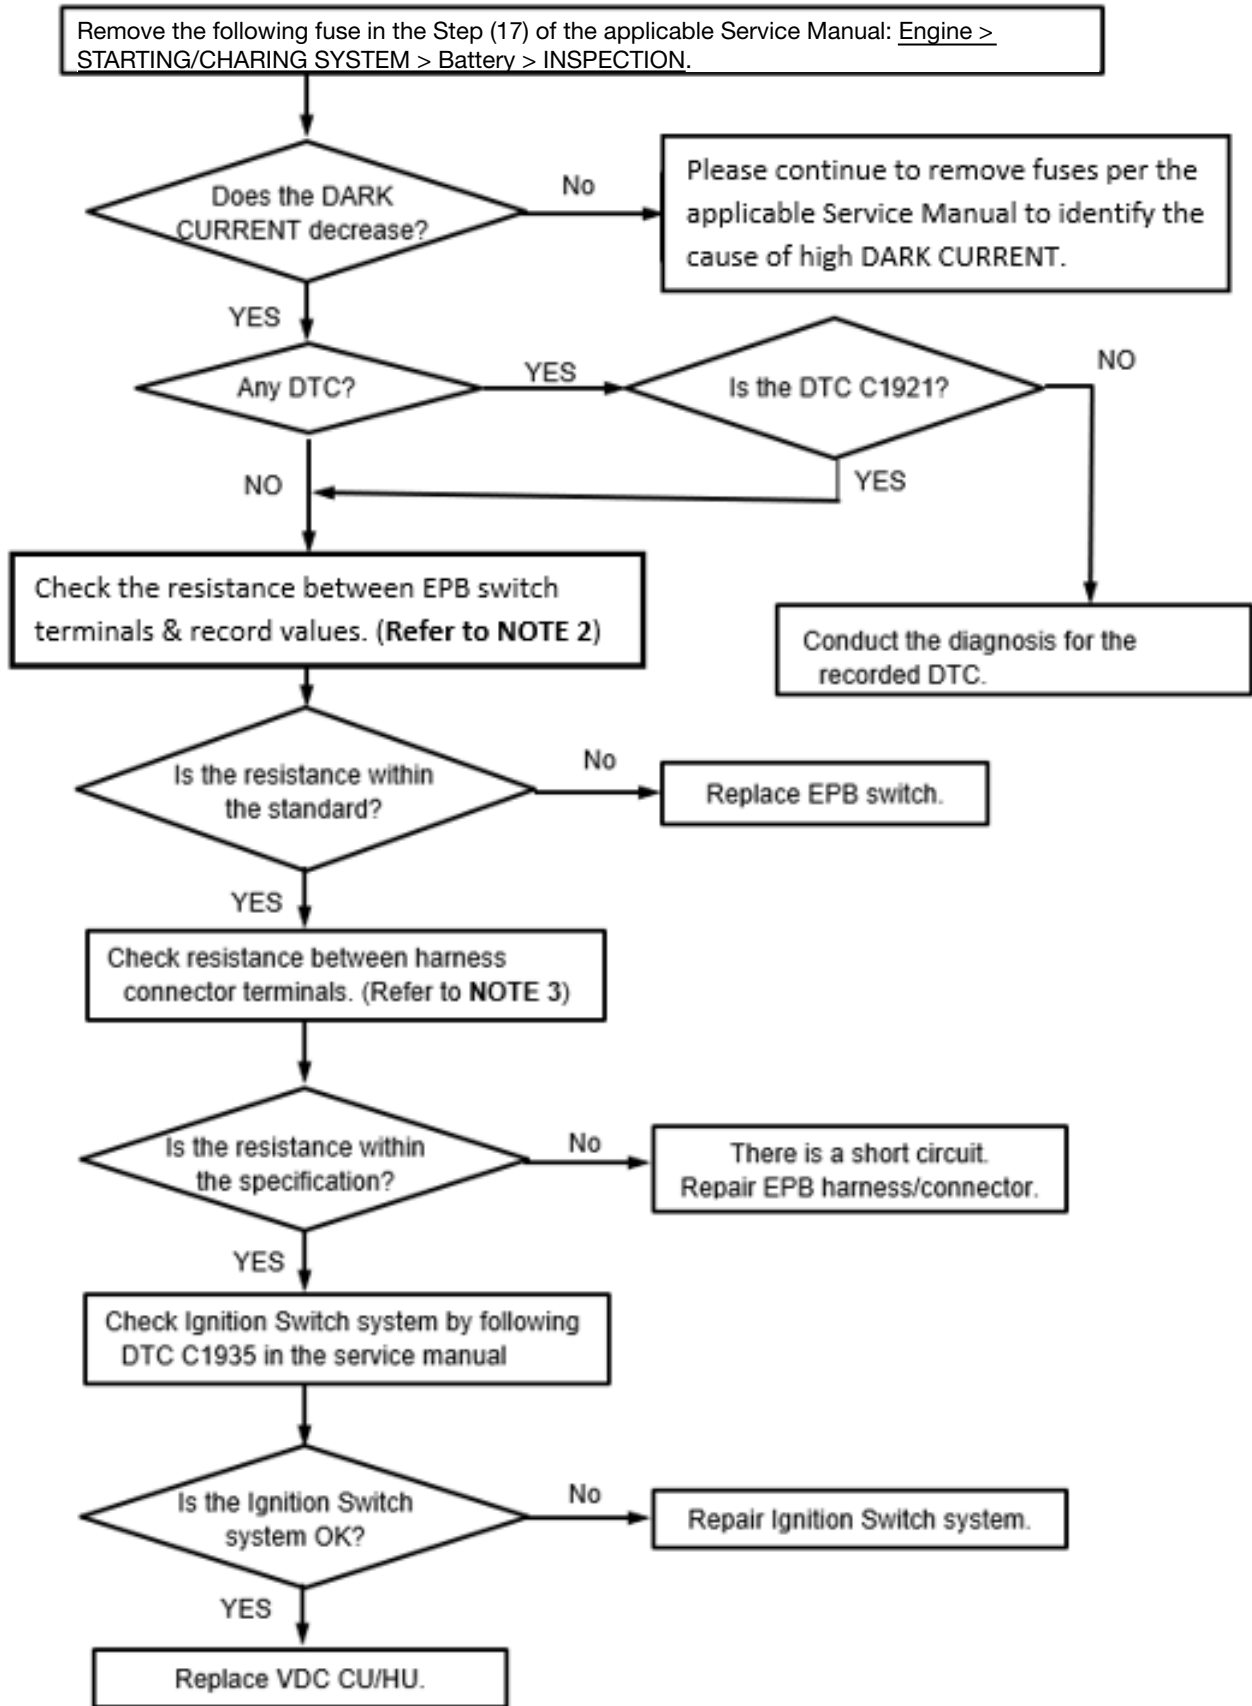
NOTE 1) Troubleshooting Tree for Dark Current (Standby Current) draw from VDC system.

When a dead battery condition is experienced due to excessive Dark Current (Standby Current) draw and the source is traced to the VDC and/ or Power Rear Gate Control Module, **it is IMPORTANT** to follow the procedures outlined in the applicable Service Manual: Engine > STARTING/CHARGING SYSTEM > Battery > INSPECTION, in conjunction with the additional diagnostic information provided below.

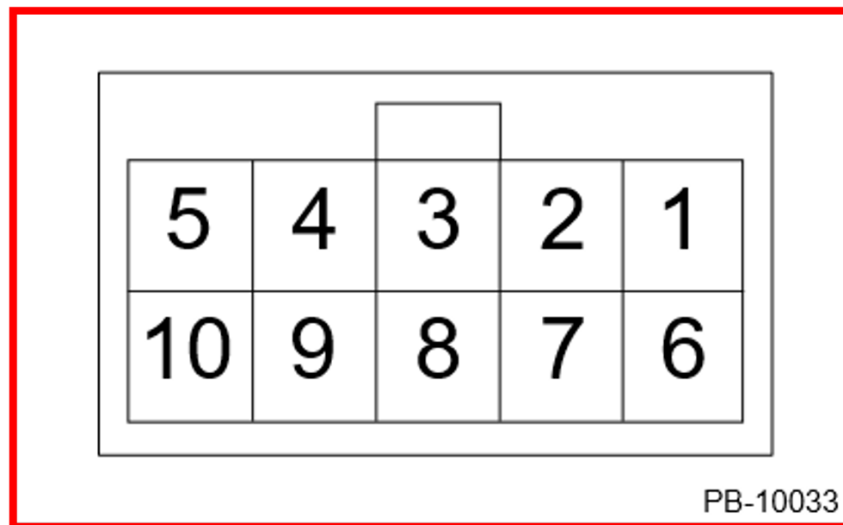
NOTE 2) How to check resistance between EPB switch terminals.

Switch Position	Terminal No.	Standard
Neutral	1-2 4-5	1MΩ and higher
	1-5 2-4	Less than 1Ω

- Confirm the ignition is switch OFF:
- Disconnect the EPB switch connector, and check if Dark Current decreases. If Dark Current decreases by disconnecting the EPB switch connector, replace EPB switch and continue diagnosis.
- Check resistance between terminals per the illustrations below.

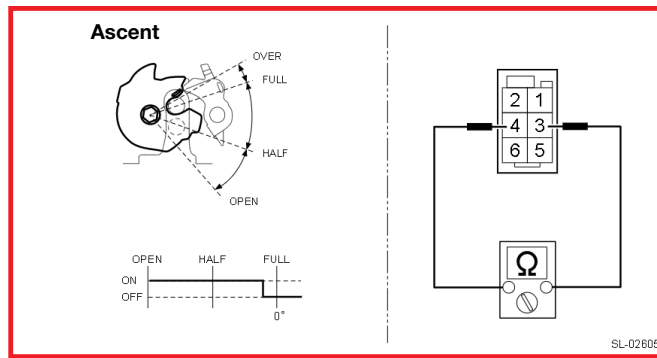
Terminal No.	Inspection Conditions	Specification
5 to 4	Open	Less Than 1 Ω
	Half	Less Than 1 Ω
	Full	60 M Ω or More
