Bulletin No.: PIP5175E

PIP5175E Slip Or Shudder During A Launch In First Second Third Or Fourth Gears Delayed Engagement Into Drive Clunk Or Bump During The 1-2 Shift

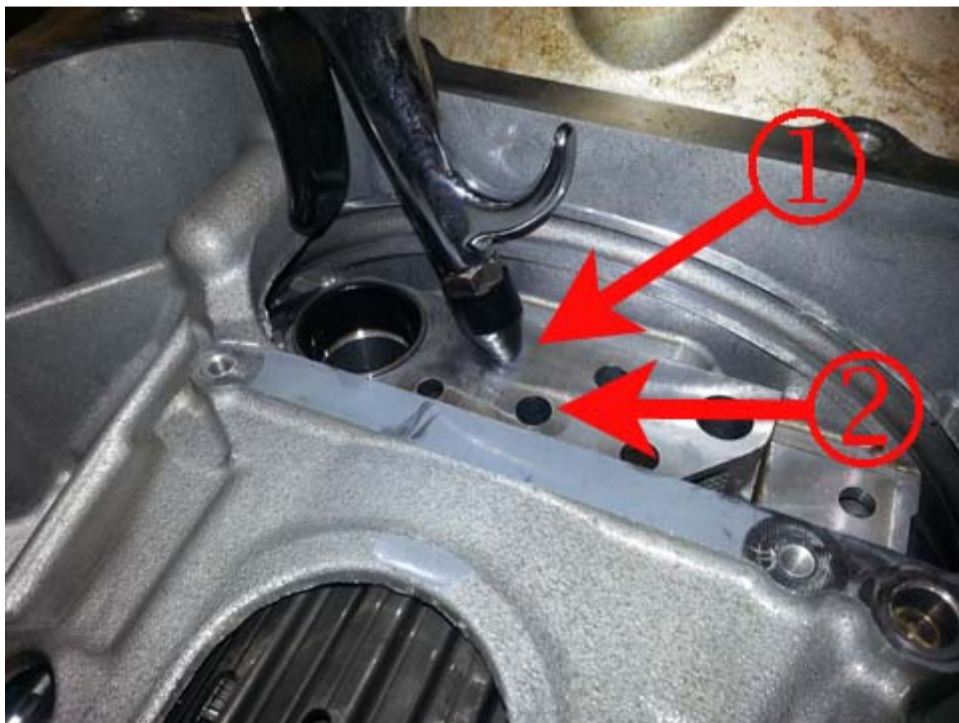
Referring to the picture below and wearing proper eye protection apply compressed air to the 1-2-3-4 clutch apply passage and inspect for air leaking out of the compensator feed passage in the pump cover.

If no leakage is found out of the compensator feed passage listen for excessive air leakage inside the transmission.

Callout 1

Component Name: Applying compressed air to the 1234 clutch passage.

Callout 2

Component Name: Compensator feed passage.

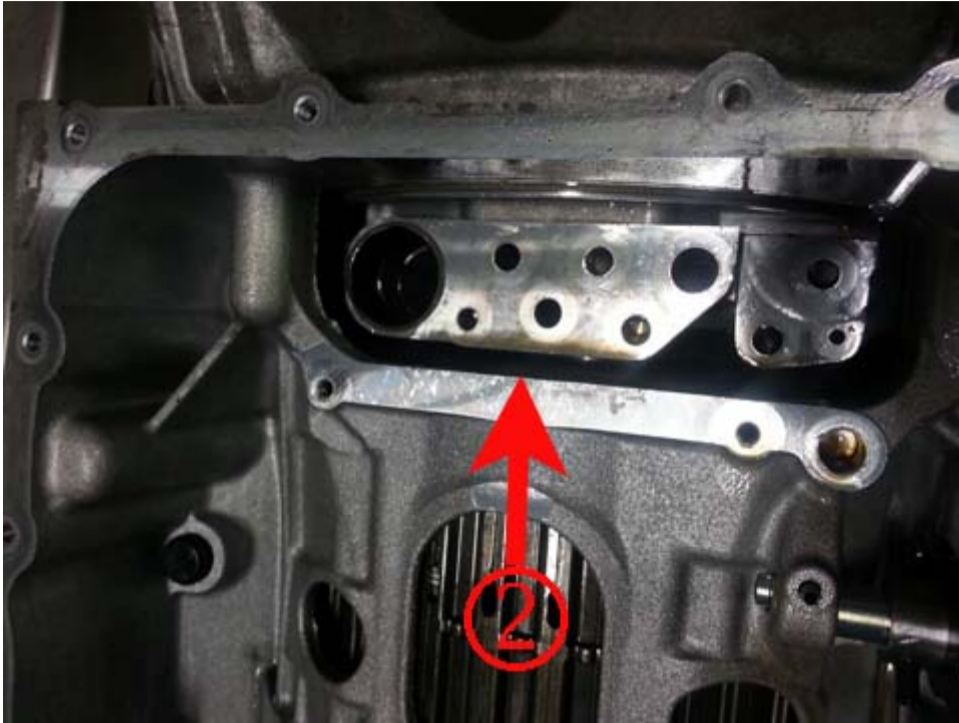
You may also notice fluid leaking or see a misaligned gasket by looking up through the case opening between the pump stator support and the 1234/35R clutch housing during this test as shown below.

Callout 2

Component Name: Gap between the pump cover and the 1234/35R clutch housing.

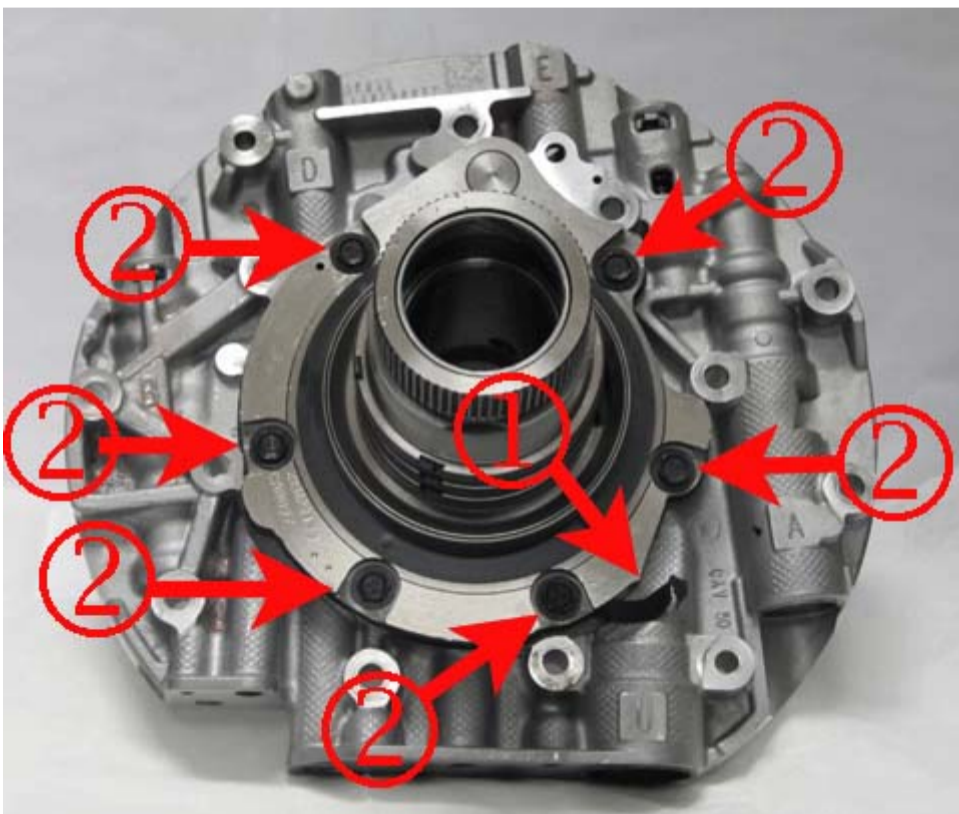
These concerns may be due to loose stator support to pump cover bolts causing a leak at the stator support to pump cover gasket.

If excessive air leakage is found inspect the transmission fluid pump for loose stator support to pump cover bolts or a misaligned stator support to pump cover gasket.

Callout 1

Component Name: Misaligned Gasket

Callout 2

Component Name: Stator Support Bolts

If any of the bolts are loose or the gasket is misaligned or leaking, the transmission pump cover must be replaced and the 1234 clutch plates should be inspected for being distressed and repaired as needed.

Note: The transmission adapts must be reset if the pump cover is replaced to address this concern.
