Preliminary Information

PIP5845A Engine Coolant Reservoir Overfilled With Discolored Coolant Possible Engine Overheat Transmission Shake Shudder Vibration Shift Performance Or Slipping

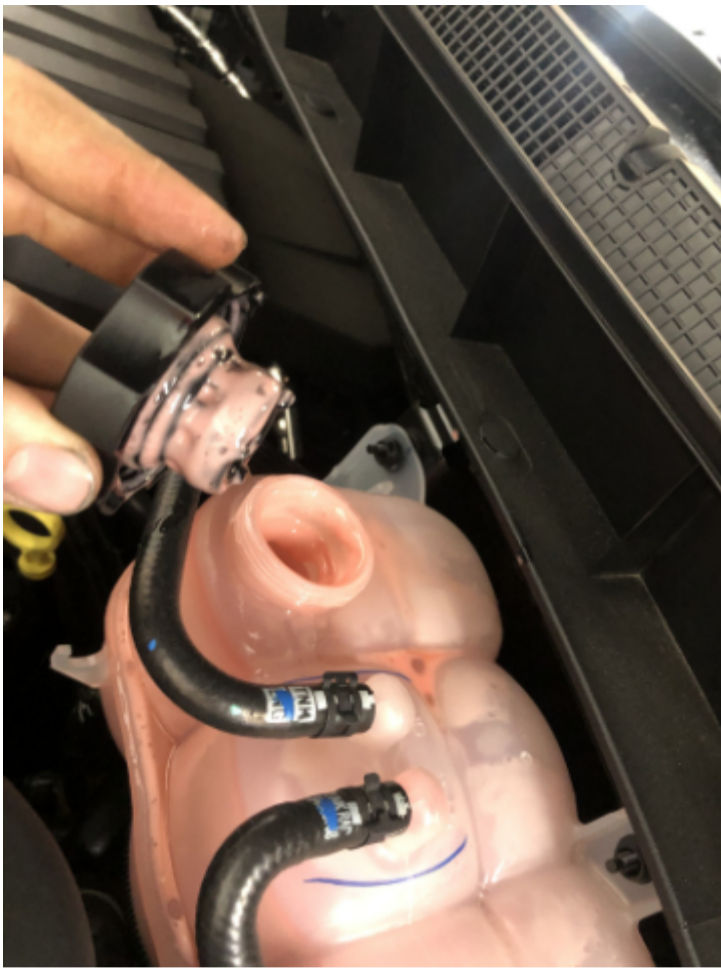
Involved Region or Country	North America
Condition	<p>Some customers may comment of the following conditions: Engine coolant reservoir is discolored with a strawberry milkshake appearance and may be overfilled to the point where coolant is being expelled from the overflow. See photo below (coolant is not bright orange and translucent). In addition to above, engine, and/or transmission may experience an overheat condition. In addition, possible degraded transmission performance including any of the following: Shudder, vibration, shake, shift performance and slipping. The transmission fluid level may be low when checked. Transmission may have overheat/burnt fluid, with or without any DTC setting, and/or without showing the strawberry milkshake appearance. Any transmission related concern found with vehicle built between the build dates listed above, should have the fluid tested for possible glycol contamination.</p>

Cause	<p>The Automatic Transmission Fluid Cooling Exchanger may have an internal leak allowing transmission fluid and engine coolant to intermix contributing to and of the above conditions.</p>

Confirm the presence of coolant in the transmission fluid using Service Bulletin # [08-07-30-035](#) (Information on Water Ethylene Glycol in Transmission) in SI.

Using [08-07-30-035](#) as a guide repair or replace the transmission assembly following SI.

Replace the Automatic Transmission Fluid Cooling Exchanger.

Thoroughly Flush the Engine Coolant System to remove the contaminated engine coolant following SI.

Refill the engine coolant system following SI.
