SERVICE BULLETIN

APPLICABILITY: 2017-18MY Forester 2.5L

NUMBER: 09-84-22R

SUBJECT: Exhaust Pipe Front (EPF) Replacement &
Warranty Extension

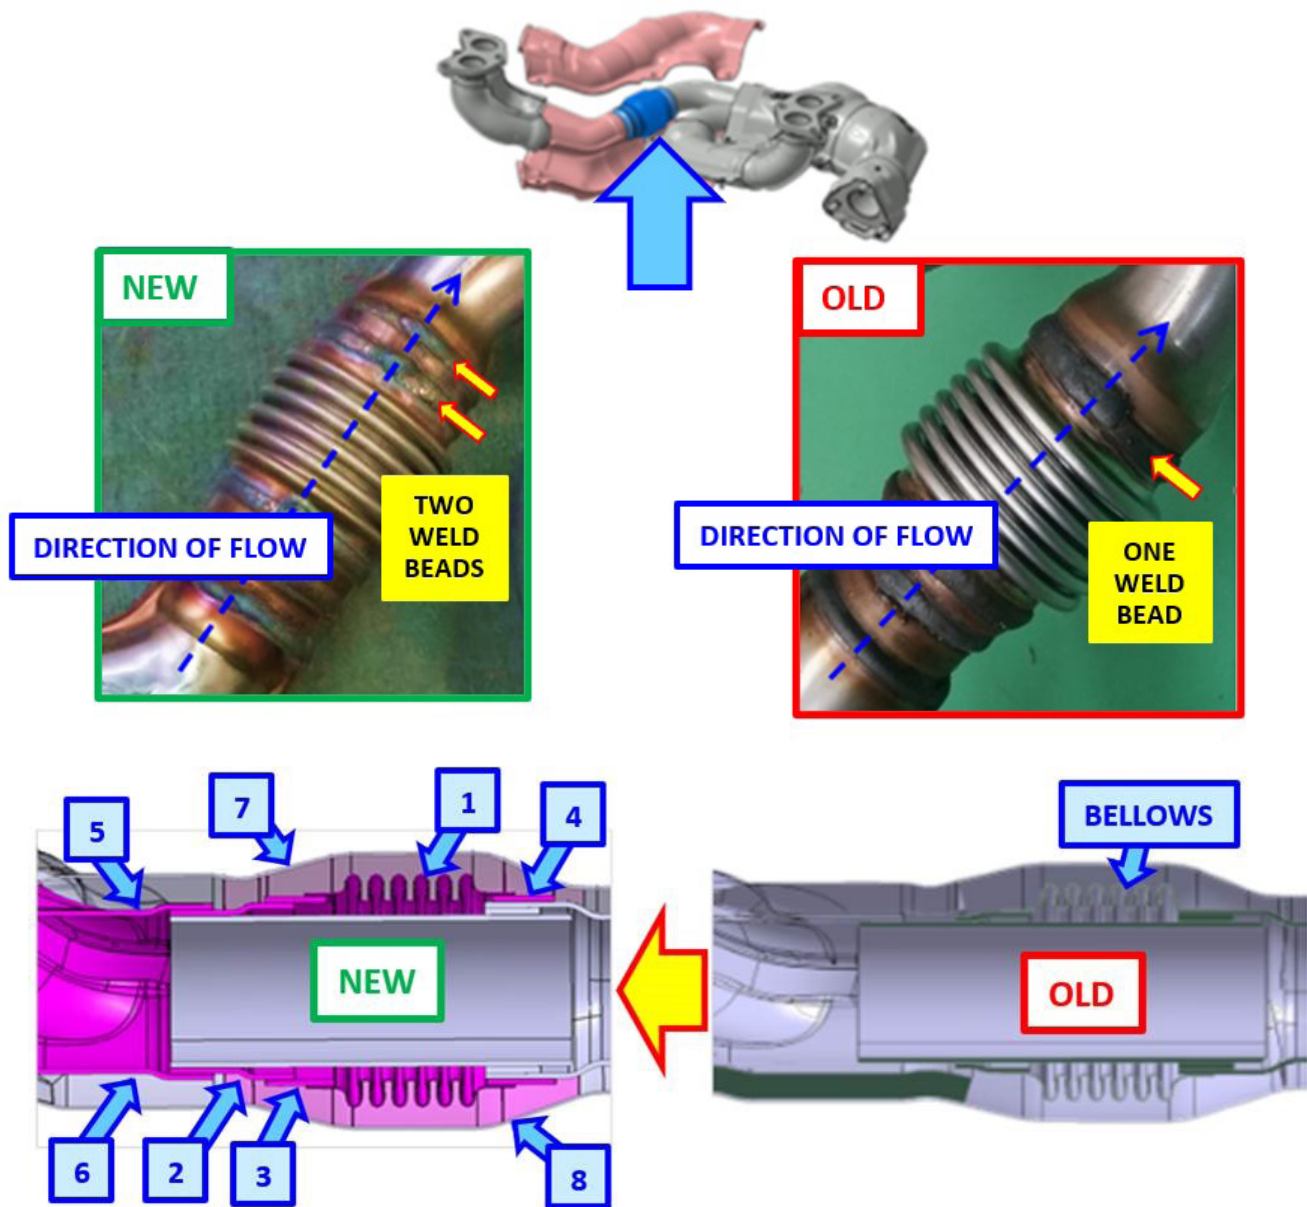
Description of Changes:

Part Description	Number	Areas of Change	Details
Front Exhaust Pipe (CONVERTER COMPLETE-FRONT)	1	Bellows	Material Change
	2	Holder	Re-Shaped
	3	Upstream Holder	Re-Sized
	4	Downstream Holder	Re-Sized
	5	Upper Elbow	Re-Shaped
	6	Lower Elbow	Re-Shaped
Upper Cover (COVER COMPLETE-CONVERTER PIPE FRONT)	7	Upper Cover	Re-Shaped (Described Next Page)
Lower Cover (COVER COMPLETE-CONVERTER PIPE FRONT)	8	Lower Cover	Re-Shaped (Described Next Page)
