## SERVICE INFORMATION BULLETIN

**APPLICABILITY:** 2020-2021MY Outback  
2019-2021MY Forester  
2019-2021MY Ascent

**NUMBER:** 07-199-21R

**SUBJECT:** Measurement of Dark Current  
(Standby Current Draw)

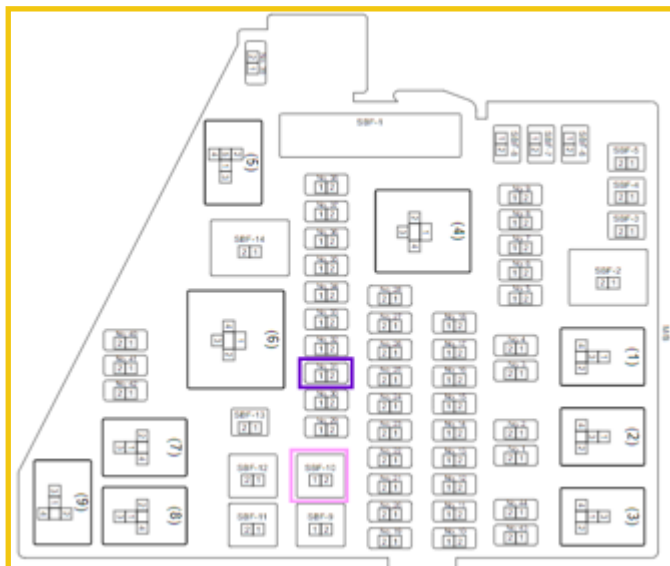
**Ascent & Forester**

**VDC Fuse**  
 Fuse No.31  
 SBF No.10  
**Power Rear Gate Fuse**  
 Fuse No.14

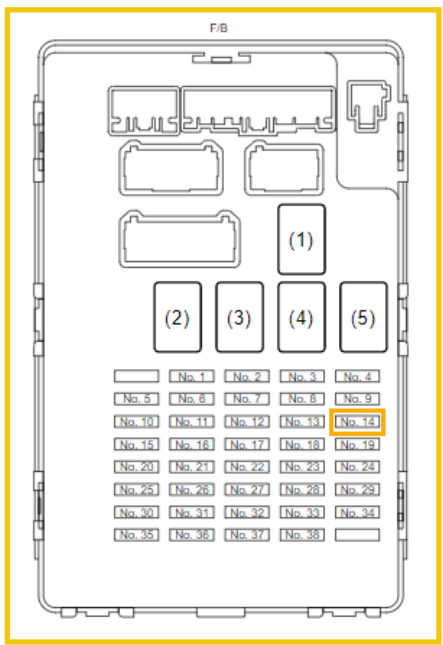
**Outback**

**VDC Fuse**  
 Fuse No.8  
**Power Rear Gate Fuse**  
 SBF No.2  
 Fuse No.37

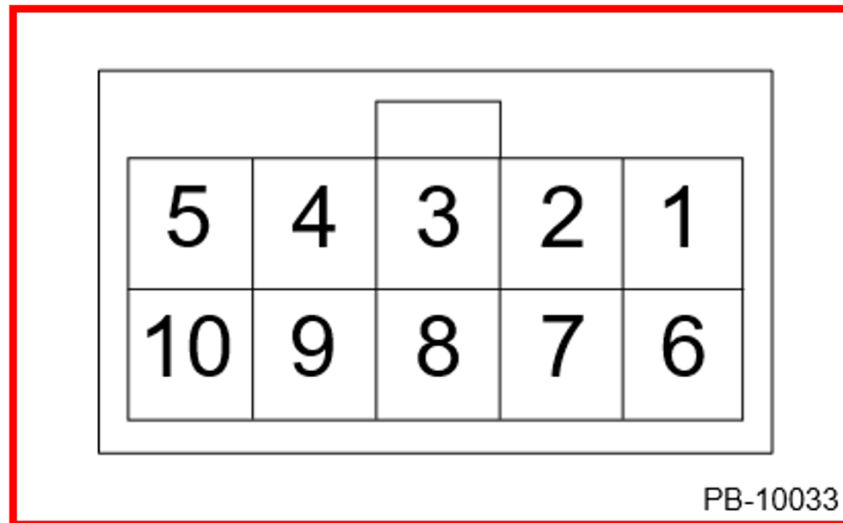
**NOTE 2)** How to check resistance between EPB switch terminals.

- Confirm the ignition is switch OFF:
- Disconnect the EPB switch connector, and check if Dark Current decreases. If Dark Current decreases by disconnecting the EPB switch connector, replace EPB switch and continue diagnosis.
- Check resistance between terminals per the illustrations below.

Switch Position	Terminal No.	Standard
Neutral	1-2 4-5	1MΩ and higher
	1-5 2-4	Less than 1Ω

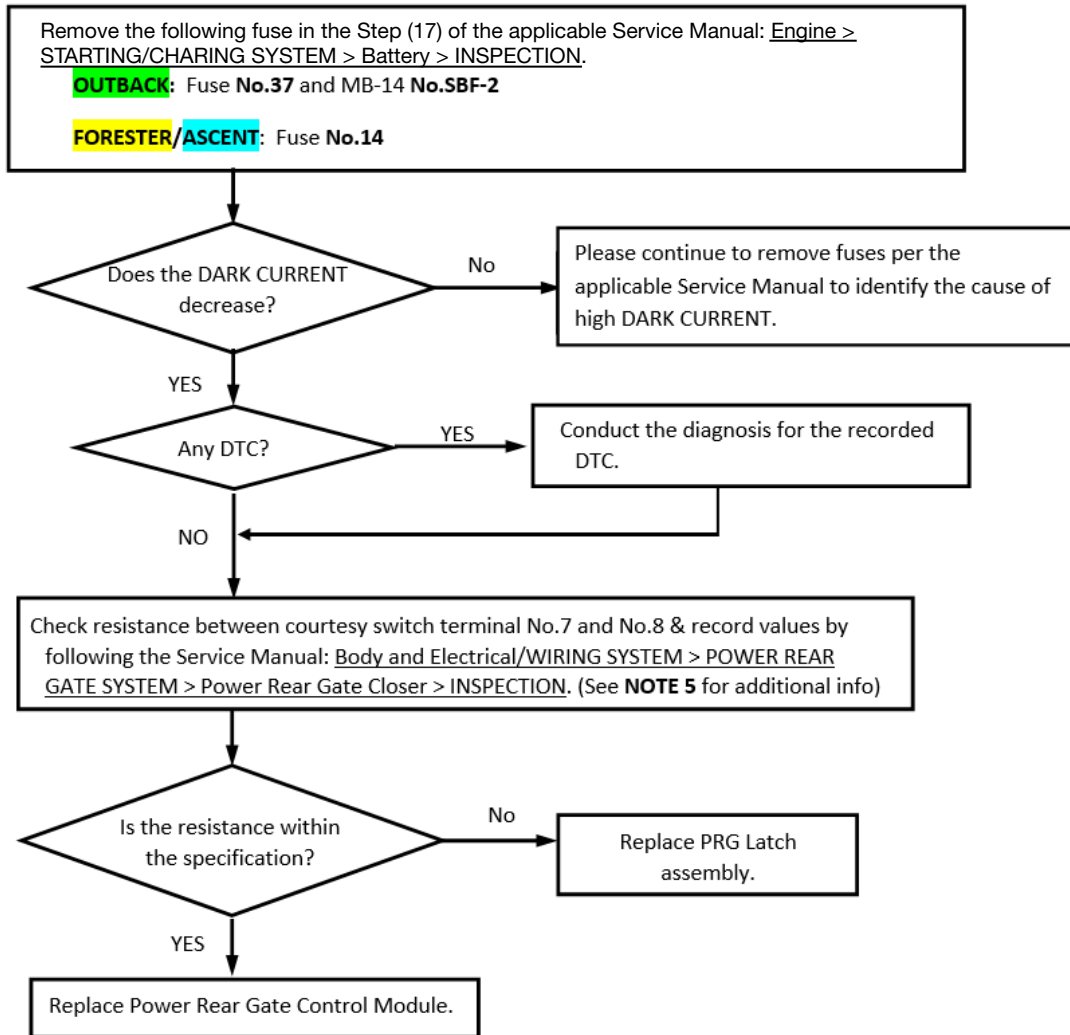
**NOTE 4) Troubleshooting Tree for excessive Dark Current draw from Power Rear Gate system:**

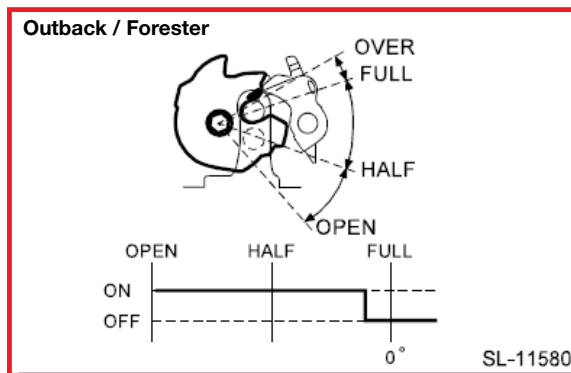
**NOTE 5) How to check resistance between terminals for Courtesy Switch.**

- Check the resistance between the terminals specified in the charts below.

Terminal No.	Inspection Conditions	Specification
7 to 8	Open	Less Than 1 Ω
7 to 8	Half	Less Than 1 Ω
7 to 8	Full	1MΩ or More

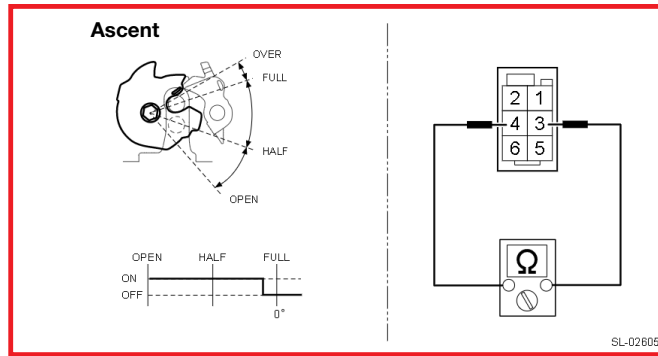
Terminal No.	Inspection Conditions	Specification
5 to 4	Open	Less Than 1 Ω
	Half	Less Than 1 Ω
	Full	60 MΩ or More
