TECHNICAL SERVICE BULLETIN

Hard Top Roof - Headliner Loose And/Or Sagging

22-2436

Ford 2021-2022 Bronco

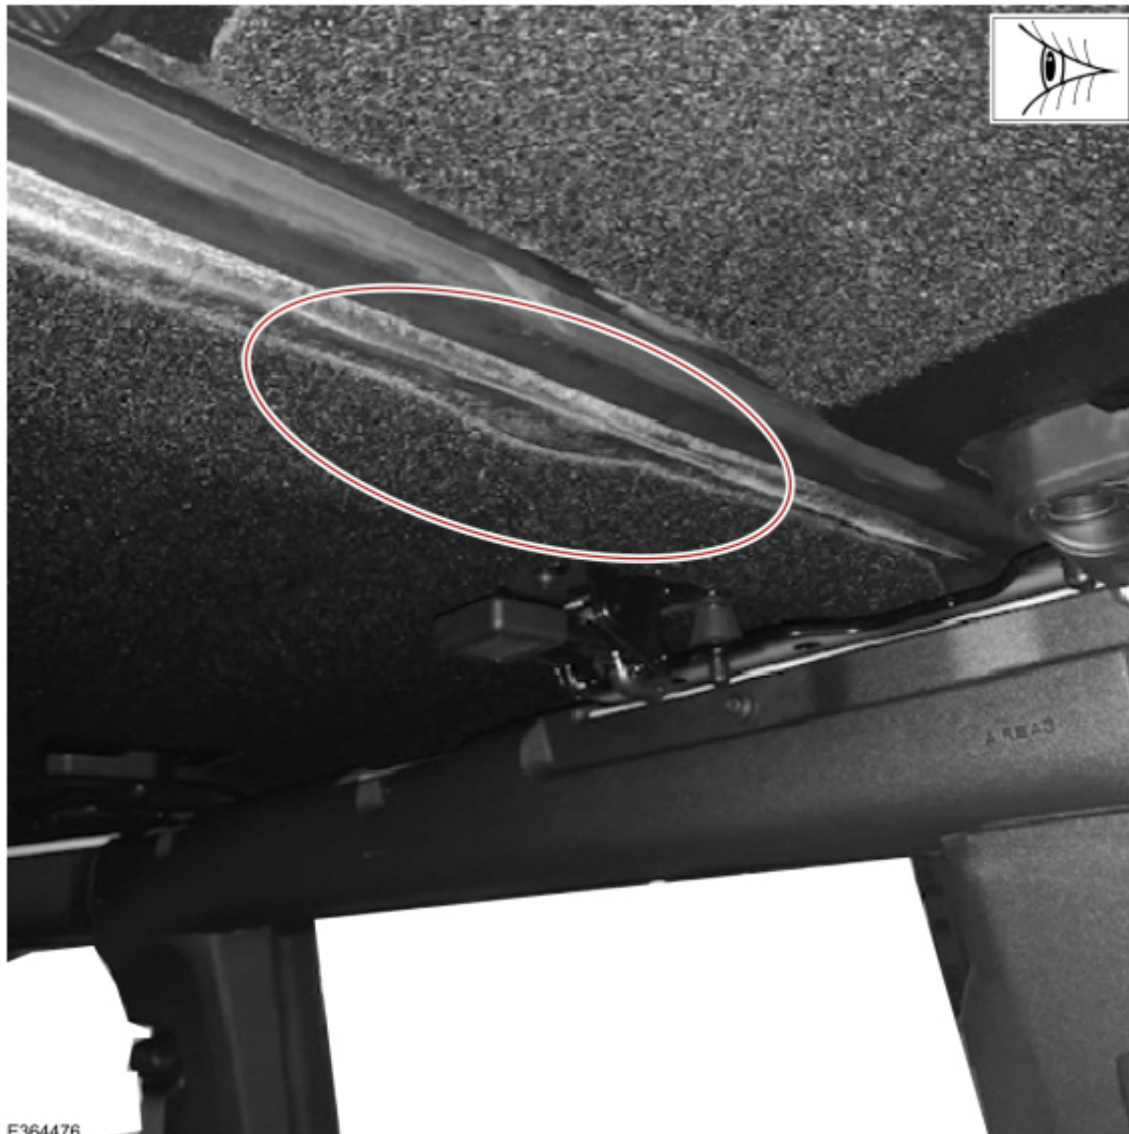
Figure 1

1. Inspect the interior headliner. Is the headliner loose and/or sagging? (Figure 1)

(1). Yes - proceed to Step 2.

(2). No - this article does not apply.

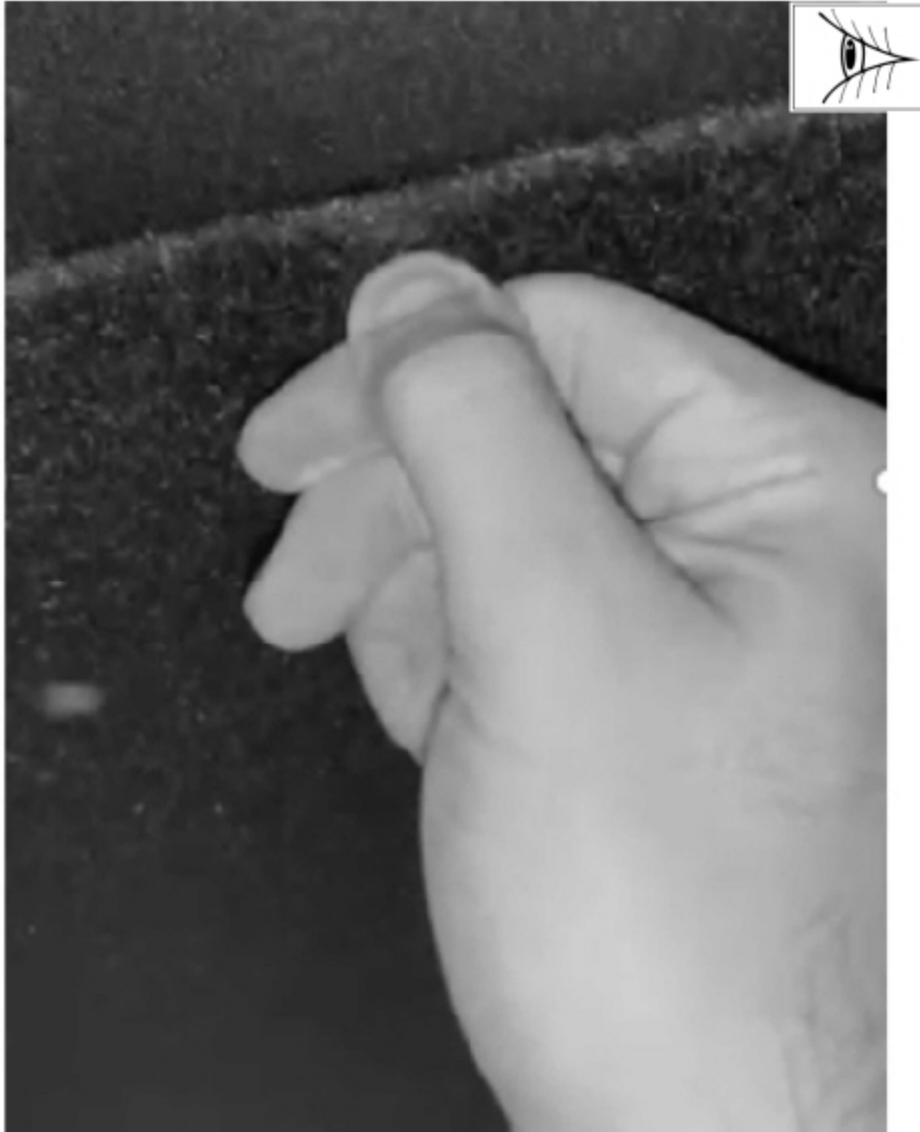
E364479

4. Does the headliner properly adhere to the roof with no visible gaps? (Figure 4)

- (1). Yes - repair is complete.
- (2). No - replace the affected headliner.
