TECHNICAL SERVICE BULLETIN

Illuminated ABS Indicator, Engine Will Not Turn Off And/Or Various Electrical Symptoms

22-2443

Ford
2020-2022 F-Super Duty

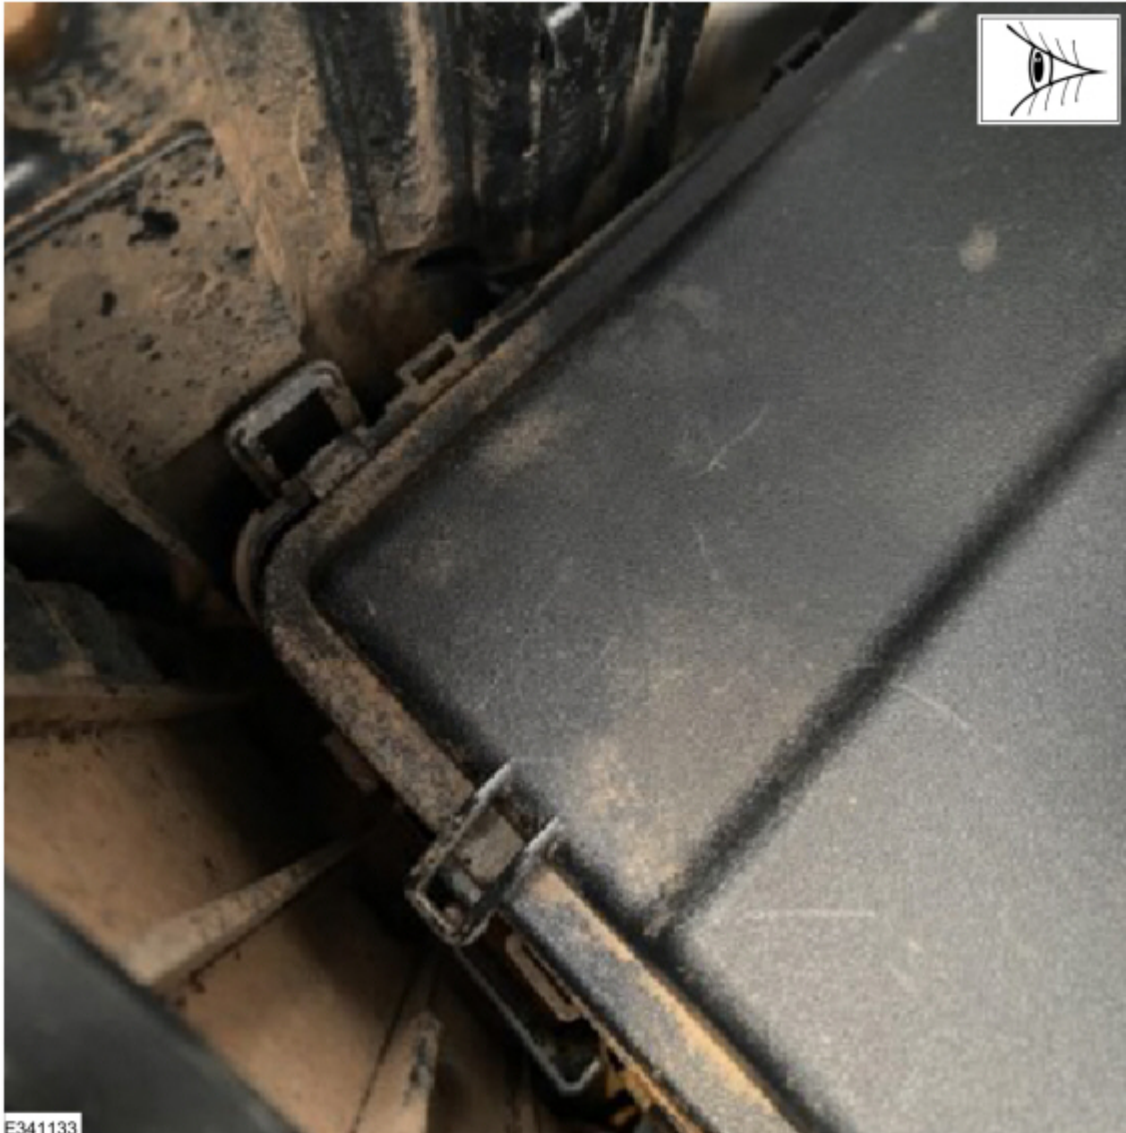
Figure 1 - Example of moisture intrusion with BJB cover on

3. Replace the BJB assembly and cover.

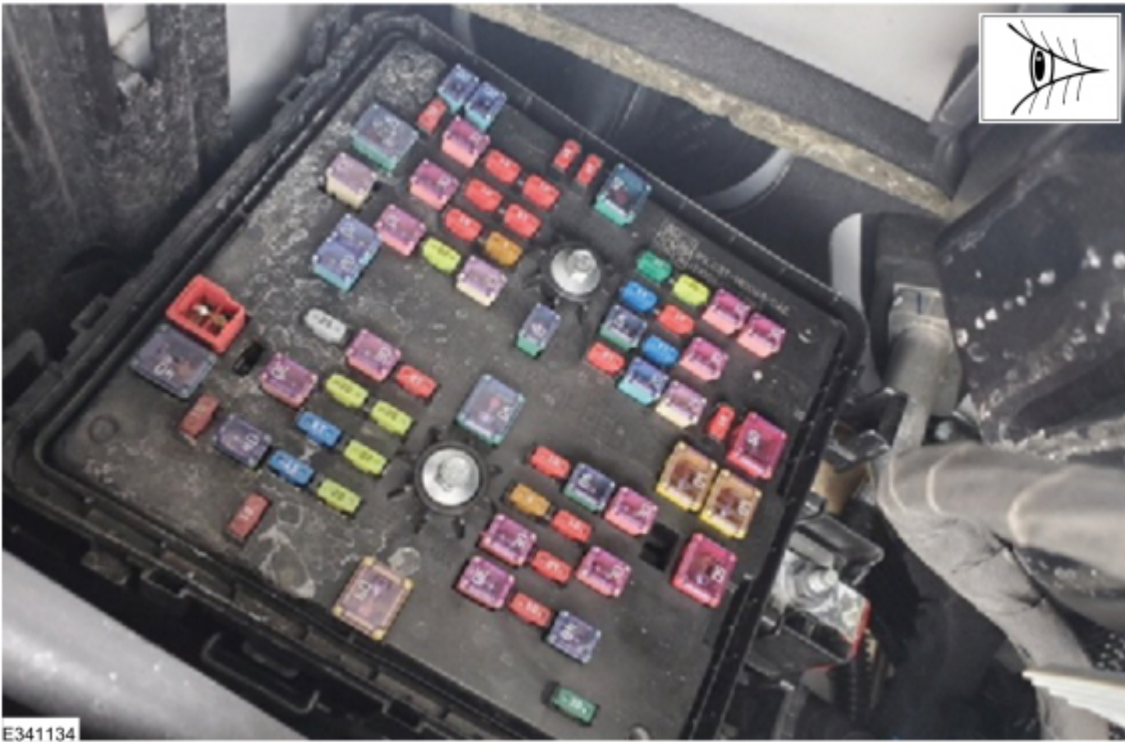
Figure 2 - Example of moisture intrusion with BJB cover off

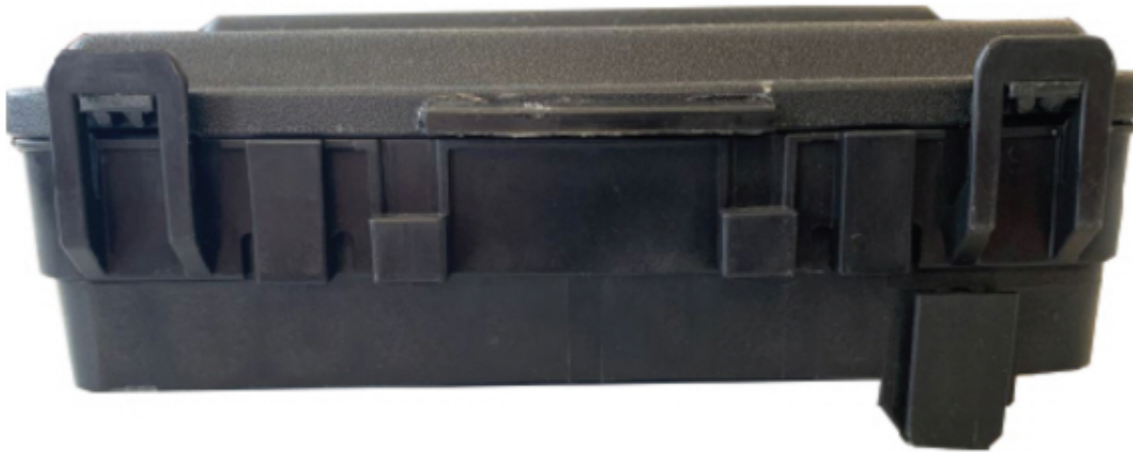
E341135

Figure 3 - Correct cover installation

- (9). Install the new BJB cover making sure the cover tabs/locking fingers are installed correctly.
- (10). Install the battery tray and battery back into the vehicle. Refer to WSM, Section 414-01.

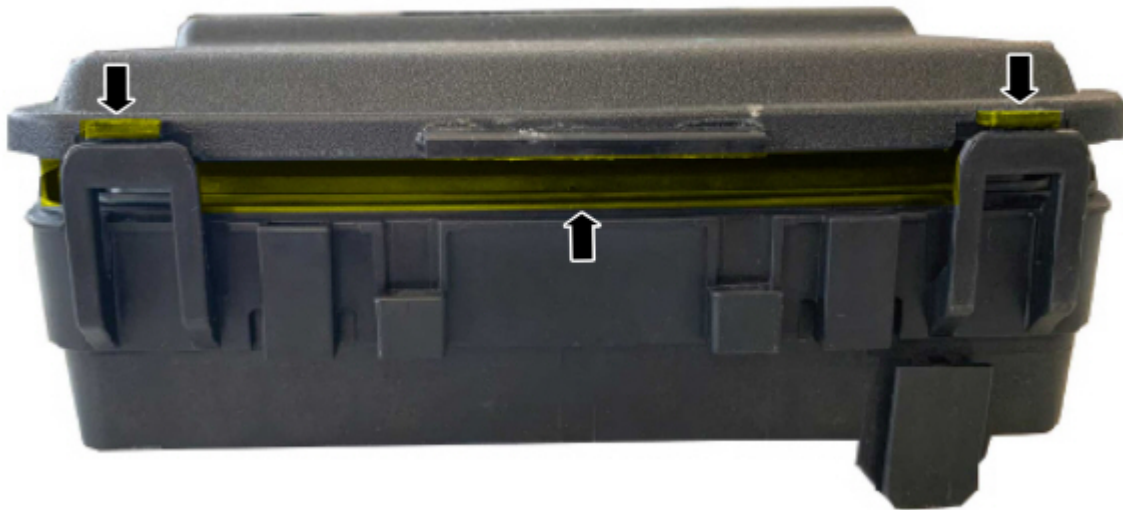
E341136

Figure 4 - Incorrect cover installation

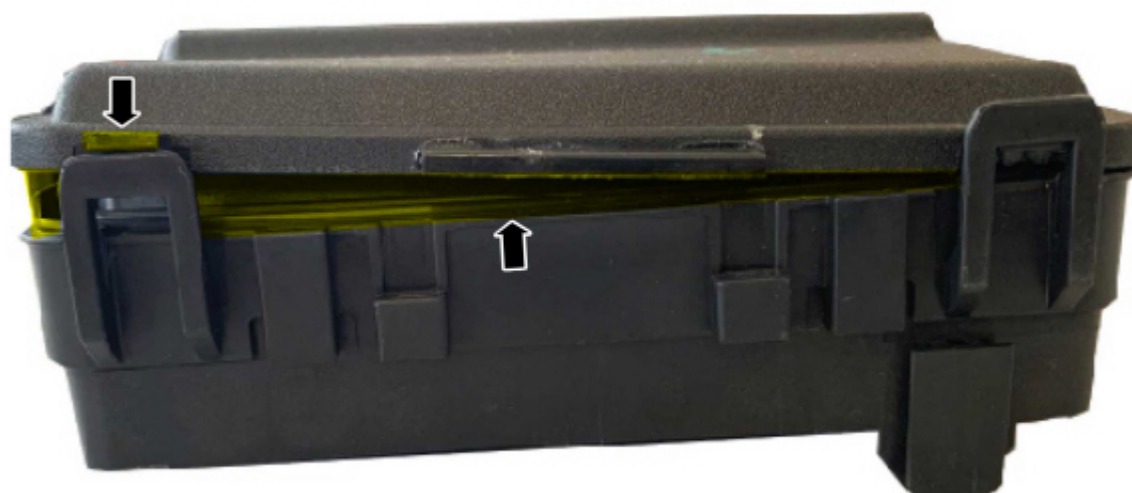
E341137

Figure 5 - Incorrect cover installation

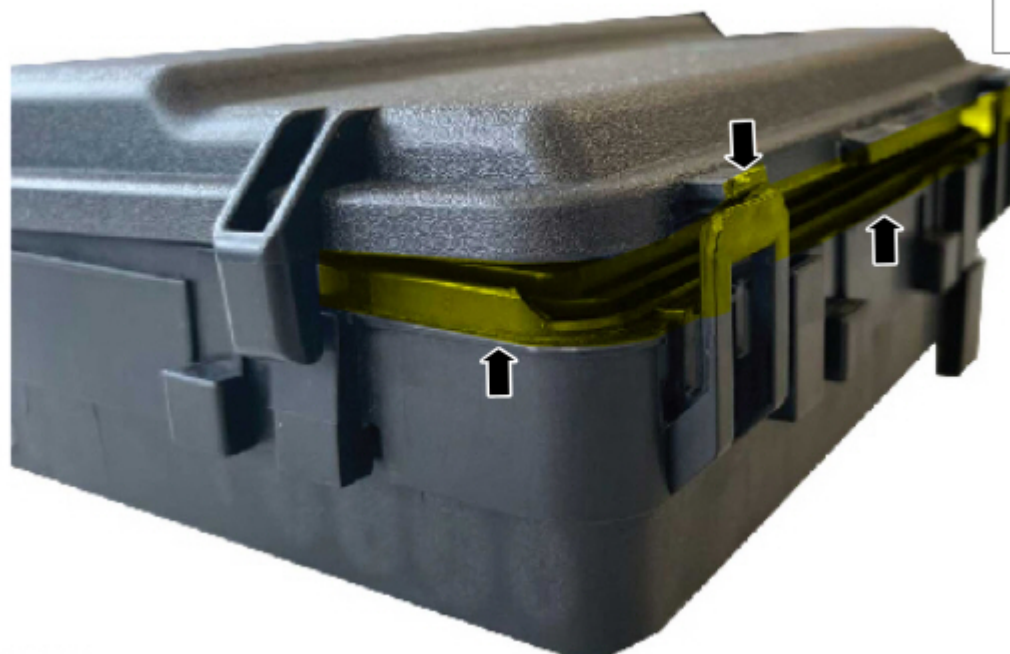
E341138

Figure 6 - Incorrect cover installation
