TECHNICAL SERVICE BULLETIN

Single Rear Wheel Only - Boom/Hum/Moan Noise From Rear While Driving At Highway Speeds

22-2444

Ford 2015-2023 Transit	Single Rear Wheel Only (Does Not Apply To Dual Rear Wheel Vehicles)
----------------------------------	---

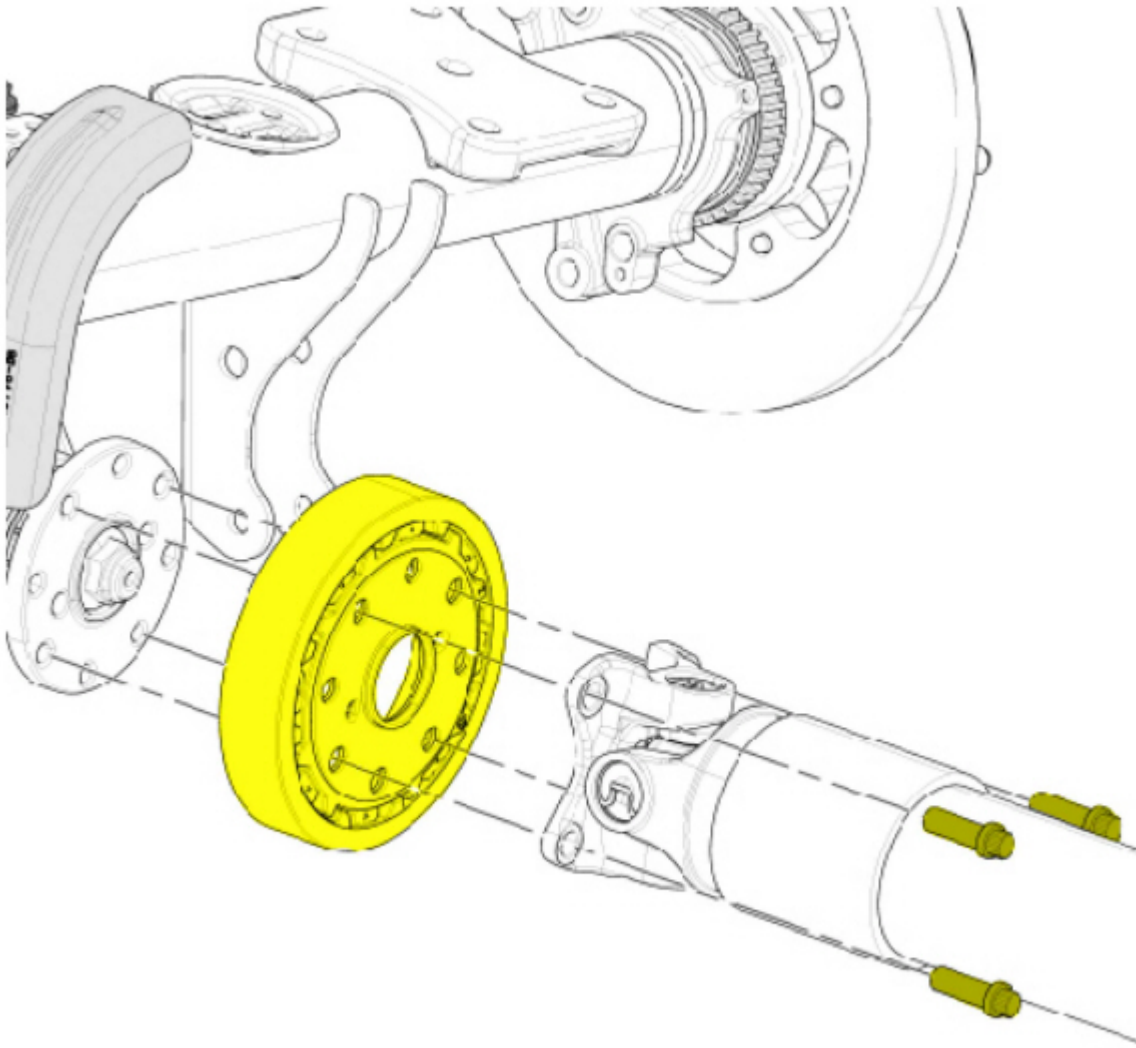
Figure 1

Issue: Some 2015-2023 Transit vehicles equipped with rear wheel drive (RWD), single rear wheel only, and U-joints at the transmission flange and rear driveshaft may experience a boom/hum/moan noise from the rear while driving. This noise is most noticeable at highway speeds:

The noise may also be present to a lesser degree at roughly half of the noted speeds. This may be due to a 2nd order driveline frequency transmitted through the rear driveshaft, rear axle and into the body through the leaf springs. To correct the condition, follow the Service Procedure to install a driveshaft torsional damper.

6. Inspect the pinion flange to driveshaft mating surface for any debris or excessive rust and clean as necessary.
7. Install the driveshaft torsional damper on the axle pinion flange. (Figure 1)

8. Align the index mark on the driveshaft and rear drive pinion flange and reinstall the driveshaft. Make sure the driveshaft fits securely over the raised flange on the torsional damper.

(1). Apply Loctite 263 to each of the 4 cleaned bolts. (Loctite to be applied in the engagement area, first 7 threads) Install the driveshaft attaching bolts and tighten to 115 Nm (85 lb-ft). Refer to WSM, Section 205-01. (Figure 1)
