SERVICE BULLETIN

APPLICABILITY: 2020-23MY Legacy & Outback
 2023MY Ascent

NUMBER: 07-213-22R

SUBJECT: Genuine Battery Replacement

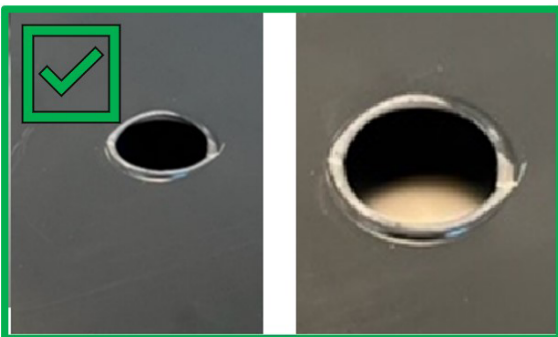
Remaining Height Is Less Than 2mm

CAUTION: Be sure the protrusions are trimmed flush. The remaining protrusion height **MUST** be less than 2mm to provide proper fitment.

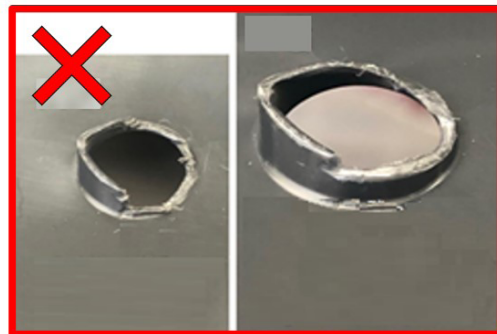
Remaining Height Is More Than 2mm
