SERVICE BULLETIN

APPLICABILITY: 2022-23MY BRZ Models **NUMBER:** 15-297-22R
SUBJECT: Reprogramming File Availability for Optimization of Gen 4 Denso CP1 Infotainment Systems **DATE:** 07/01/22
REVISED: 01/06/23

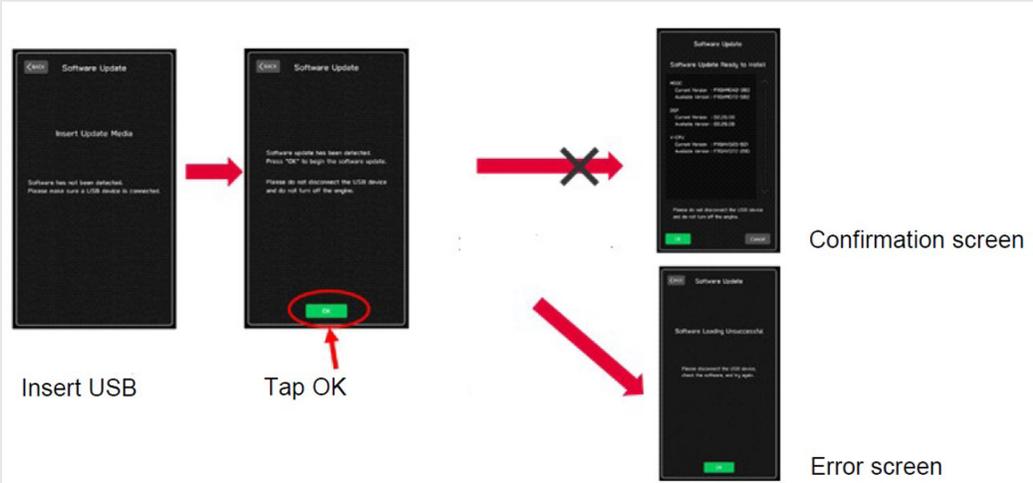
Number	Symptoms to be Improved:
<p>12</p>	<p>When conducting USB reprogramming, the screen transition to error screen instead of confirmation screen.</p>

<p>Insert USB</p> <p>Tap OK</p> <p>Confirmation screen</p> <p>Error screen</p>
<p>13</p>	<p>When “Software Update” is selected in the Dealership Mode, the following initialization process does not end more than 20 minutes. *</p>

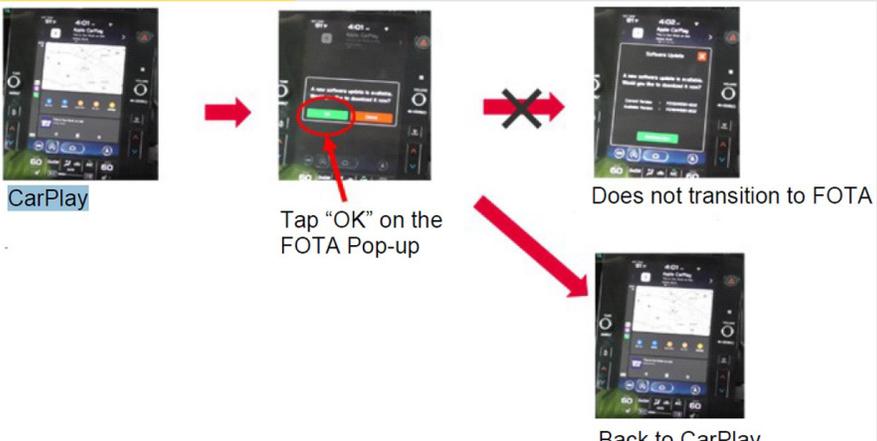
<p>Note* In case this USB update failure occurs, retry updating according to the instructions in “Appendix A ”</p>
<p>14</p>	<p>When the FOTA pop-up (new software availability notification) is displayed while the CarPlay is being used, the display comes back to CarPlay screen even if the customer tries to get into the FOTA screen.</p>

<p>CarPlay</p> <p>Tap “OK” on the FOTA Pop-up</p> <p>Does not transition to FOTA</p> <p>Back to CarPlay</p>

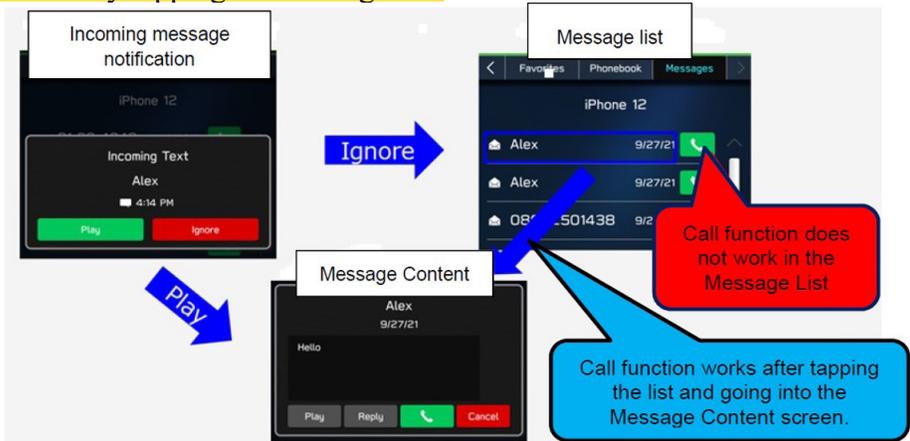
Number	Symptoms to be Improved:
<p>15</p>	<p>Call function does not work in the Message List (after ignoring the incoming message notification.). However, the call function can still be used after getting into the Message Content screen by tapping the message list.</p>

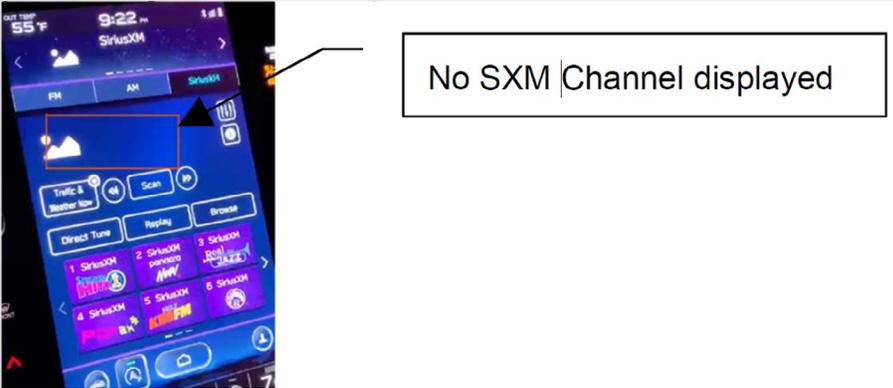
26	<p>SXM has blank screen and no sound when the SXM screen had been selected as audio source at the previous ignition off timing.</p>

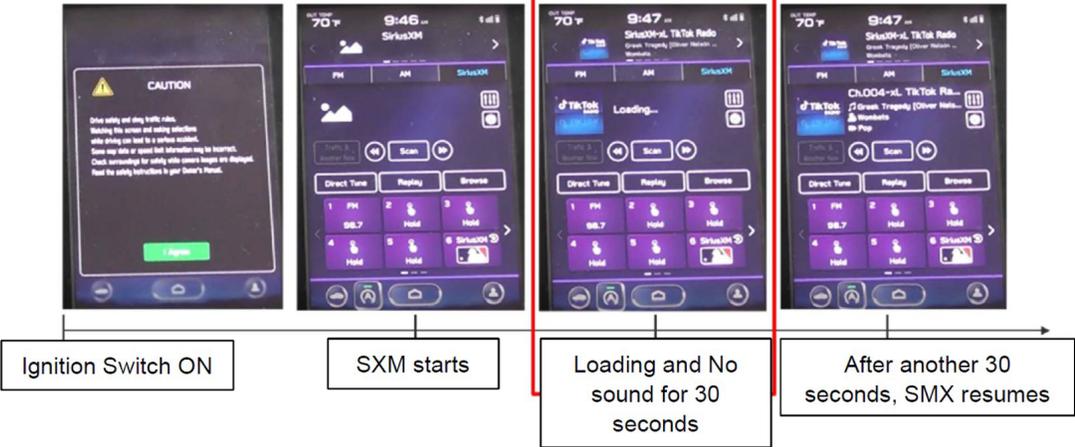
27	<p>About 30 seconds after starting the SXM the operation is paused with loading screen and resume after another 30 seconds. This symptom occurs when the SXM screen had been selected as audio source at the previous ignition off timing.</p>

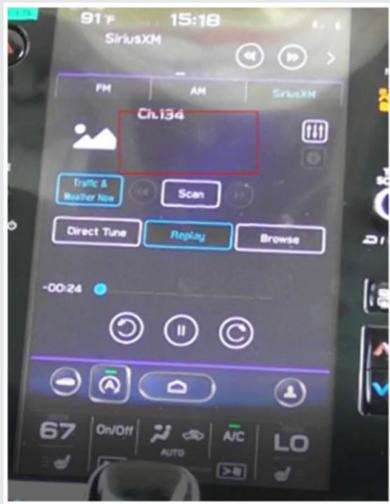
30	<p>The channel information becomes blank when the seek button (<< / >>) of the steering satellite switches is pressed continuously to control the Traffic & Weather Now (TWN) in SXM.</p>

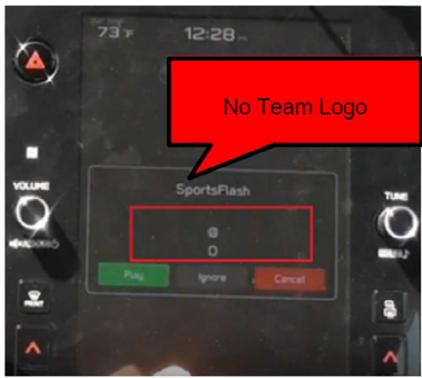
31	<p>The team logo is not displayed on Sports Flash screen when the SXM screen had been selected as audio source at the previous ignition off timing.</p>
