SERVICE BULLETIN

APPLICABILITY: 2019-22MY Ascent
2020-22MY Legacy & Outback 2.4L Turbo

NUMBER: 16-136-22R

SUBJECT: Vibration & Possible Judder Concern on Turns Under Acceleration

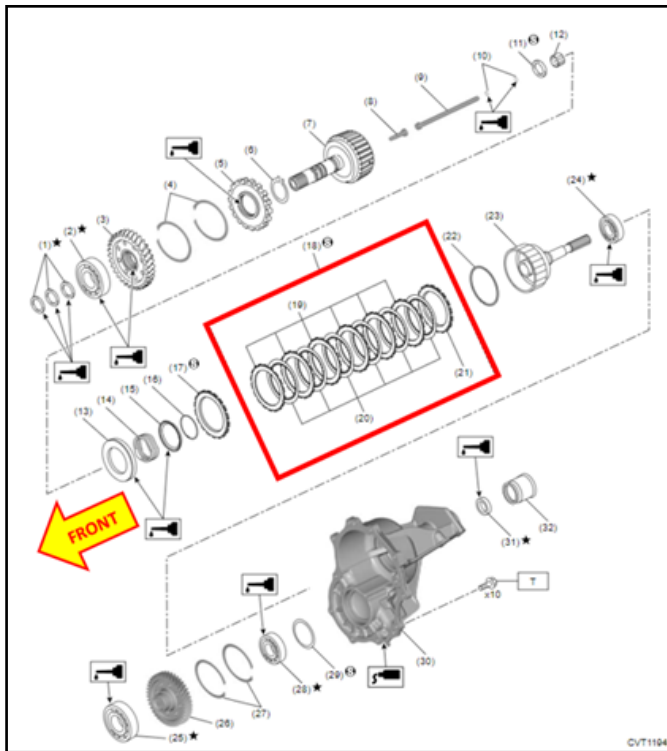
PART INFORMATION:

This service bulletin provides a temporary repair procedure to address vibrations and/or judder concerns experienced on turns during acceleration. If either of these conditions are verified, follow the confirmation process outlined below. If confirmed and until further notice, the multiple plate transfer (MPT) clutch will require replacement. A revised repair procedure will be introduced at a later date.

There is a specified sequence of assembly for the Driven Plates (19) and the Drive Plates (20).
