**PRODUCT CAMPAIGN BULLETIN**

**APPLICABILITY:** 2019-2022MY Ascent

**NUMBER:** WRL-22R

**SUBJECT:** PTC Heater Ground Bolt

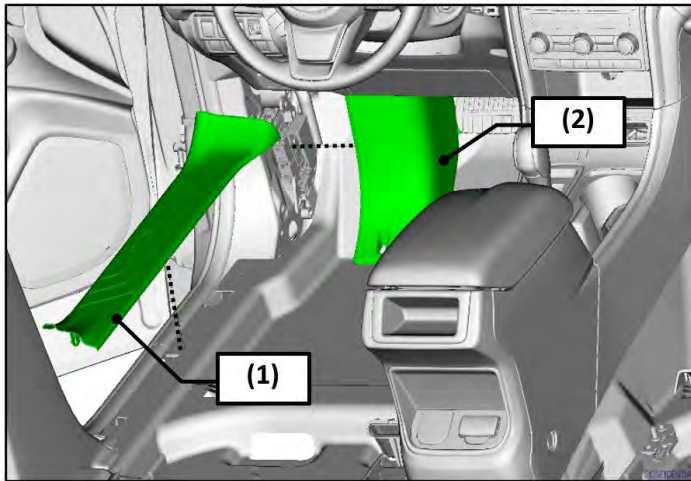
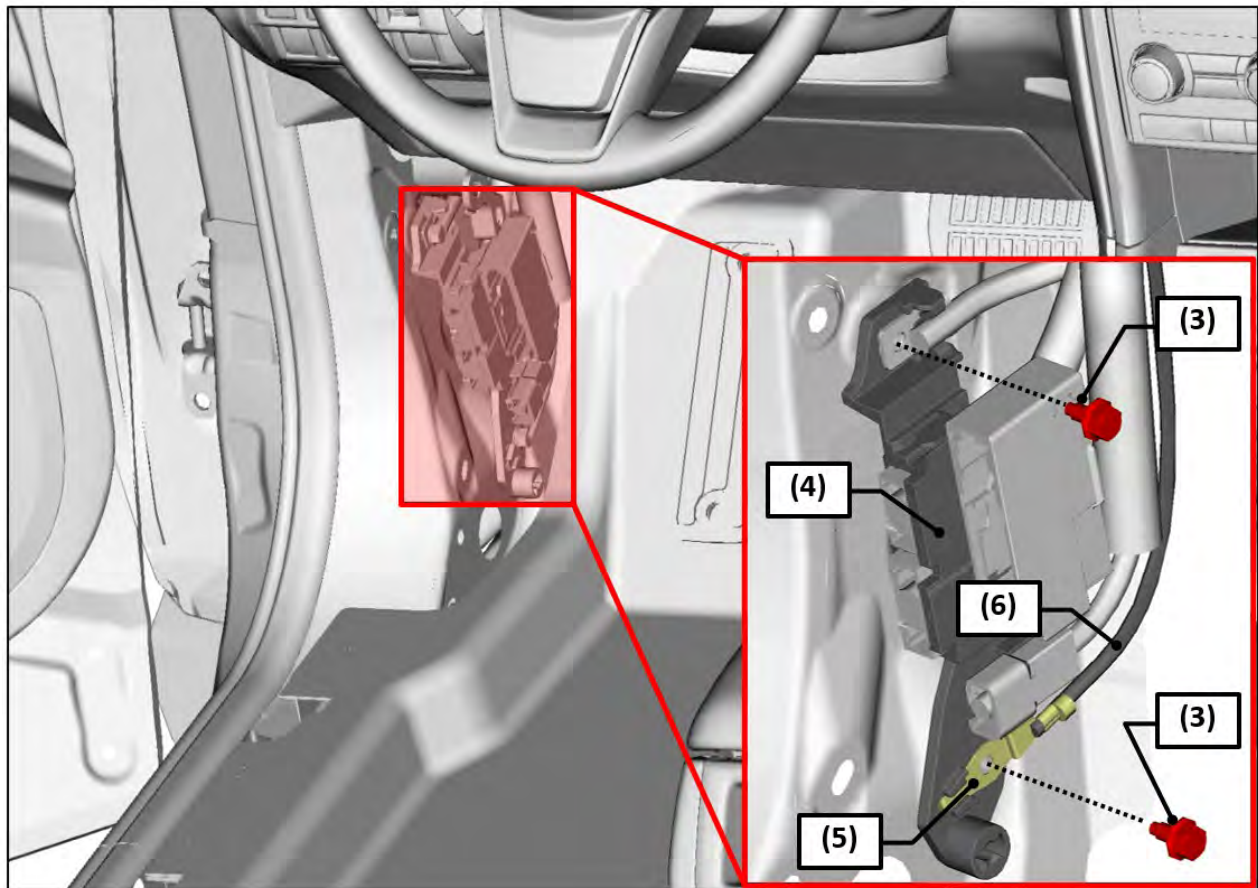
Diagram 1

(3) Ground bolts

**Tightening Torque: 13 N·m**

(5) Ground terminal

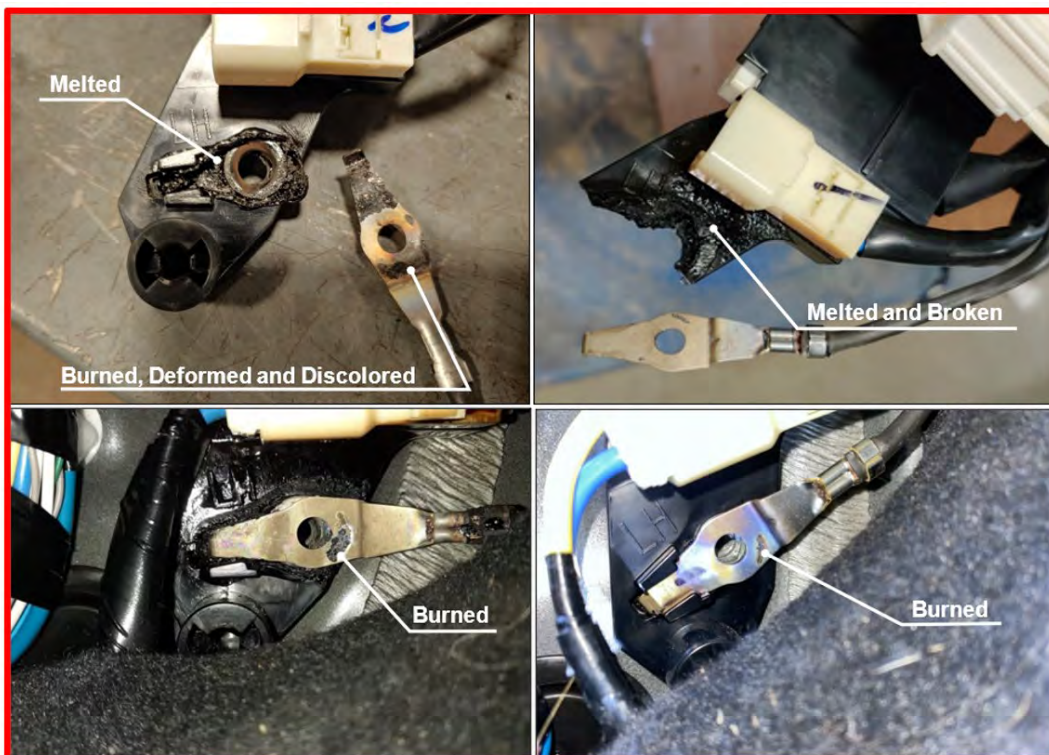
The ground bolt that secures the ground terminal of the Positive Temperature Coefficient (PTC) heater may have been improperly fastened during vehicle production. This potential condition may result in the melting of the ground terminal and surrounding components when the PTC heater is in operation, increasing the risk of a fire.

**STEP 10:** CAREFULLY inspect the PTC heater ground terminal and peripheral parts for any damage. See the example images of overheat damage below.

For all potentially affected vehicles, Subaru retailers will replace the PTC heater ground bolts and, if necessary, replace the ground wire harness and connector holder at no cost to the customer.

**IMPORTANT:** If any damage is found, a QMR will be required with detailed photos of the damage attached and the repair parts order information noted in the comments section.

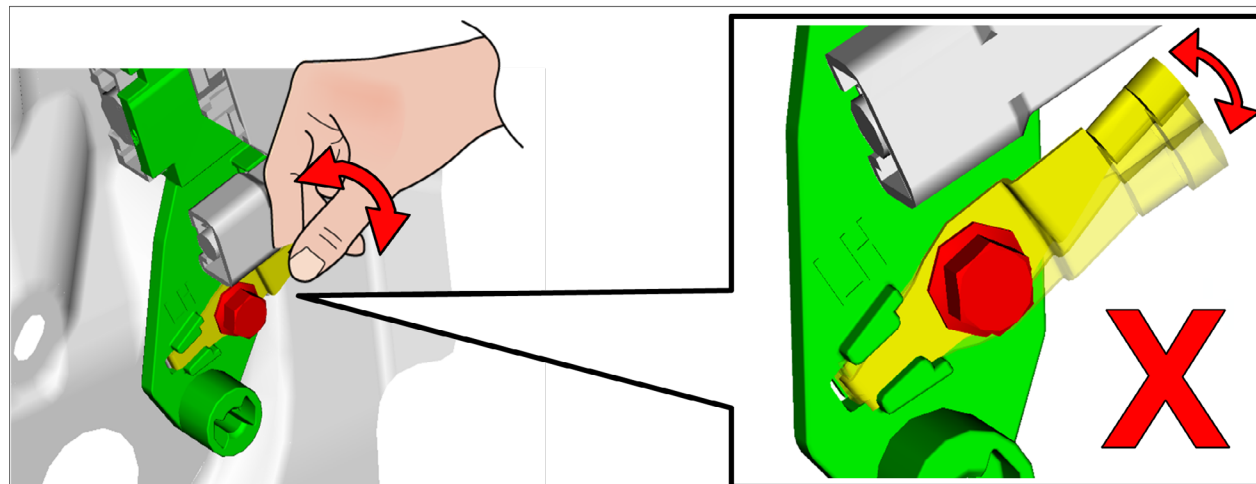
**CAUTION:** Any loose connection could cause a possible thermal event.

**STEP 25:** Confirm there is no movement with the ground terminal. Check for any loose contact by attempting to move the terminal with your fingers in an up/down direction. There is no need to pull the ground cable when checking for loose contact.
