## SERVICE BULLETIN

**NUMBER:** 16-132-20R

**SUBJECT:** Diagnostic Information for Alleged Chain Slip Condition on TR580 / TR690 Transmissions

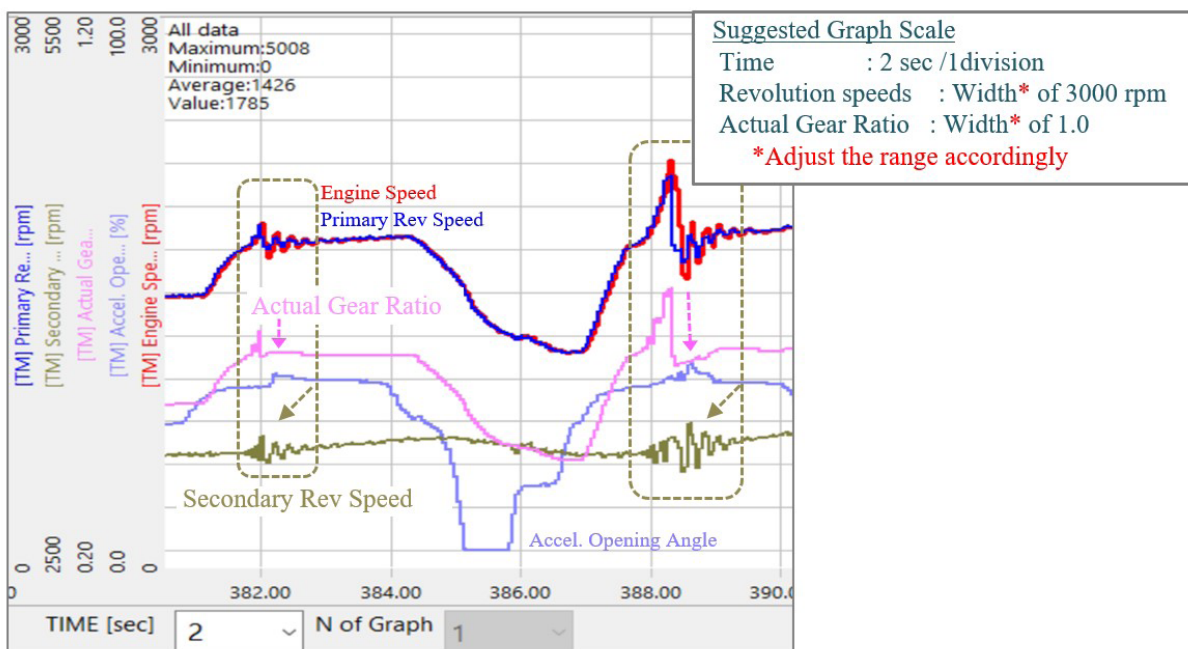
## 2. Short-Time Slip:

When a short-time slip occurs, the changes in the Actual Gear Ratio monitor will be larger than 0.1 per 0.1 second. After the Actual Gear Ratio monitor resumes to stable conditions, distinct fluctuations in revolution speed continues.

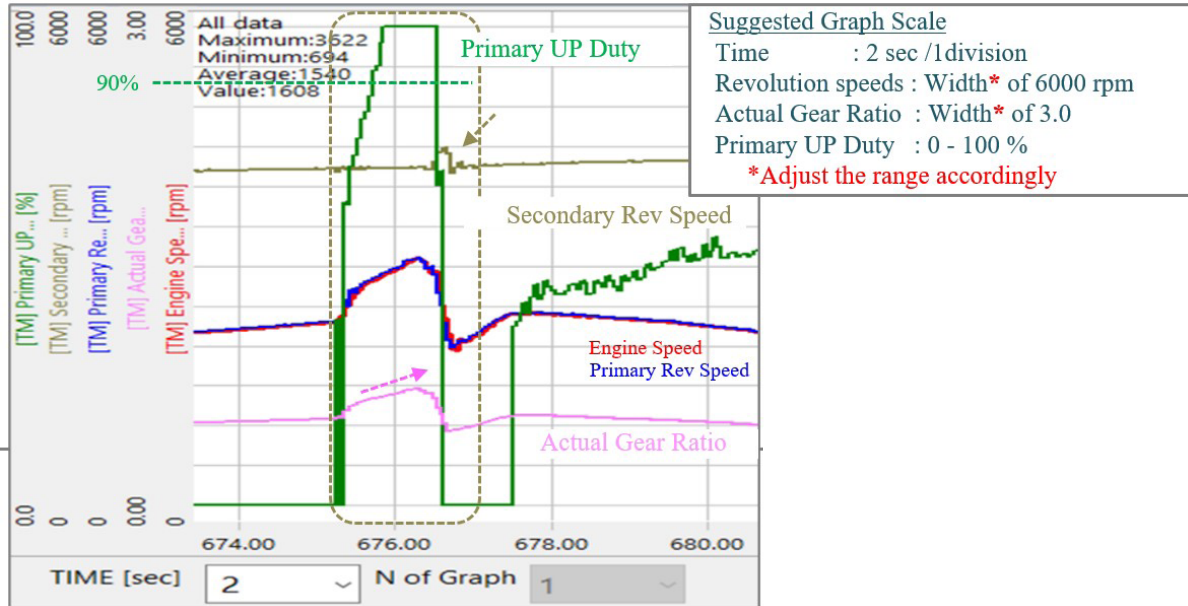
### 3. Long-Time Slip:

When a long-time slip occurs, the Primary UP Duty monitor will be larger than 90% and the Actual Pulley Ratio monitor lowers for a duration of 0.5 seconds or more. Even after the Actual Gear Ratio monitor resumes to stable conditions, distinct fluctuations in revolution speed continues.

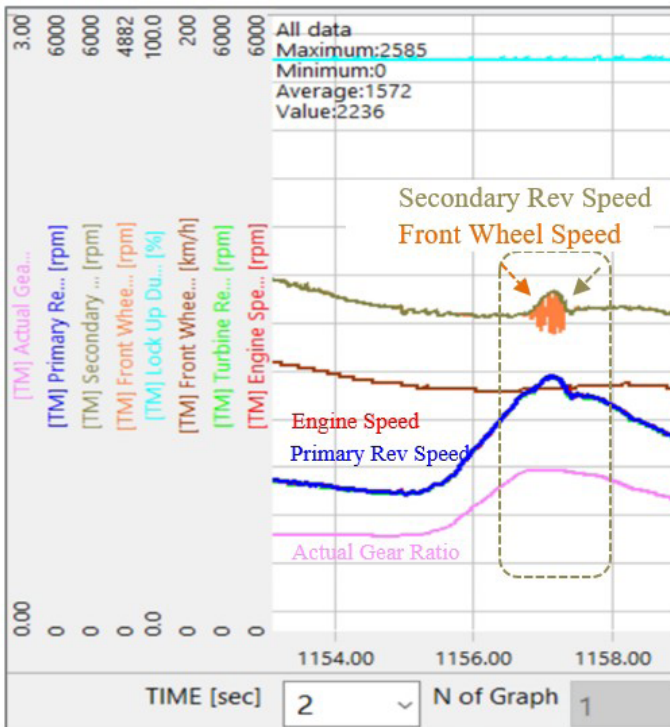
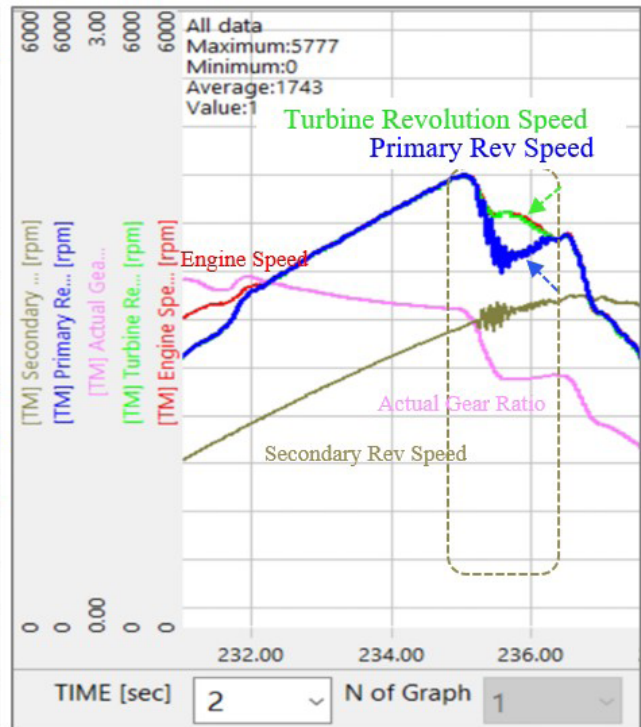
#### 1. Forward Clutch Slip Shock:

This shock can occur when the forward clutch slips. If this situation is reported, reprogram the TCM with new software if it is available.

The rotation speeds for the upstream and downstream sides of the forward clutch do not synchronize when driving.

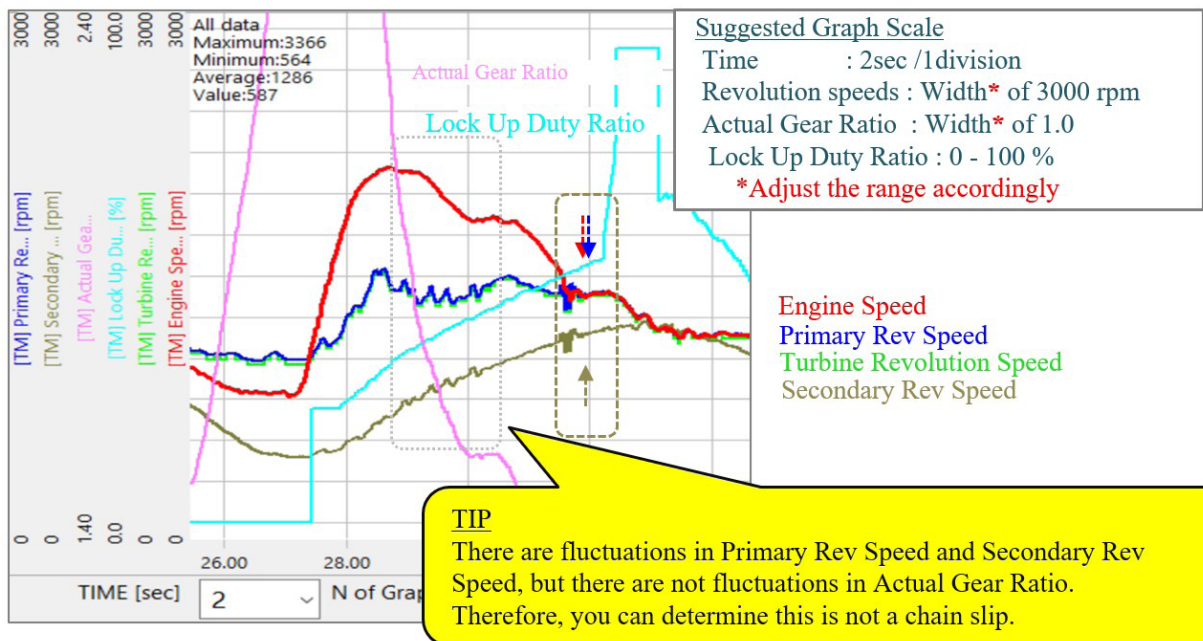
## 2. Lock Up Clutch Engagement Shock:

This shock can occur when the lock up clutch engages rapidly. If this situation is reported, reprogram the TCM with new software if it is available.

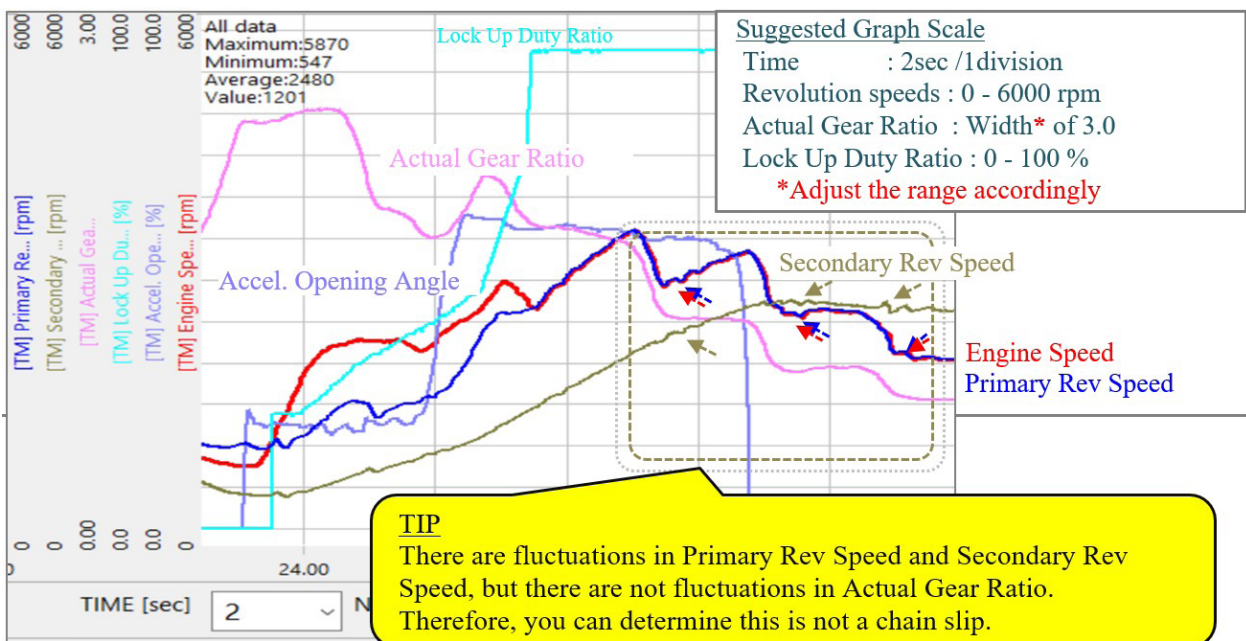
## 3. Shift Up Shock:

This shock can occur when the CVT upshifts. If this situation is reported, reprogram the TCM with new software if it is available. If there is no new software available or the reprogramming does not remedy the issue, report the situation to Techline.

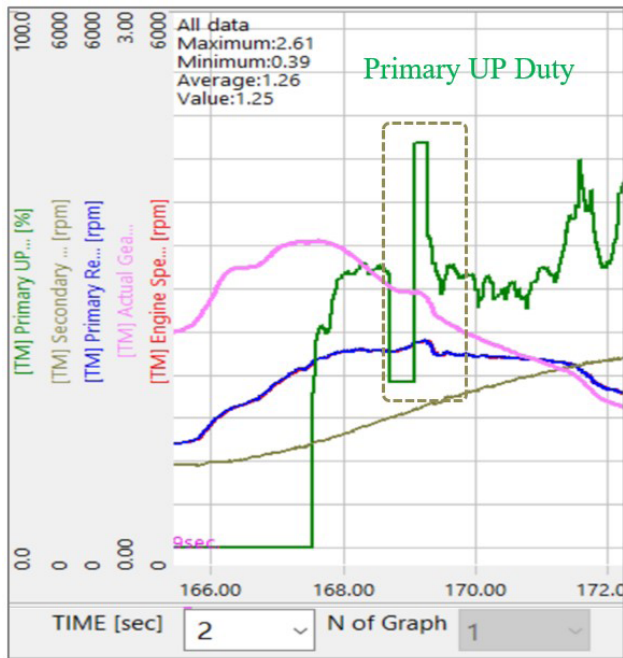
#### 4. Primary Up Duty Square Control (Ascent Models up to 2021MY):

A harsh shift can be felt while driving. If this situation is reported, reprogram the TCM with new software if it is available. If there is no new software available or the reprogramming does not remedy the issue, report the situation to Techline.
