**SERVICE BULLETIN**

**APPLICABILITY:** 2020-22MY Legacy and Outback Models      **NUMBER:** 15-261-20R  
**SUBJECT:** Reprogramming File Availability for Optimization of Gen 4 Denso CP1 Infotainment Systems      **DATE:** 03/10/20  
**REVISED:** 01/12/23

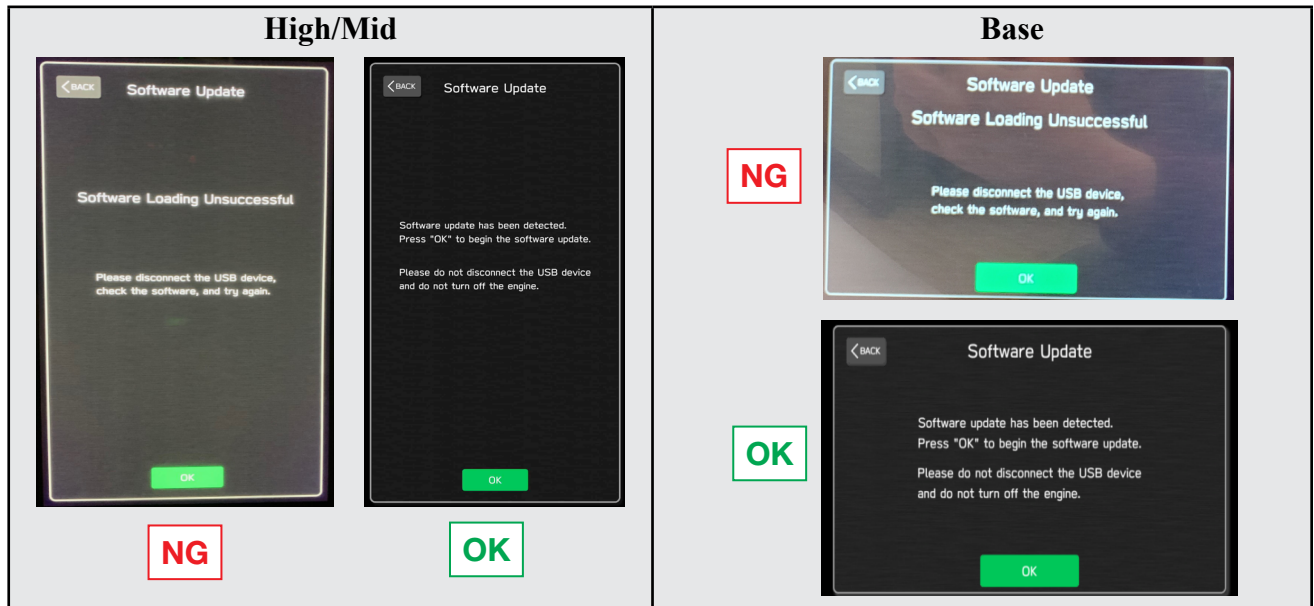
**NOTE:** If after plugging in the USB, the screen displays a **Software Loading Unsuccessful** message, confirm the USB device has been properly formatted and the the software on the device matches the system being reprogrammed (example: Base software is being used to update a Base system) and retry.

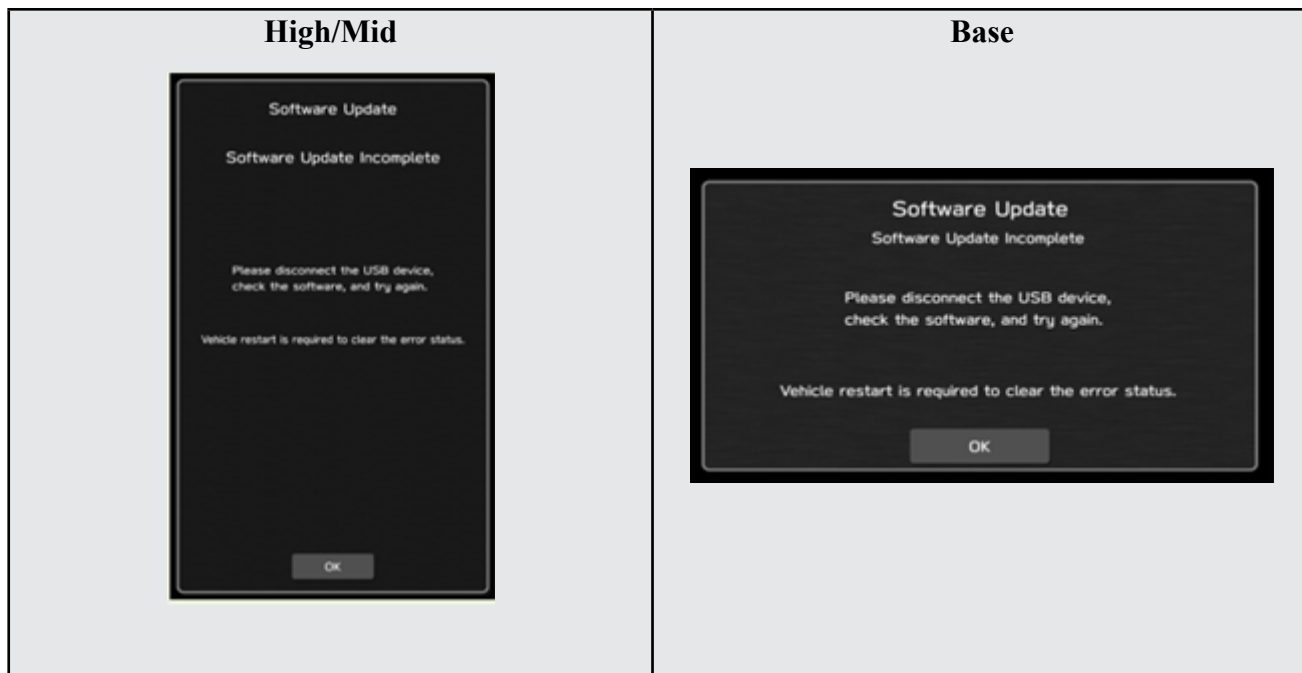
If you get the message Software Update Incomplete as shown below, please don't replace the hardware but retry updating the software according to the instructions in "Appendix B" on pg. 21.

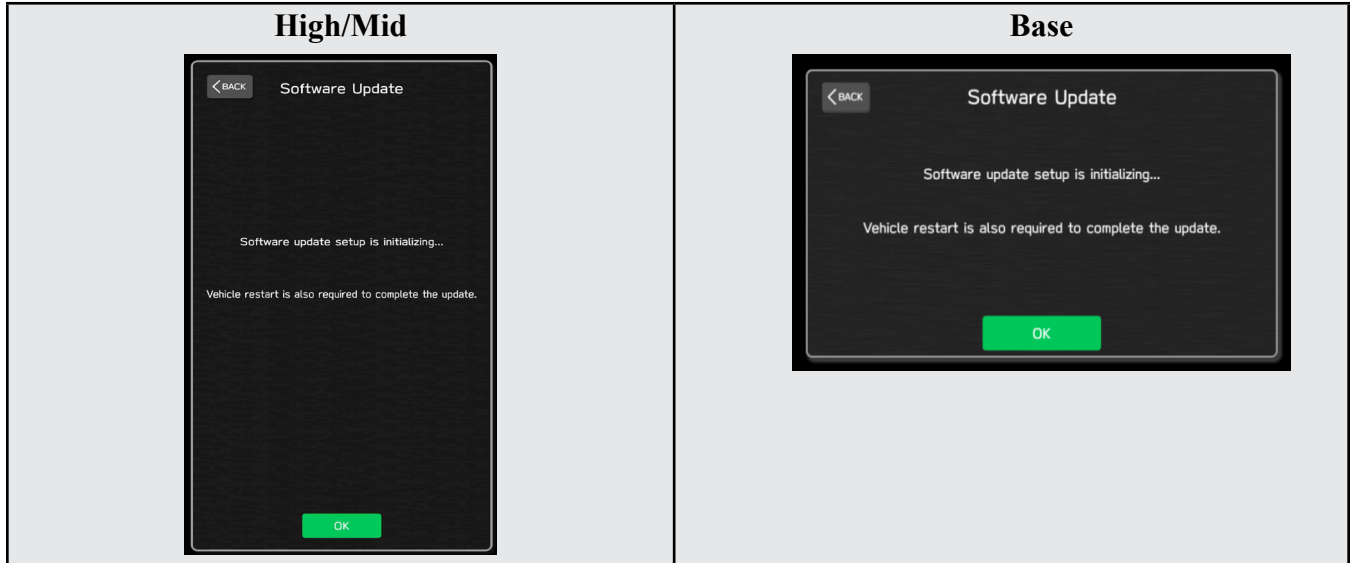
- If the screen shown below appears, **WAIT** for approximately 30 minutes or as long as necessary (waiting for longer than 60 minutes might indicate system malfunction). In that case please perform recovery according to the instructions in “Appendix B ” to allow the Software update setup initialization process to complete.

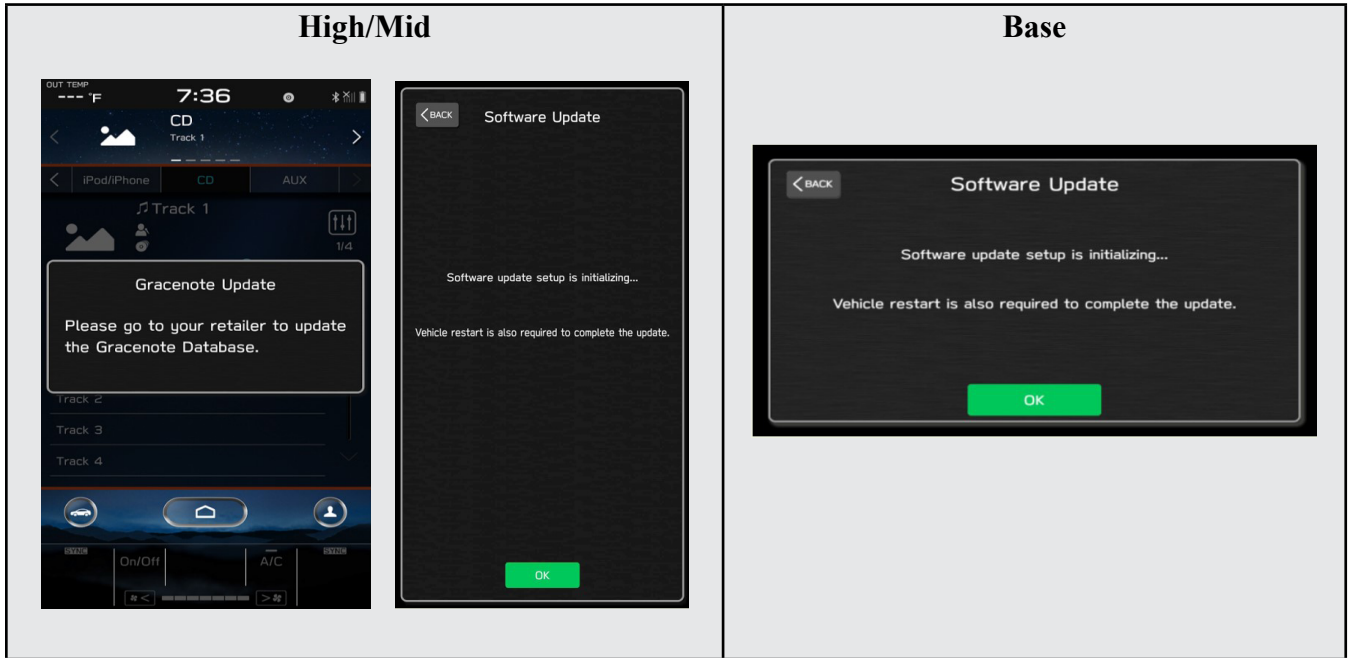
In case the Gracenote update popup screen appears or software initializing screen does not go away for more than 20 minutes, please perform steps 2-1 to 2-11.

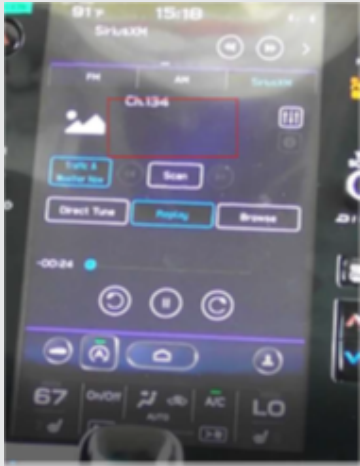
30	<p>The team logo is not displayed on Sports Flash screen when the SXM screen had been selected as audio source at the previous ignition off timing.</p>

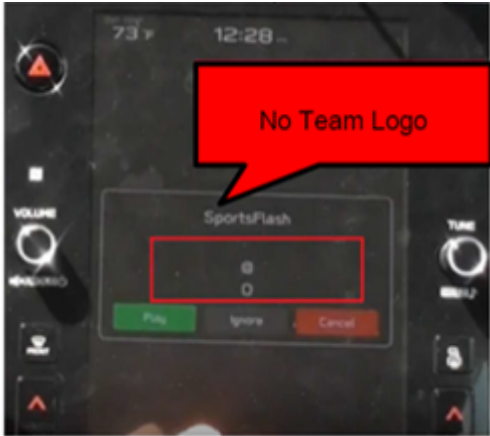
31	<p>The team logo is not displayed on Sports Flash screen when the SXM screen had been selected as audio source at the previous ignition off timing.</p>
