SERVICE BULLETIN

APPLICABILITY: 22MY WRX Models **NUMBER:** 15-301-22R
SUBJECT: Reprogramming File Availability for Optimization of Gen 4 Denso CP1 Infotainment Systems **DATE:** 09/09/22
REVISED: 01/12/23

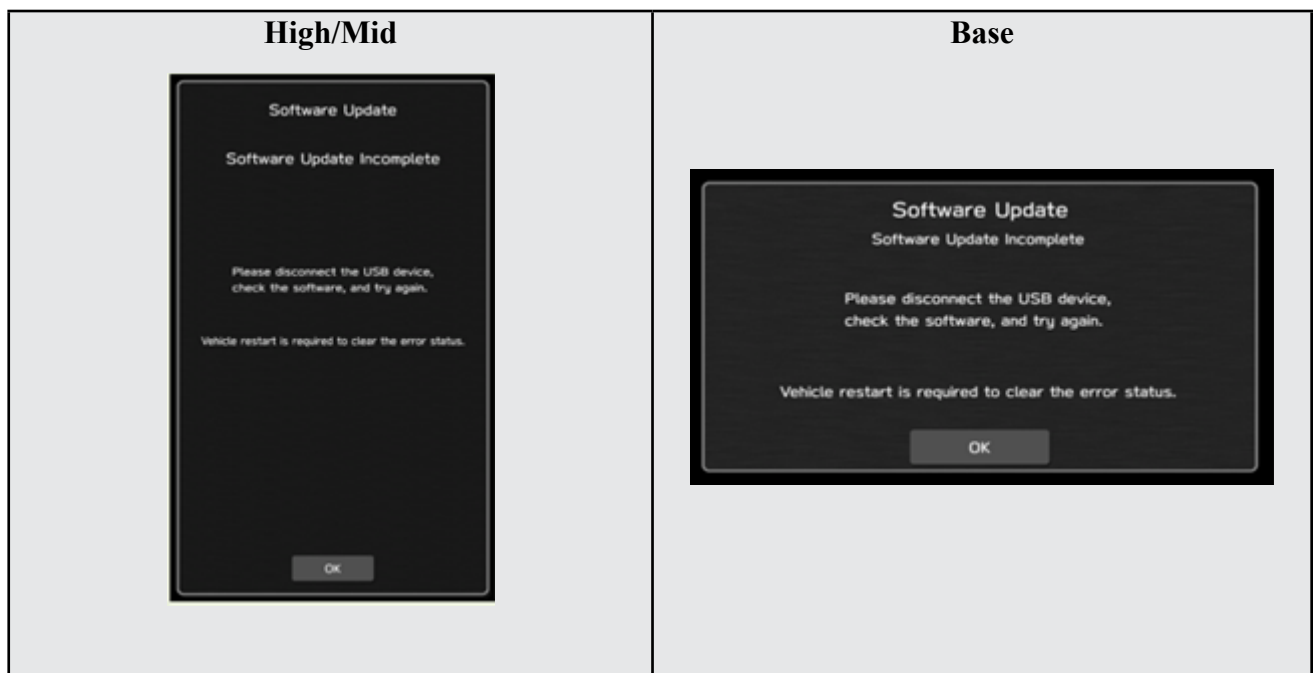
If you get the message **Software Update Incomplete** as shown below, please don't replace the hardware but retry updating the software according to the instructions in "**Appendix B**" on pg. 17.

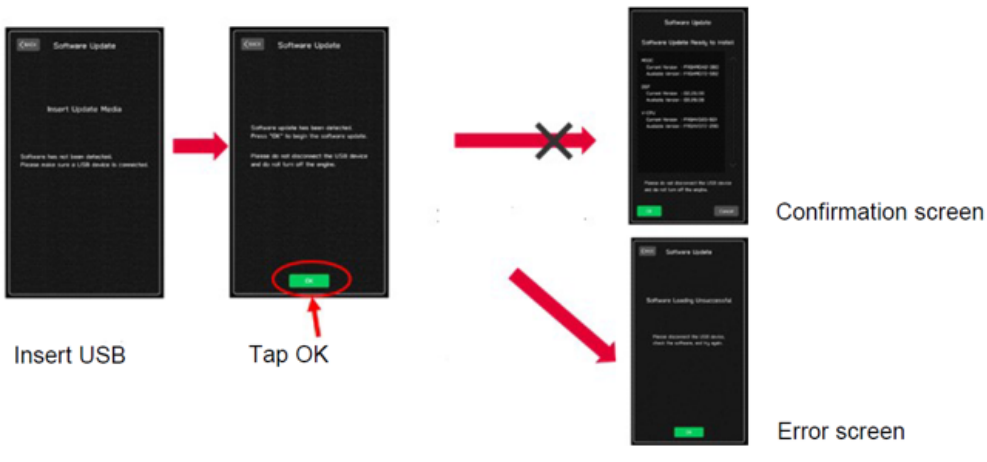
Number	Symptoms to be Improved:
12	<p>When conducting USB reprogramming, the screen transition to error screen instead of confirmation screen.</p>

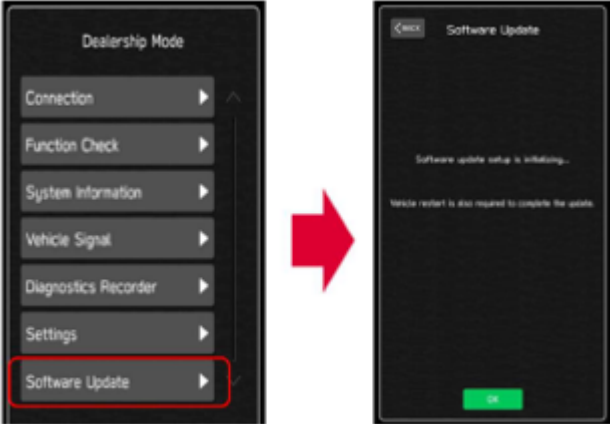
<p>Insert USB</p> <p>Tap OK</p> <p>Confirmation screen</p> <p>Error screen</p>
13	<p>When “Software Update” is selected in the Dealership Mode, the following initialization process does not end more than 20 minutes. *</p>

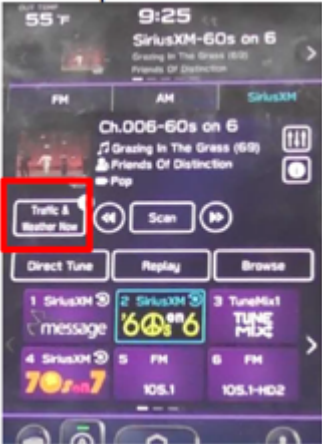
Number	Symptoms to be Improved:
25	<p>No response when touching “Traffic & Weather Now (TWN)” on SMX screen.</p>

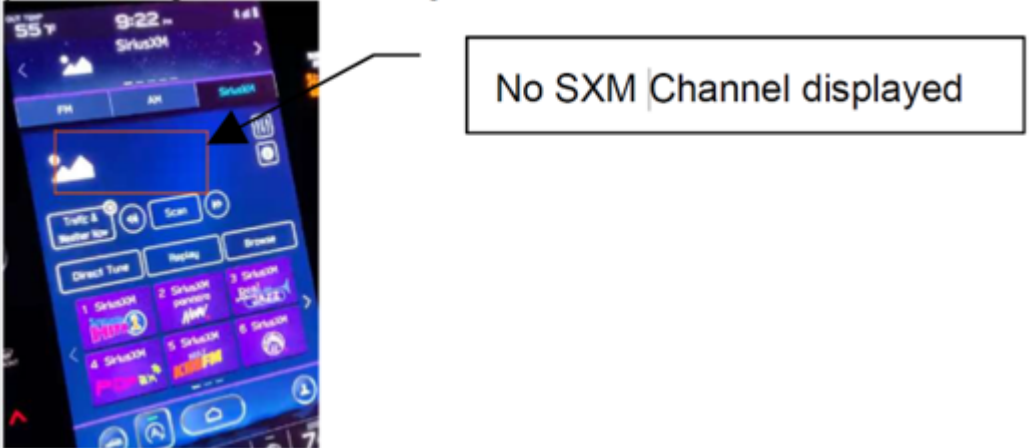
26	<p>SXM has blank screen and no sound when the SXM screen had been selected as audio source at the previous ignition off timing.</p>

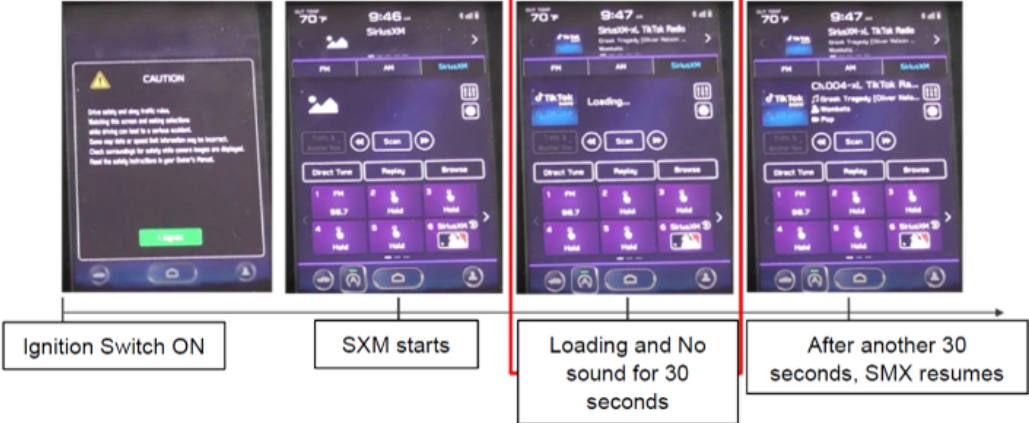
27	<p>About 30 seconds after starting the SXM the operation is paused with loading screen and resume after another 30 seconds. This symptom occurs when the SXM screen had been selected as audio source at the previous ignition off timing.</p>

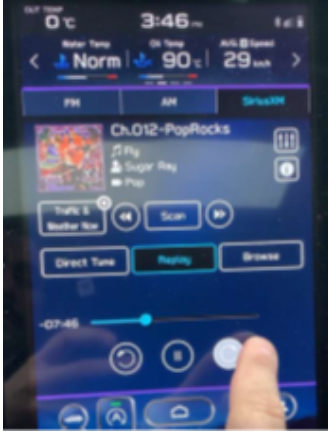
Number	Symptoms to be Improved:
29	<p>“Fast forward” does not work in SXM replay function. (Fast Rewind works.)</p>

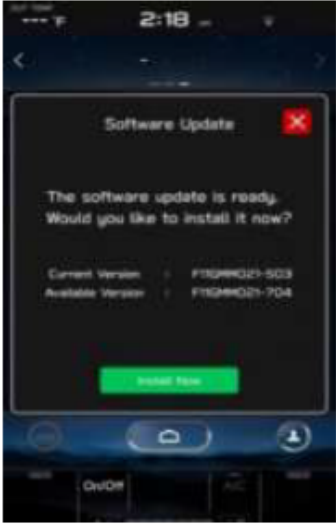
Number	Symptoms to be Improved:
1	<p>System restarts itself during FOTA (Firmware Over The Air) update. FOTA operation is conducted in two processes: downloading (from the server to the Cockpit Control Unit via Wi-Fi) and installation (inside the Cockpit Control Unit). During the FOTA operation, after the new software has been downloaded to the Cockpit Control Unit (CCU) customer is to push “Install Now” on the Center Information Display (CID) to start installation of the software.</p>

<p>However, in rare case, the CCU restarts itself* during installation.</p>

<p>Note* Even if this symptom occurs, after approximately 2 minutes, the system resumes, and the CID comes back to the below screen. Customer can then push the “Install Now” to proceed with the installation.</p>
