SERVICE BULLETIN

APPLICABILITY: 2020-22MY Legacy and Outback Models **NUMBER:** 15-261-20R
SUBJECT: Reprogramming File Availability for Optimization of Gen 4 Denso CP1 Infotainment Systems **DATE:** 03/10/20
REVISED: 02/13/23

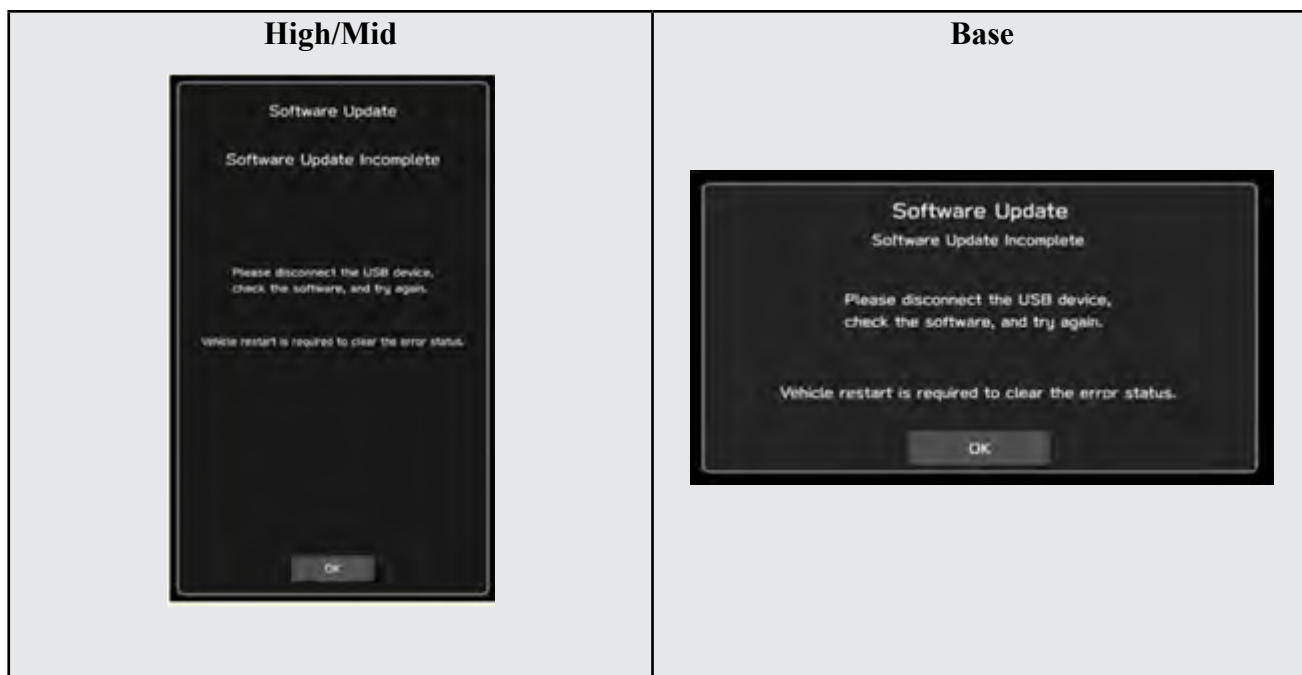
If you get the message Software Update Incomplete as shown below, please don't replace the hardware but retry updating the software according to the instructions in "Appendix B" on pg. 21.

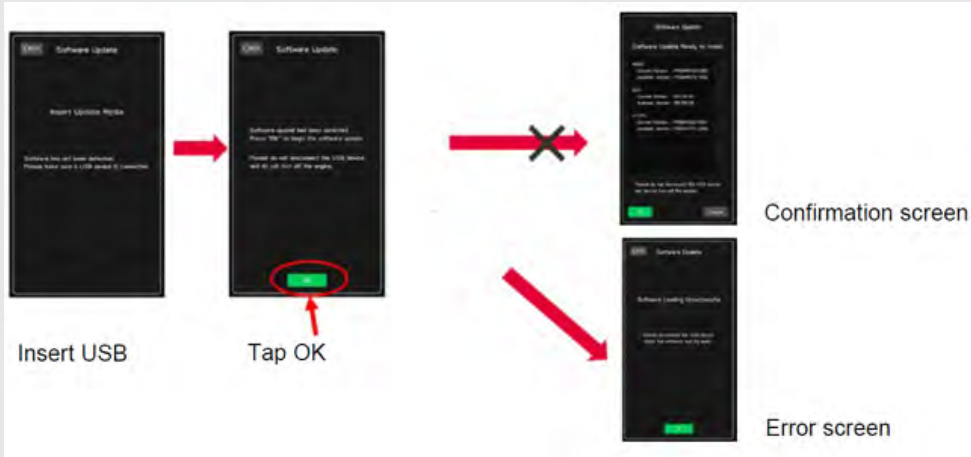
Number	Symptoms to be Improved:
12	<p>When conducting USB reprogramming, the screen transition to error screen instead of confirmation screen.</p>

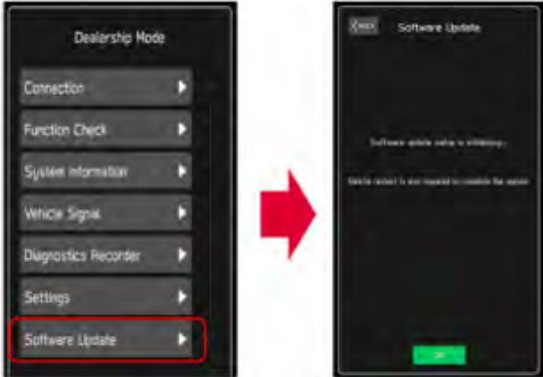
13	<p>When “Software Update” is selected in the Dealership Mode, the following initialization process does not end more than 20 minutes. *</p>

<p>Note* In case this USB update failure occurs, retry updating according to the instructions in “Appendix A”</p>
14	<p>When the FOTA pop-up (new software availability notification) is displayed while the CarPlay is being used, the display comes back to CarPlay screen even if the customer tries to get into the FOTA screen.</p>

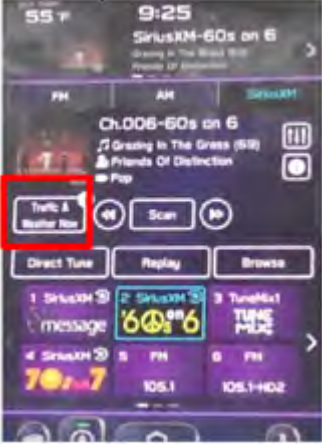
Number	Symptoms to be Improved:
25	<p>No response when touching “Traffic & Weather Now (TWN)” on SMX screen.</p>

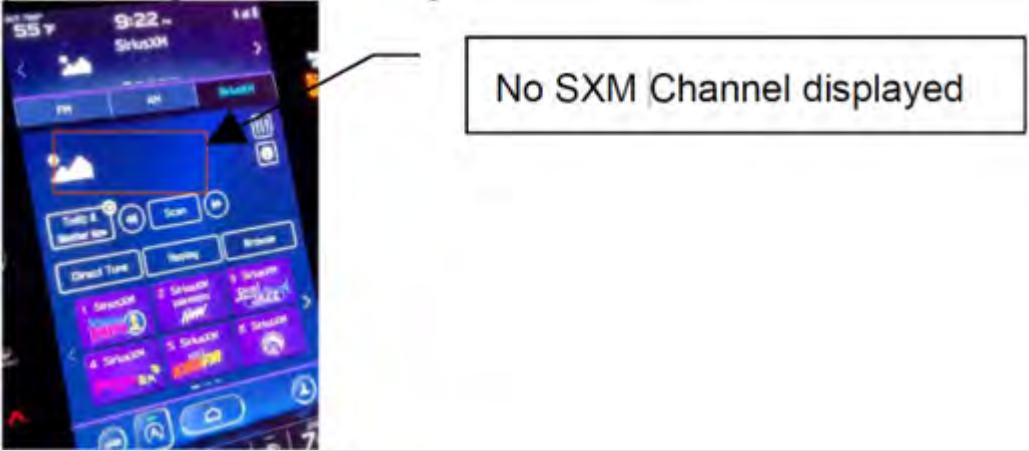
26	<p>SXM has blank screen and no sound when the SXM screen had been selected as audio source at the previous ignition off timing.</p>

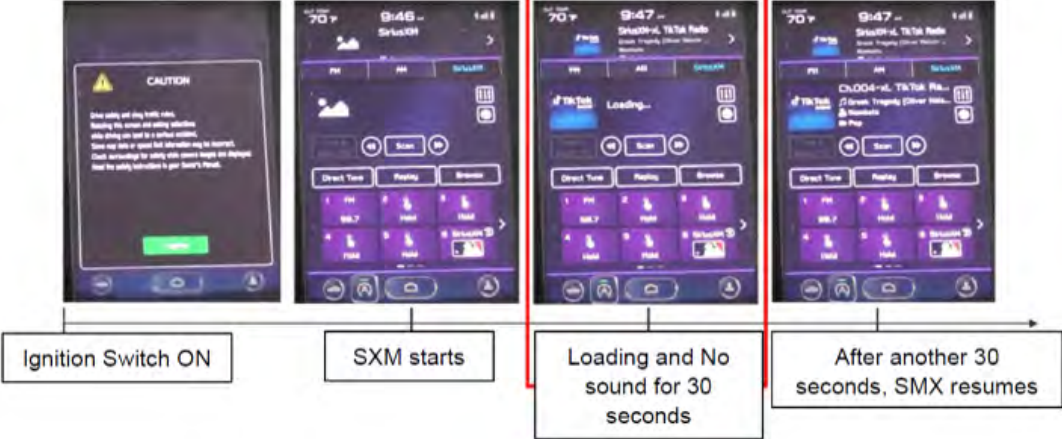
27	<p>About 30 seconds after starting the SXM the operation is paused with loading screen and resume after another 30 seconds. This symptom occurs when the SXM screen had been selected as audio source at the previous ignition off timing.</p>

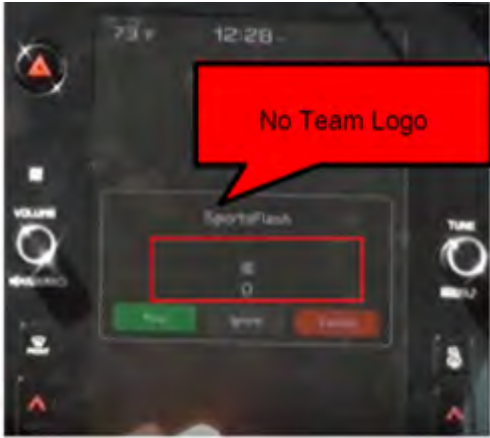
31	<p>The team logo is not displayed on Sports Flash screen when the SXM screen had been selected as audio source at the previous ignition off timing.</p>

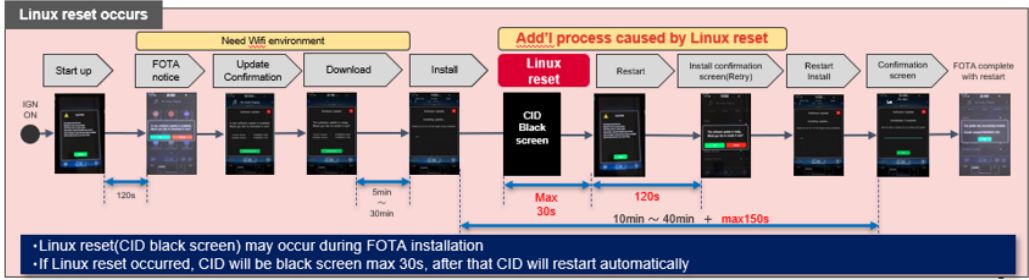
<p>However, in rare case, the CCU restarts itself* during installation.</p>

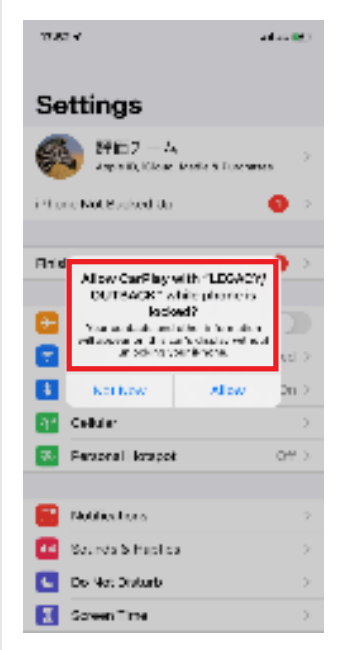
Number	Symptoms to be Improved:
1	<p>Momentary Black Display; The CID (Center Information Display) and in rare case together with the LCD in the combination meters go blank (black) momentarily. This condition might be followed by CP1 reboot.</p> <p>NOTE: Rear View Camera function is not impacted by this condition.</p>
2	<p>Blank display when connecting CP1 to Wi-Fi network with long name (over 32 characters).</p>
3	<p>While using Apple CarPlay, “SUBARU” is displayed on the iPhone Setting menu instead of vehicle name <LEGACY/OUTBACK>.</p>

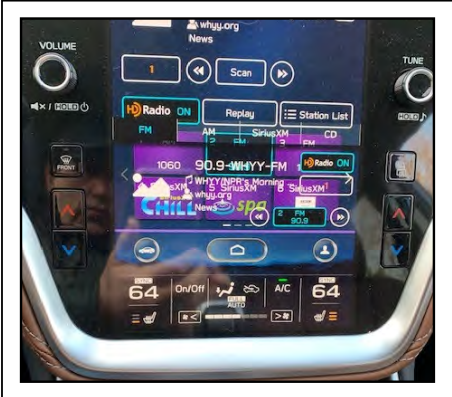
5	CarPlay stopped working after hanging up a hands-free phone call.
6	<p>CID shows multiple images simultaneously.</p>

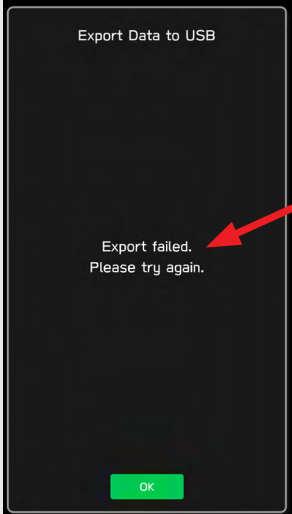
4	<p>Diagnostics Recorder Data cannot be exported to the USB memory device. When the diagnostic log data is being downloaded (by selecting: Dealership Menu > Diagnostics Recorder > Export Data to USB), it fails after the progress bar reaches almost 90% with an error message of Export failed. Please try again.</p>
