SERVICE BULLETIN

APPLICABILITY: 23MY Outback/Legacy Models **NUMBER:** 15-305-22R
 23MY Ascent Models **DATE:** 11/15/22
SUBJECT: Reprogramming File Availability for Optimization of Gen 4.5 Denso CP1.5 Infotainment Systems **REVISED:** 02/24/23

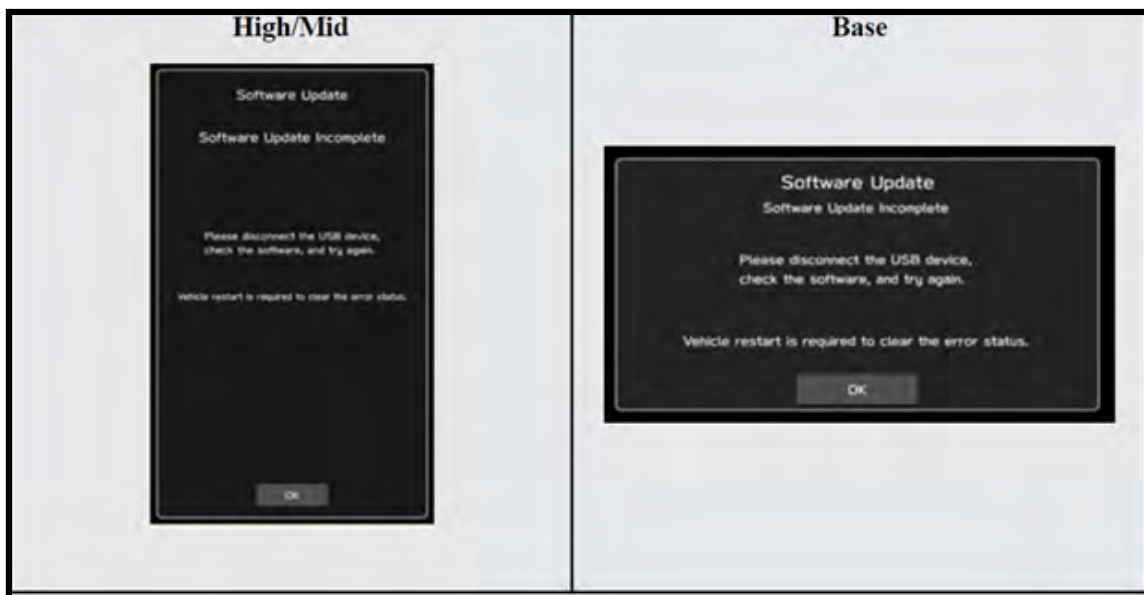
If you get the message **Software Update Incomplete** as shown below, please don't replace the hardware but retry updating the software according to the instructions in "**Appendix B**" on pg. 17.

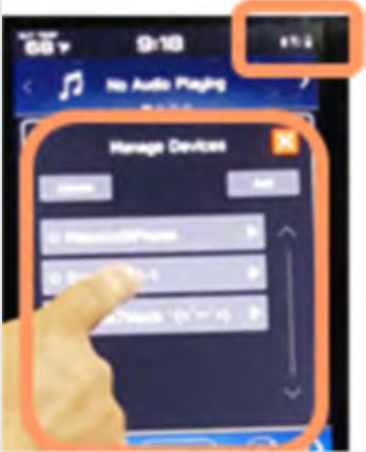
Number	Symptoms to be Improved:
1	CID goes black and does not accept any control.
2	CID reboots.
3	“Manage Devices” is grayed out and cannot establish Bluetooth connection.
4	When the Bluetooth connection is cancelled manually on the mobile phone side during hands-free calling, the Bluetooth connection is disabled for that particular mobile phone. Even when it occurs, the connection can be reestablished by deleting the device in “Manage Devices” and register the device again by adding operation.
5	Bluetooth connection fails against the device that was paired before and “Manage Devices” is grayed out.
6	Bluetooth connection is disabled with a discrepancy in the display of status bar (showing Bluetooth devices being connected) and the “Manage Devices” screen (showing no Bluetooth devices being connected.) <div style="text-align: center;">

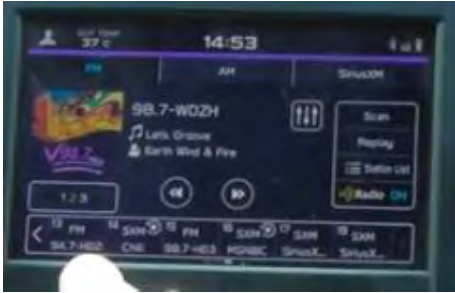
Number	Symptoms to be Improved:
11	<p>Sound is lost when changed to Subchannel 2 right after a preset HD radio channel has been selected.</p>

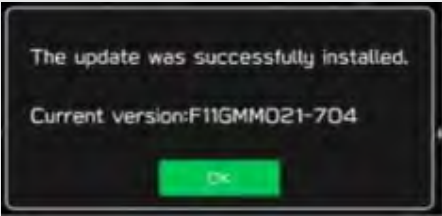
12	<p>After the destination is set on Navi screen, voice recognition command of “Find <POI category> along route” is made, search results are not given in order of distance.</p>
13	<p>When “Call” button is pressed in “Confirm Destination” screen of Navigation system (to call the destination site,) the call can be made but the screen does not transit to phone call screen.</p>
14	<p>Popup of “The update was successfully installed” is not displayed after reboot (IG-OFF and ON) operation of FOTA (Firmware Over The Air) update.</p>

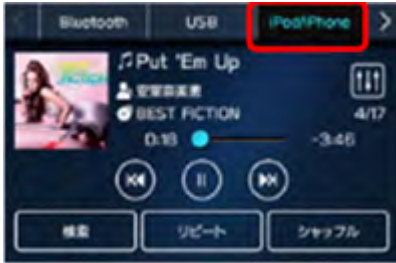
Number	Symptoms to be Improved:
1	<p>iPod/iPhone tab in Media screen cannot be selected, when connected by USB.</p> <p>The symptom occurs when the iPhone is connected to CP1.5 via Bluetooth in parallel to USB connection by error. (It is supposed to be connected either via Bluetooth or by USB.)</p>

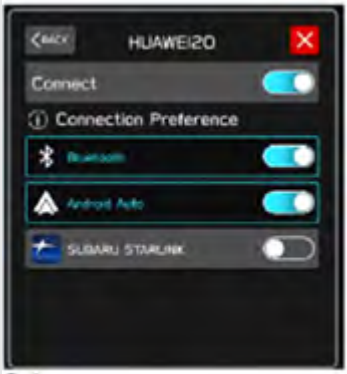
2	<p>On the "Manage Devices" screen Bluetooth cannot be selected as connection preference.</p>

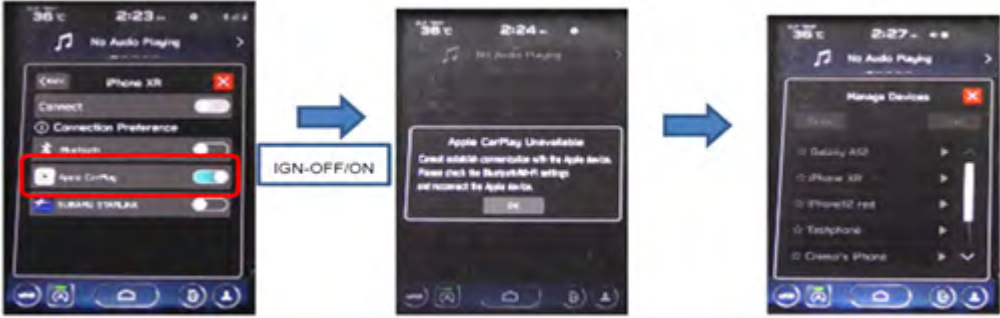
Number	Symptoms to be Improved:
7	<p>Manage Device Screen becomes dark and inoperative when Ignition Switch is turned Off and On while starting CarPlay by CID operation.</p>

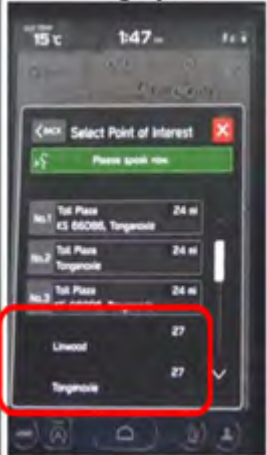
8	<p>Cannot connect to CarPlay via wireless connection. This symptom possibly occurs after the Ignition Switch was turned Off and On abruptly.</p>
9	<p>POI Search Result shows only city names and distances (without unit) when voice recognition POI search with Category name like “Find toll gate” is used.</p>

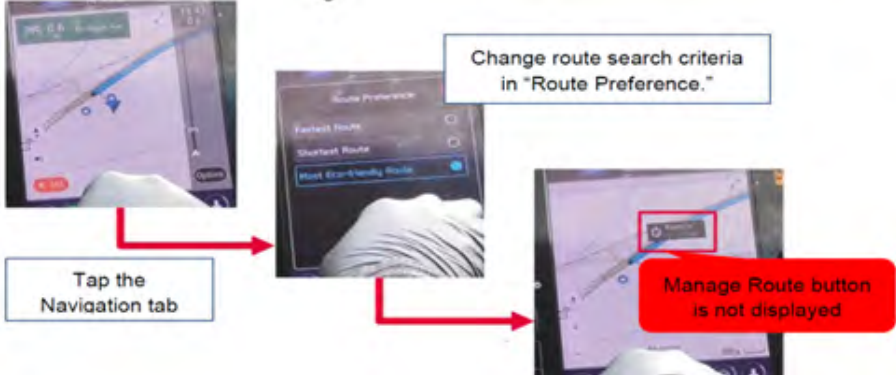
10	<p>Navigation restarts itself, when the letters are rashly entered or deleted using keyboard function to search destination.</p>
11	<p>“Manage Route” button is not displayed when touching the route line on Navigation system, when the route search criteria got changed in the Route Preference Screen after a route had been searched.</p>
