SERVICE BULLETIN

APPLICABILITY: 2020-22MY Legacy & Outback
2022 Outback Wilderness

NUMBER: 09-97-22

SUBJECT: DTCs: P0014, P0016, P0017, P0018 & P0019

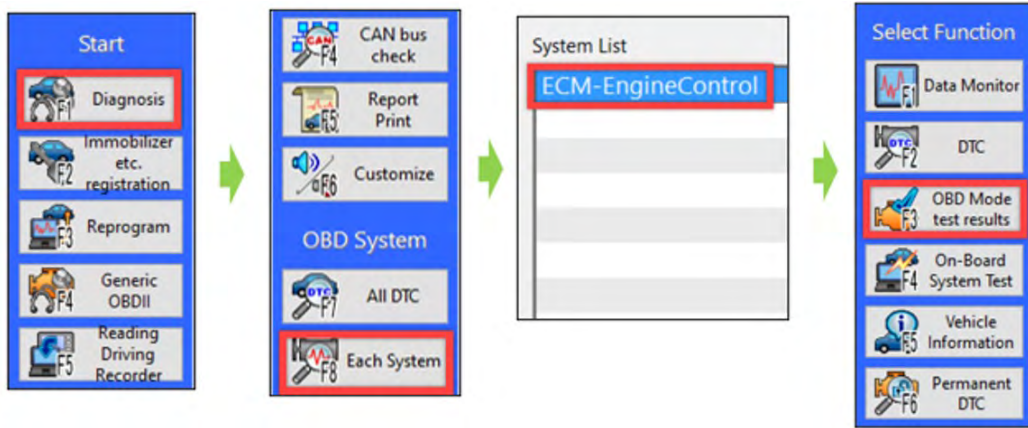
(*1) Instructions on how to perform and read the OBD MODE test results. This procedure will be required when performing the diagnostic Steps outlined below.

Read the following data monitor values:

1. MID - \$35 TID - \$8B
2. MID - \$35 TID - \$8C
3. MID - \$35 TID - \$8D
4. MID - \$35 TID - \$8E

5. MID - \$36 TID - \$8B
6. MID - \$36 TID - \$8C
7. MID - \$36 TID - \$8D
8. MID - \$36 TID - \$8E

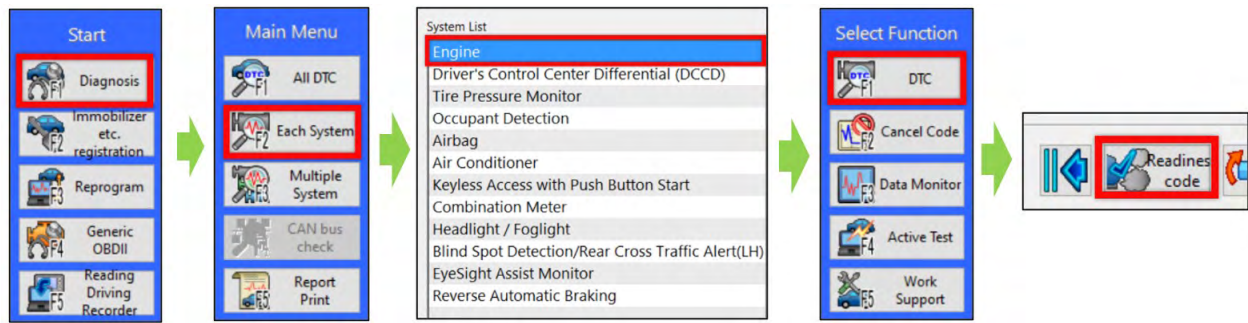
P. Read the readiness codes for P0016, P0017, P0018, P0019, P000A, P000B, P000C, and P000D. Confirm the self-diagnosis is complete and that the codes are not pending.
