**SERVICE BULLETIN**

**APPLICABILITY:** All 2019-**23MY** Vehicles with Gen 2 Telematics      **NUMBER:** 15-219-18R  
**SUBJECT:** Error Code 202 and / or 204 Generated During      **DATE:** 06/21/18  
 Gen 2 Telematics Subscription Process      **REVISED:** **02/28/23**

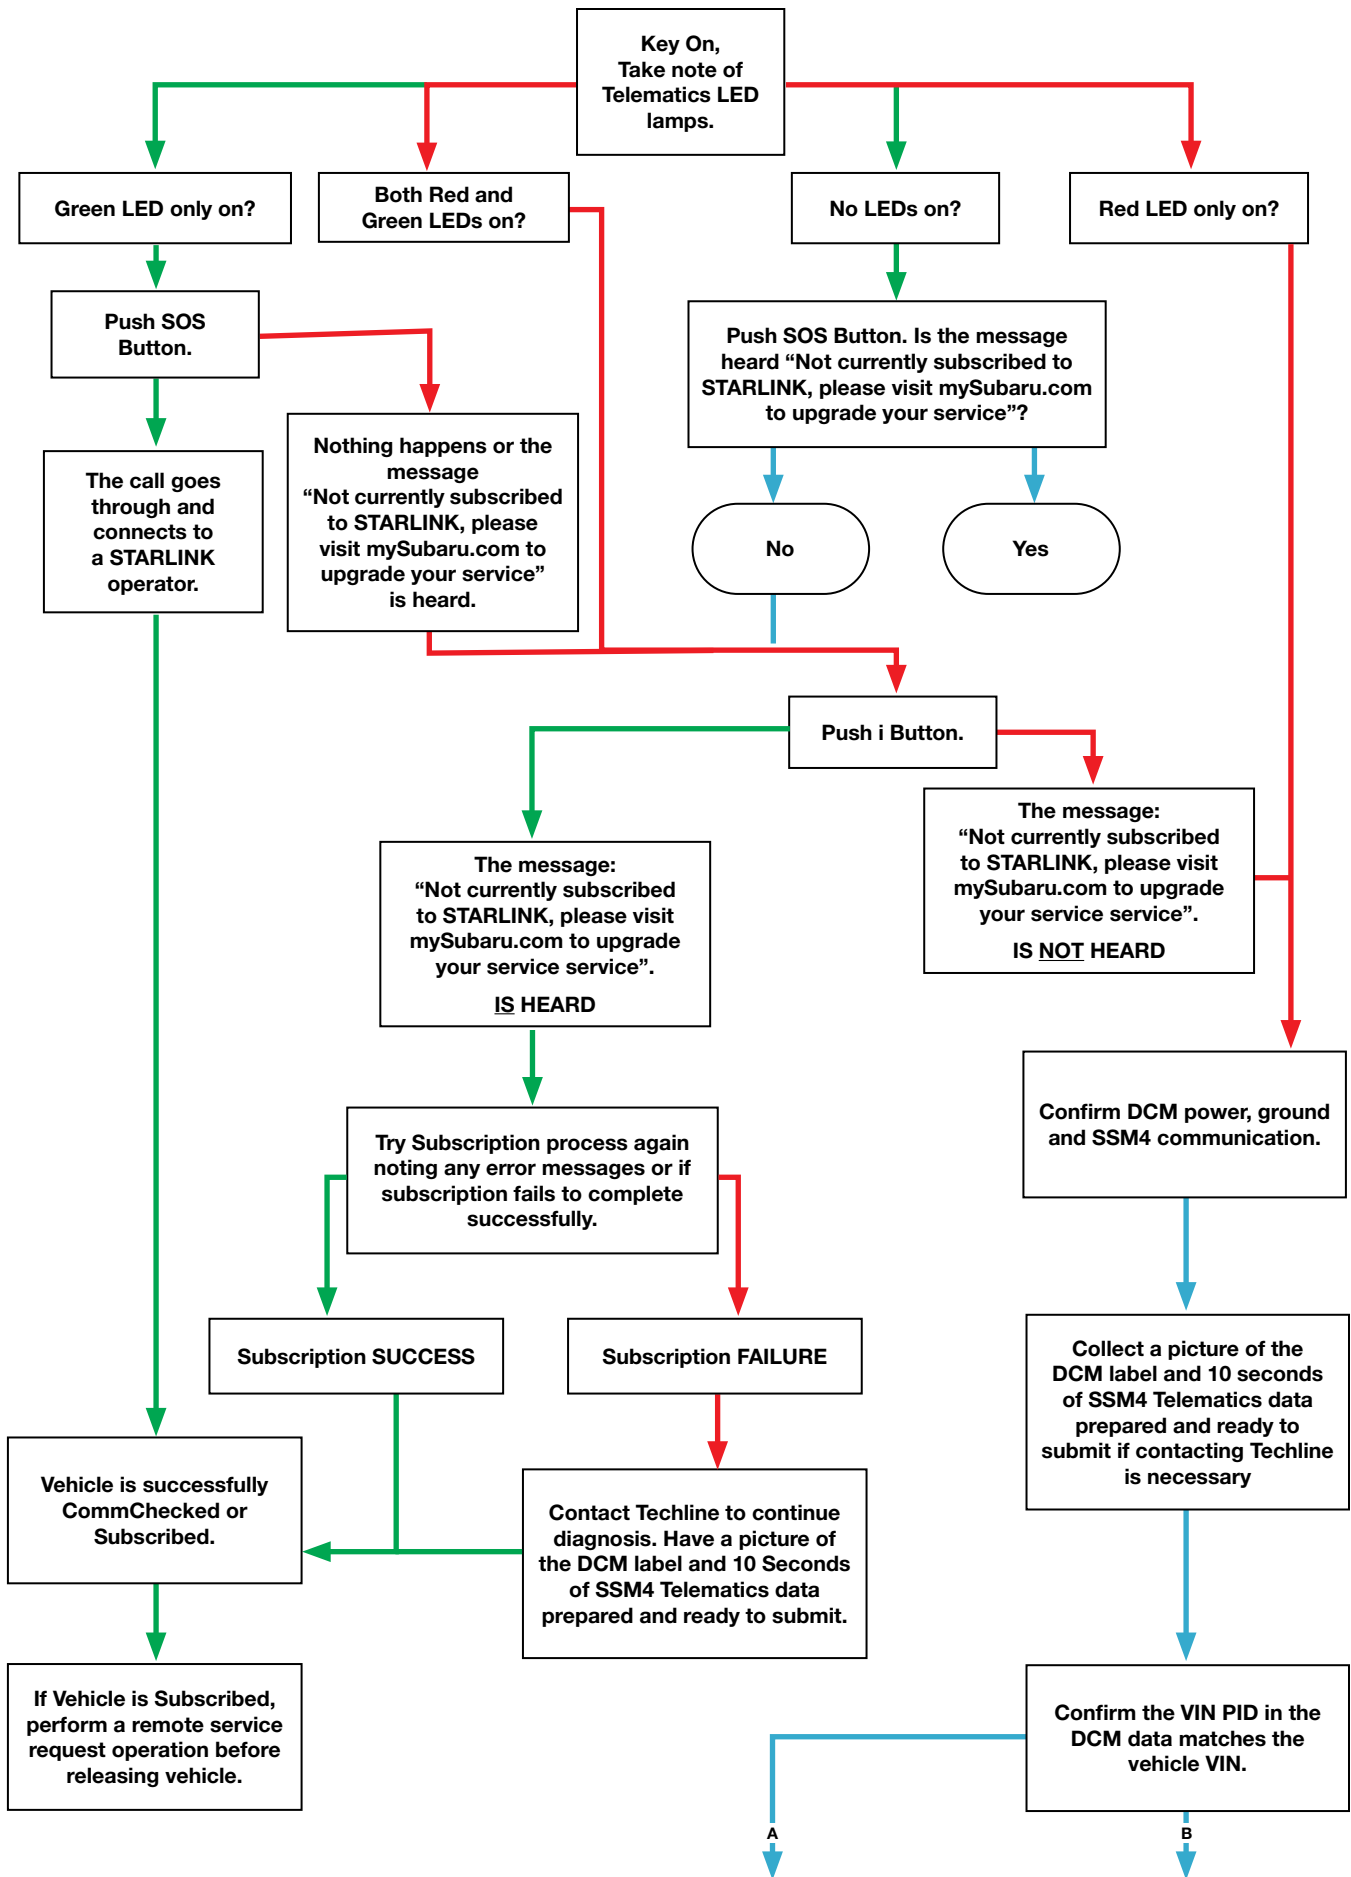
# “Appendix A”

**NOTE:** A flow chart to use as an additional diagnostic reference tool has been provided in “APPENDIX A” beginning on pg. 5.
