# TECHNICAL SERVICE BULLETIN

## Second Row Seat Back Does Not Fold Down Or Recline

**23-2036**

<b>Ford</b> 2018-2023 Expedition
<b>Lincoln</b> 2018-2023 Navigator

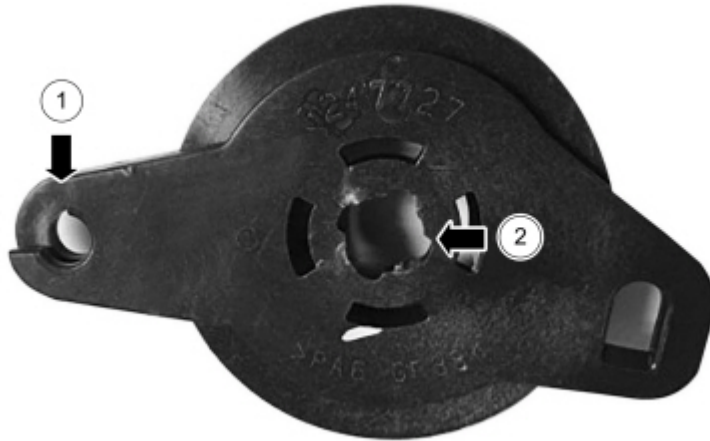
Figure 1

**Issue:** Some 2018-2023 Navigator and Expedition vehicles may exhibit a concern where the second row seat back does not fold down or recline when the recline handle is pulled upward or the second row single seat easy entry seat fold switch is pressed. This concern may occur with vehicles equipped with two or three second row seats. This may be due to a broken recliner release lever. To correct this concern, replace the recliner release lever.

Possible locations for damage on the recline release lever. (Figure 1)

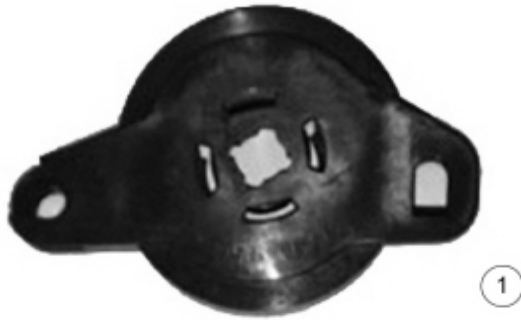
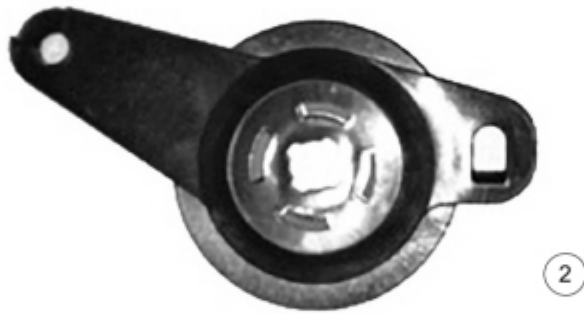
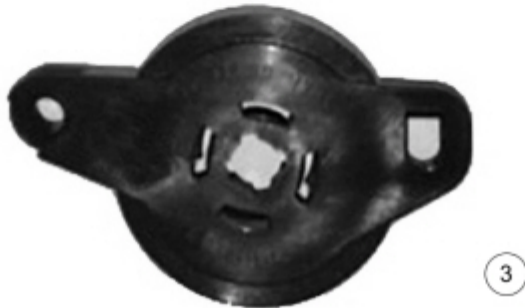
Figure 2

There are three different recline release levers based on the seat repair. (Figure 2)

Item	Description
1	Right seat release lever
2	Middle seat release lever
3	Left seat release lever

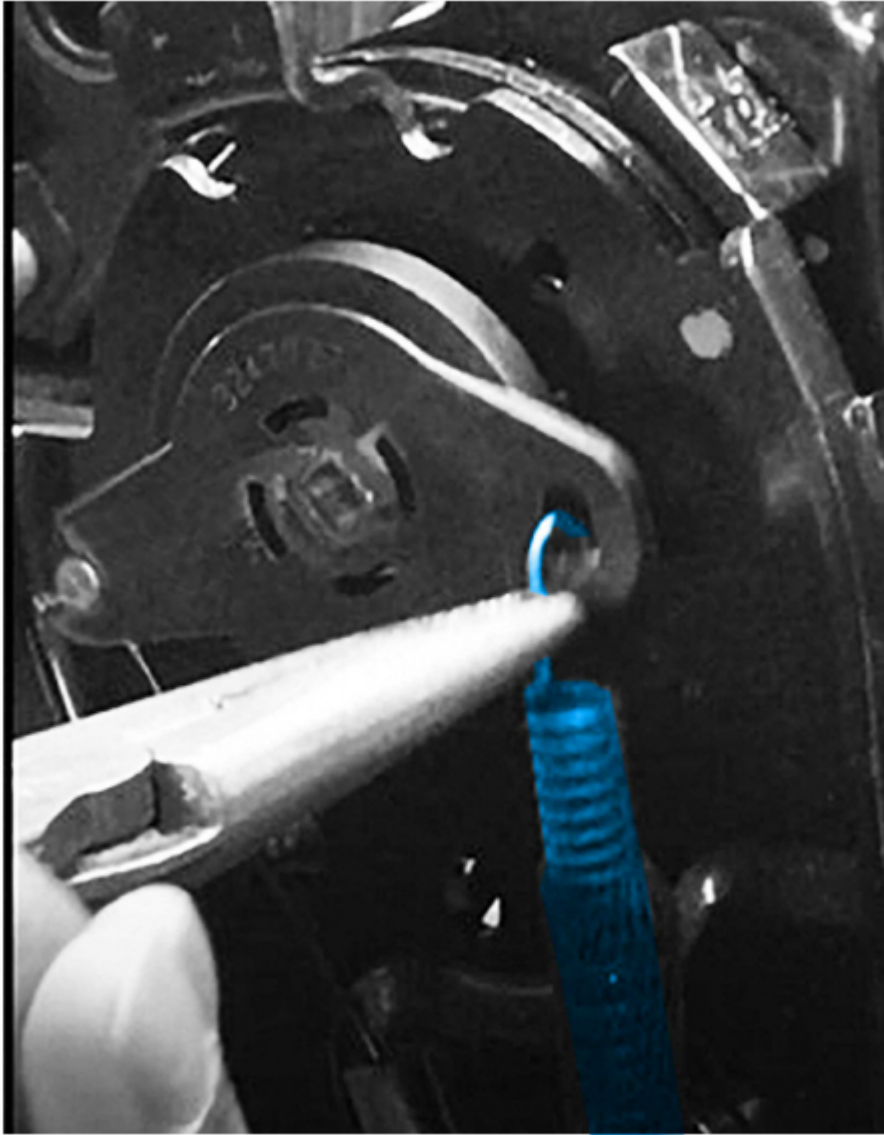
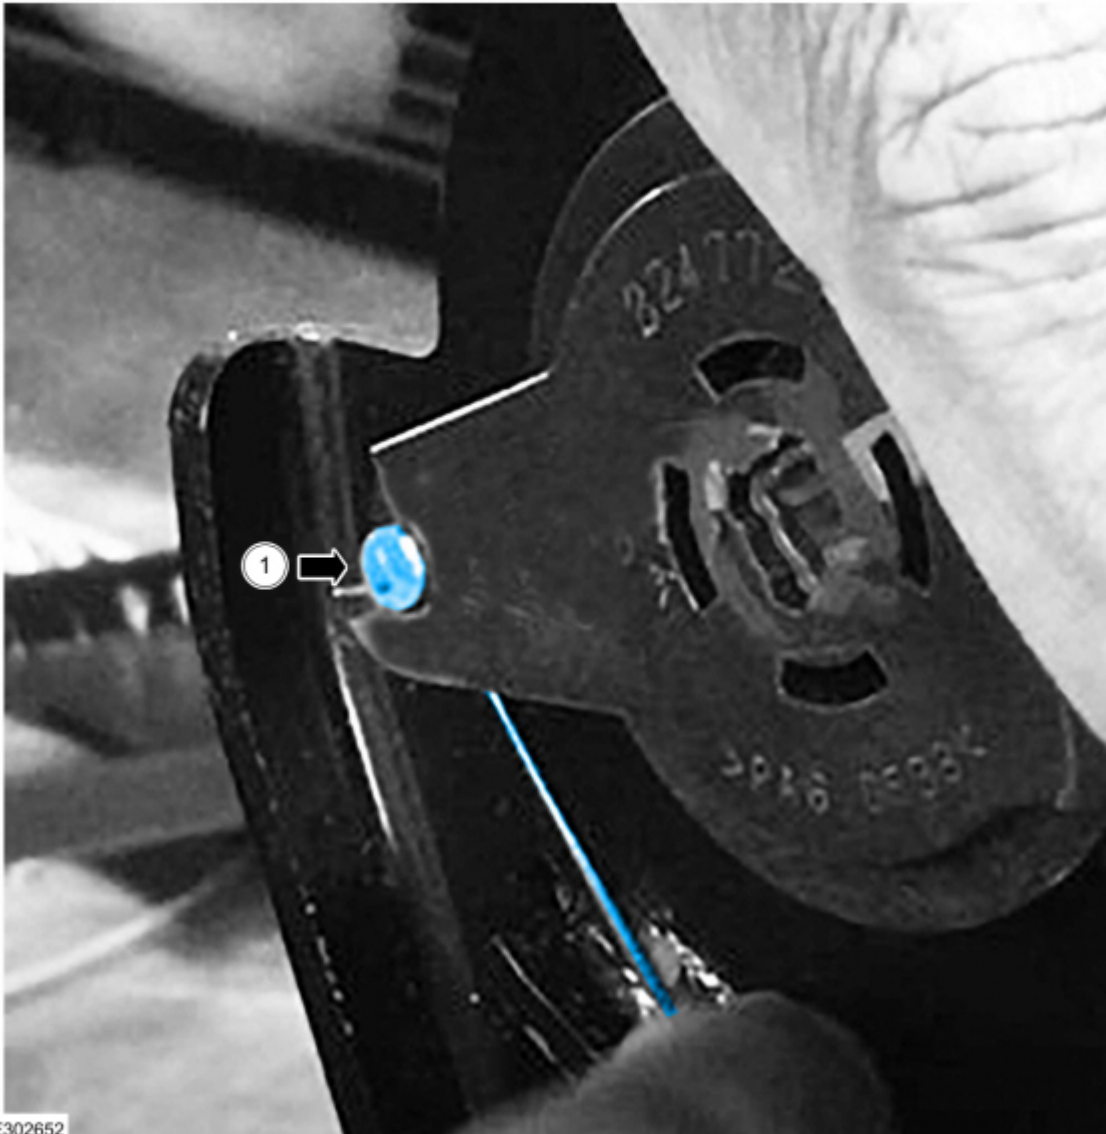
- If either of these attachment points on the recline release lever are damaged, the replacement recline release lever will need both the spring and release cable reattached. (Figures 11-12)
