TECHNICAL SERVICE BULLETIN

4WD - Illuminated MIL With DTC U2002 - Built On 17-Nov-2022 And Through 28-Nov-2022

23-2055

Ford 2022-2023 F-150	Built on 17-Nov-2022 and through 28-Nov-2022
--------------------------------	--

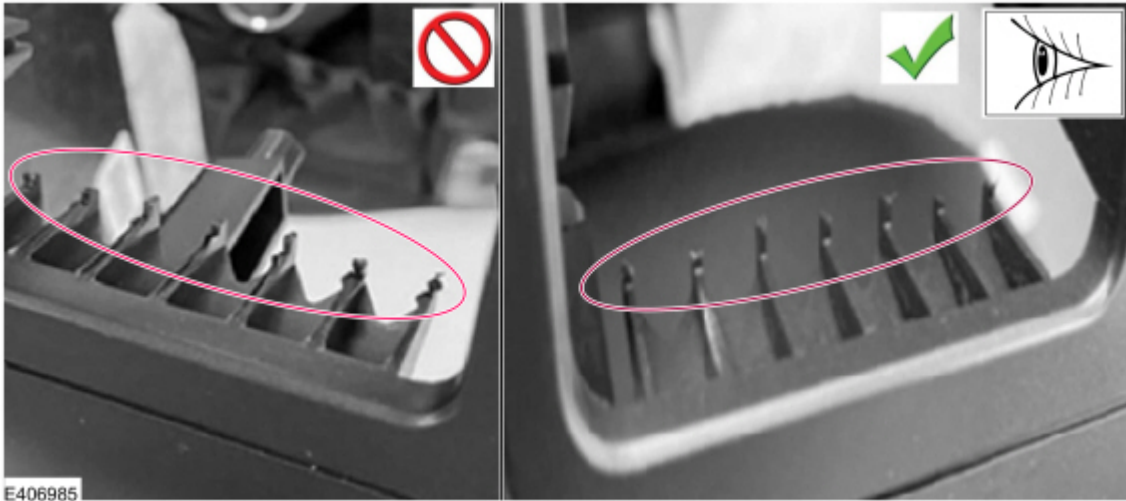
Figure 1

Issue: Some 2022-2023 F-150 vehicles equipped with four-wheel drive (4WD), without a center console, and built on 17-Nov-2022 and through 28-Nov-2022 may exhibit an illuminated malfunction indicator lamp (MIL) with diagnostic trouble code (DTC) U2002 stored in the powertrain control module (PCM). This may be due to an issue with the lower centerstack trim panel where the all terrain control panel (ATCM) mounts. To correct the condition, follow the Service Procedure to replace the lower centerstack trim panel.

1. Remove the ATCM and inspect the right side of the lower centerstack trim panel where the ATCM mounts for excess material contacting the 4x4 switch (Figure 1). Refer to Workshop Manual (WSM) Section 307-07A, All Terrain Control Module (ATCM) - Vehicles Without: Center Console, Steps 1-8 for ATCM removal.

4. Replace the lower centerstack trim panel.
