SERVICE BULLETIN

APPLICABILITY: 2010-2011 Impreza Models
 2010-2013 STI Models
 2010-2011 Forester Models

NUMBER: 15-162-13

SUBJECT: Service Procedure for Replacement of the Bluetooth
 Microphone for Kenwood Audio / Navigation Systems

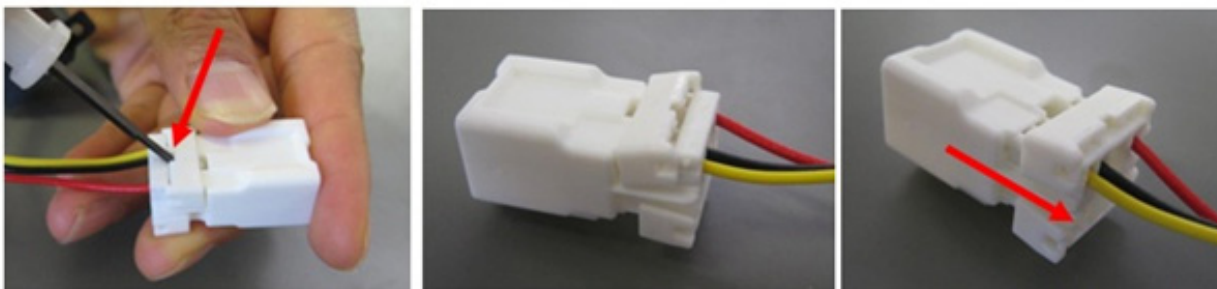
Before unlock

After unlock

Holder slid backward

- Unlock the holder of the new microphone's harness connector. Insert a small flat-blade screwdriver under the indentation of the holder then lift up gently to unlock it as shown in the photos below. Once unlocked, slide the holder backward.

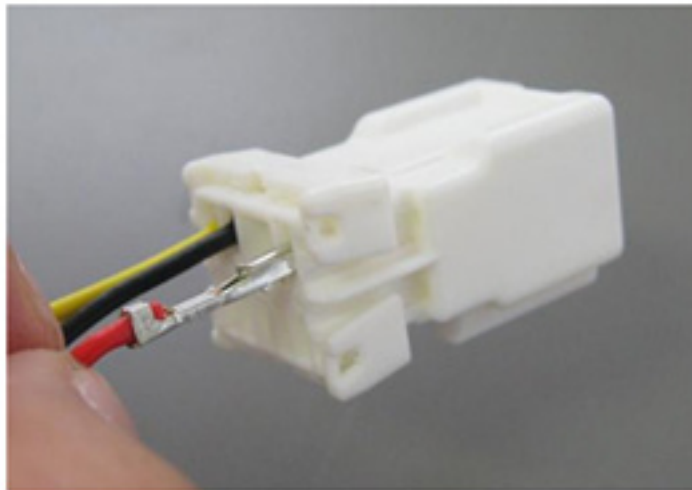
Proper orientation when reinstalling terminals

- Remove all three wires from both the replacement and the vehicle's original microphone harness connectors.
- Reinstall the terminals of the replacement microphone's harness into the vehicle's original microphone harness connector as shown below. The connector is being viewed from the front in these two illustrations.

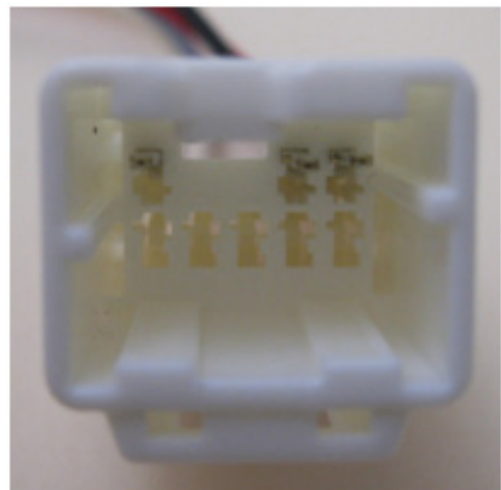
View from front of connector
