SERVICE BULLETIN

APPLICABILITY: 2010-12MY Legacy and Outback Models
 2009-12MY Forester Models
 2008-12MY Impreza, WRX and STI Models

NUMBER: 12-144-13
DATE: 02/07/13

SUBJECT: Front Door Glass Does Not Close Properly

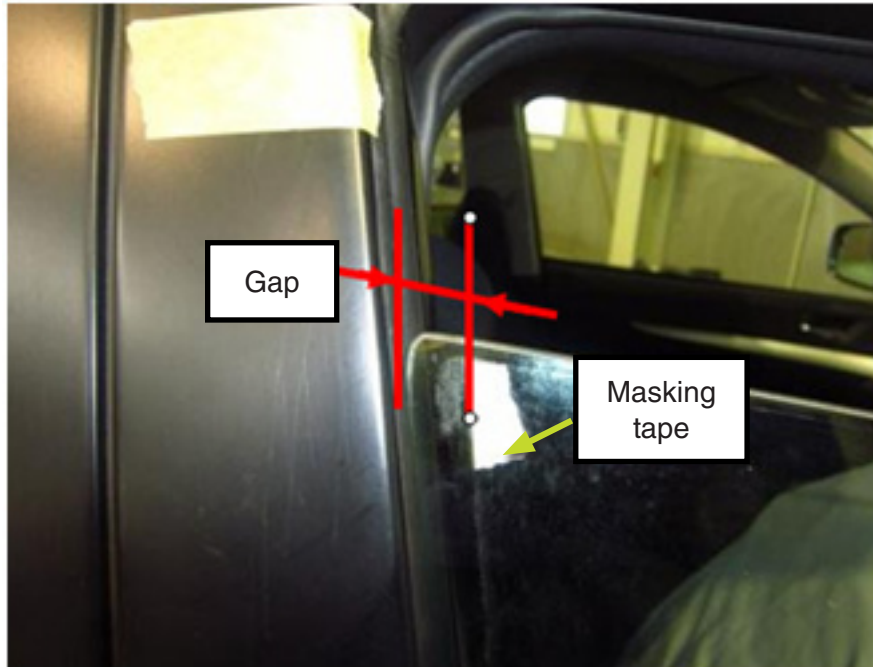
- Determine if the front door glass is tilting forward when opening. With the window fully closed, put a piece of masking tape vertically on the glass near the top corner parallel to and against the rubber weather stripping (glass run channel). Lower the window a couple inches then see if the masking tape has moved away from the run channel creating a gap as shown in the photo below. If a gap is verified, the joint between the upper and lower window sash will need to be inspected for a misalignment condition causing the glass to bind in the run channel.

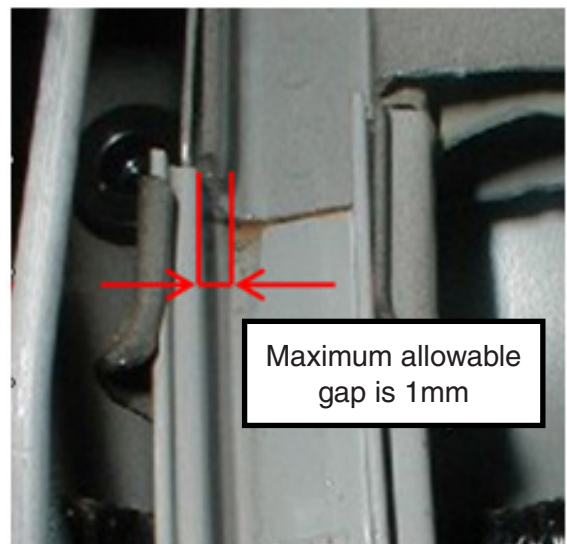
- Inspect the sash joint as shown in the photo above, right. If the gap is found to be more than 1mm, the lower sash will need to be removed and the flanges on the lower bracket re-shaped with pliers as shown below, right. Making small changes at a time then trial fitting after each will provide the best results.
