## SERVICE BULLETIN

**APPLICABILITY:** 2010MY and later Legacy and Outback Models      **NUMBER:** 12-164-14  
**SUBJECT:** Film Residue Removal from Underside of Front Seat Cushion Covers      **DATE:** 02/24/14

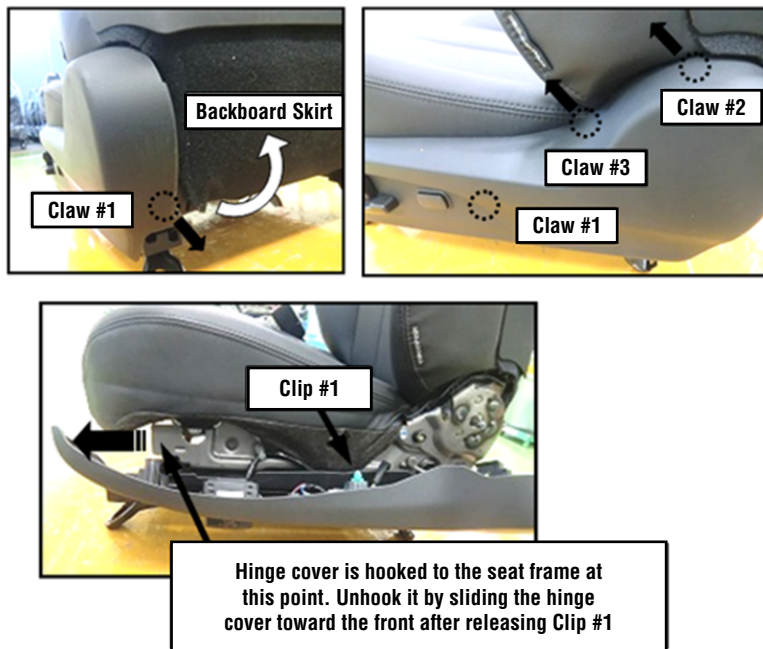
#### FOR POWER SEAT:

- Remove the front seat assembly following the procedure in the applicable Service Manual.
- Remove the side hinge cover by first releasing and turning up the backboard skirt as shown in the photo sequence below then **CAREFULLY** releasing all 3 of the hinge cover claws and Clip #1 from the back of the cover as shown below.

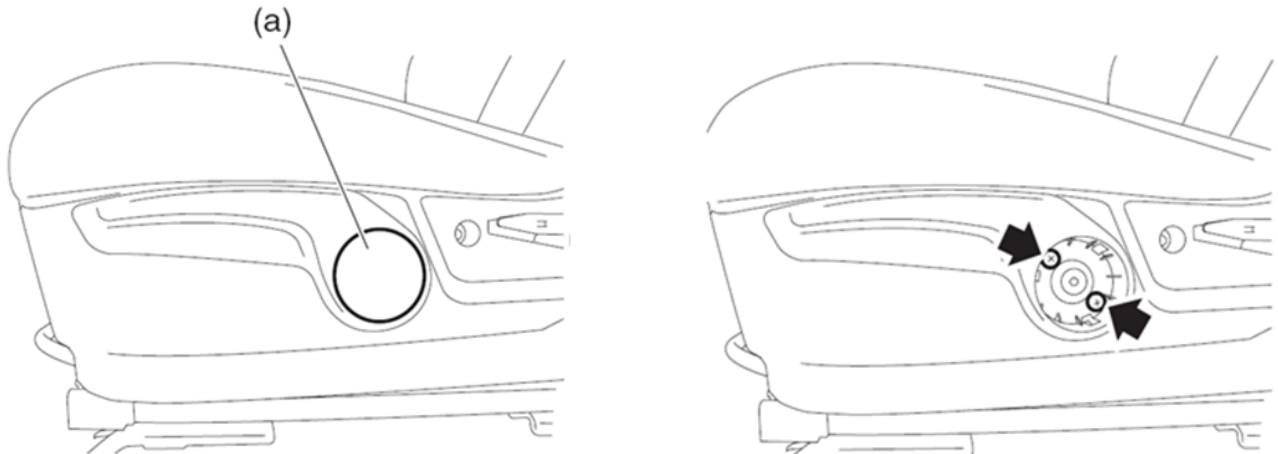
- **CAREFULLY** remove the lift lever trim cap (a) with a small flat-blade screw driver or modified plastic trim tool to access the 2 lever retaining screws.

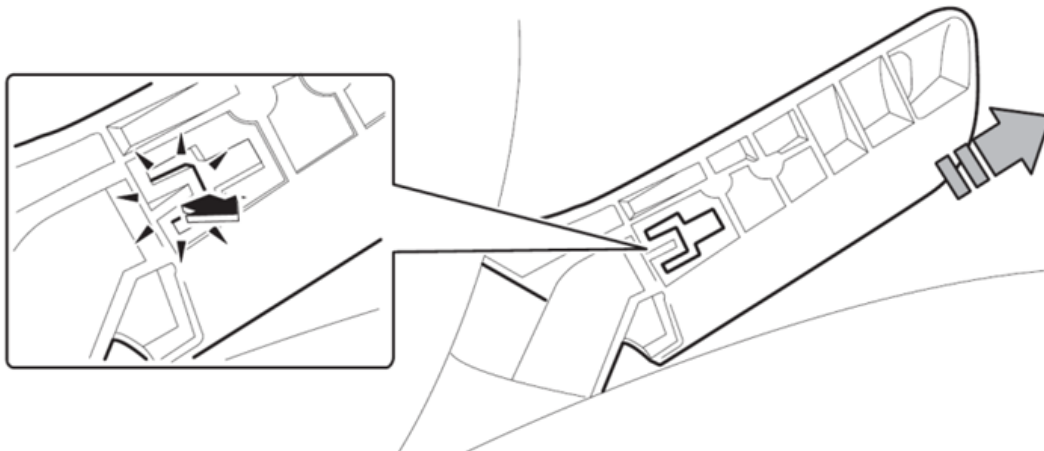
- Remove the reclining lever cover by **CAREFULLY** releasing the claw and sliding it off the lever.

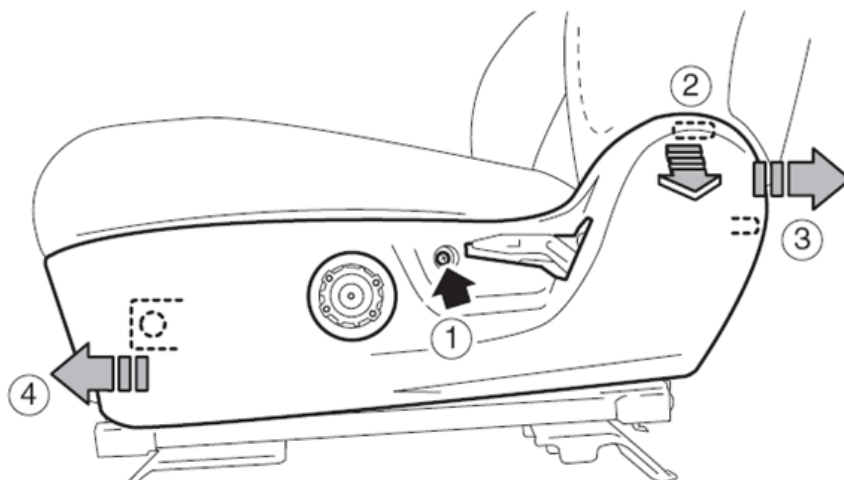
- Remove the 2 lift lever screws, the lift lever and the 3rd screw (#1 below). Release the top claw (#2), rear claw (#3) by pulling the cover backward just enough to release it, then front claw (#4) will release when sliding the hinge cover trim forward to remove it from the seat.

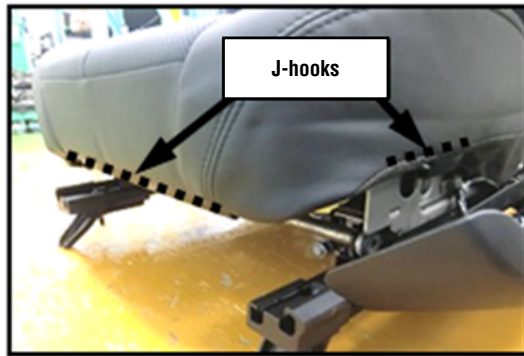
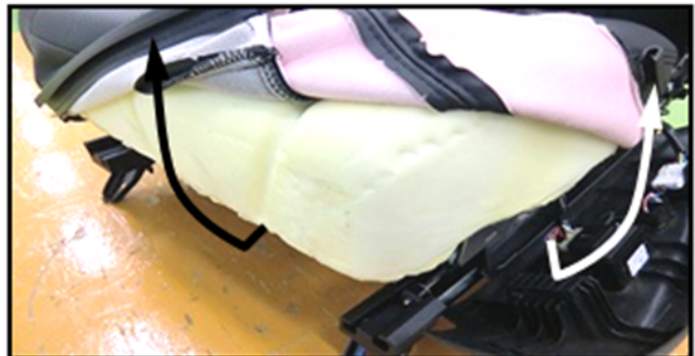
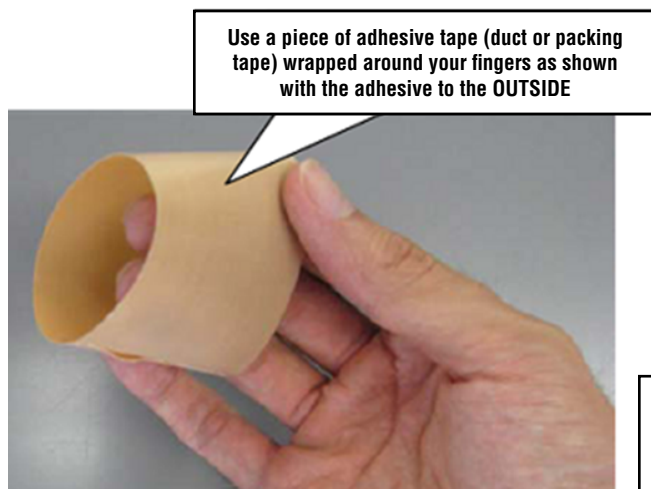
- After the hinge cover is removed, remove the two J-hooks and release the seat cushion trim cover from the corners of the seat cushion and frame. There should be no need to remove any hog rings. The pinkish-colored material shown below, right is the DOW film which may separate and gather or “ball-up” causing bumps or similar surface appearance imperfections as described previously.
