## SERVICE BULLETIN

**APPLICABILITY:** 2010~2013MY Legacy and Outback equipped with Sunroof  
**SUBJECT:** Water Leak from the Map Light Area

**NUMBER:** 12-117-10R  
**DATE:** 03/30/10  
**REVISED:** 02/14/13

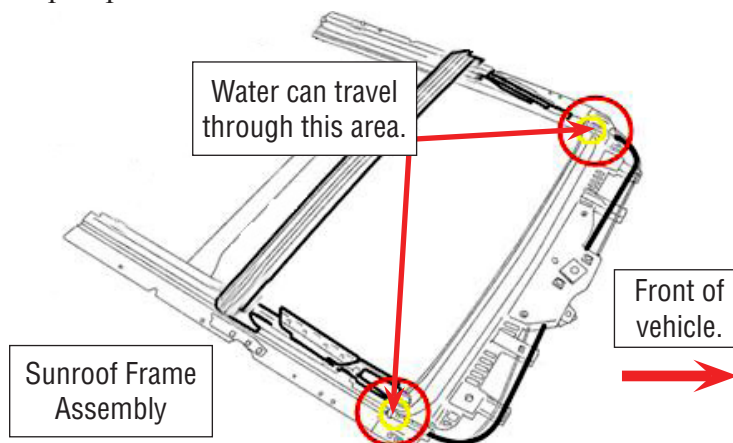
If you encounter a customer complaint that water is leaking from the map light area, it could be caused by water leaking through the area of the sunroof cable mechanism. To remedy the condition, silicone sealer will need to be applied to both of the front end caps as indicated below. Refer to the repair procedure listed below.
