SERVICE BULLETIN

APPLICABILITY: 2013-14MY BRZ

NUMBER: 12-162-14

SUBJECT: Design Change to Rear Combination Lamps to Prevent Insect Intrusion

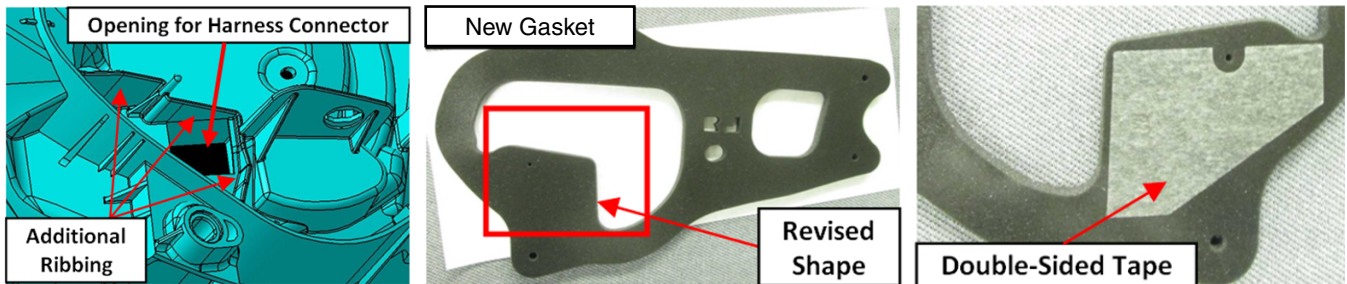
A design change has been made to the rear combination lamp assemblies and the packing (gaskets) to prevent insects from getting inside the housings. Extra ribbing has been added around the vehicle harness connector openings along with a revised shape and addition of double-sided tape to the gaskets for improved sealing.
