## SERVICE BULLETIN

**APPLICABILITY:** 2013-14MY Legacy and Outback Models with  
2.5L FB Engine  
2011-14MY Forester Models with 2.5L FB Engines  
2012-13MY Impreza and 2013MY XV Crosstrek  
Models with 2.0L FB Engine

**NUMBER:** 02-157-14R

**SUBJECT:** Surface Treatment Change To Oil Control Piston Rings

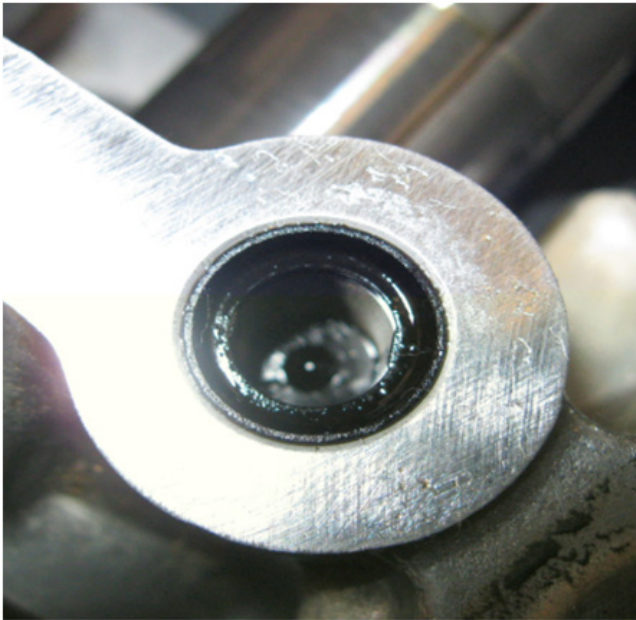
Cam Carrier Filter Screen

- Don't forget to clean (**without removing**) the filter screens in the cam carriers (one filter in each carrier). In addition, always be sure to do a thorough inspection and cleaning of the oil pan, pick-up tube and screen as shown in the photos below before reassembly.

- **IMPORTANT:** If by chance the AVCS filter screens in the cam carriers have come loose or fallen out during disassembly, **they are directional and MUST be reinstalled in their original position.** There is an oil passage in the cam case which **MUST** align with a hole on the outside diameter of the filter screen tube otherwise, oil flow to the AVCS will be restricted or blocked resulting in engine damage.

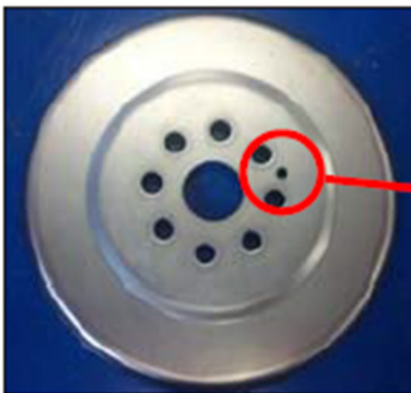
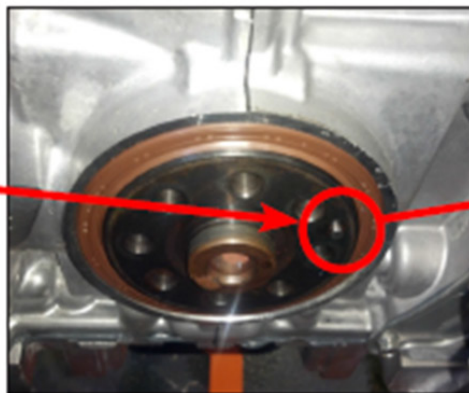
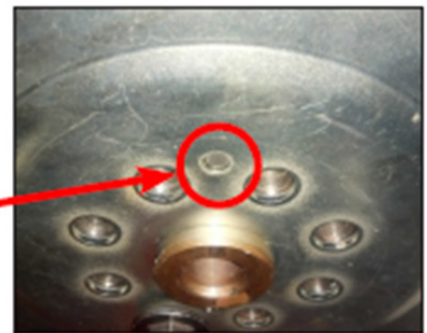
- **REMINDER:** When replacing the short block, in addition to transferring the crankshaft position sensor, be sure to index the reluctor properly onto the crankshaft as shown in the photos below. The reluctor is indexed by a dowel pin in the rear crankshaft flange which aligns with a corresponding hole in the reluctor. It is possible to install the reluctor without indexing it correctly. Failure to index the reluctor correctly will result in a no-start condition due to an out of time crank position signal to the ECM.
