SUBARU

SERVICE BULLETIN

NUMBER: 02-144-13R

SUBJECT: Surface Treatment Change To Oil Control
 Piston Rings

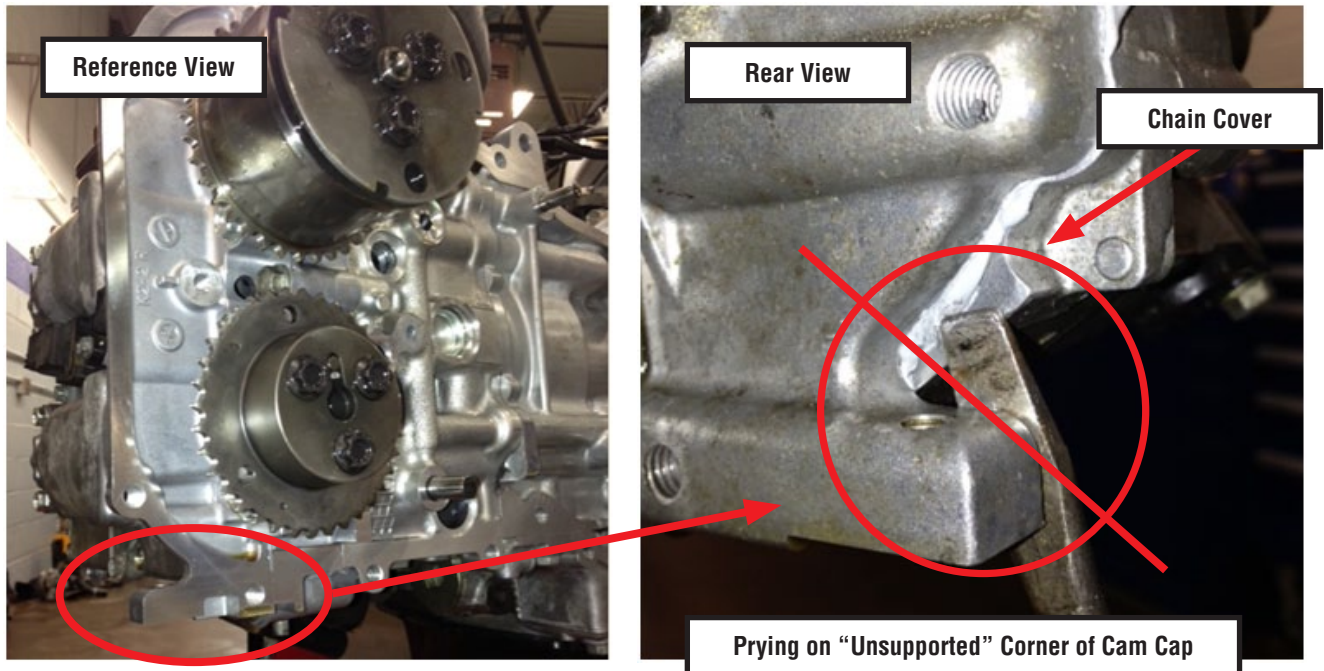
- **IMPORTANT:** After all 32 bolts securing the chain cover are removed, be **VERY** careful where you pry and what you pry on to break the silicone sealant bond. The photos below show an example of where NOT to pry. In this case, the cam cap became cracked requiring a complete cam carrier replacement. Patience is the key!
