SERVICE BULLETIN

APPLICABILITY: 2013 MY BRZ

NUMBER: 12-145-13R

SUBJECT: Condensation in Rear Combination Lamps,
 Retaining Nut and Sealing Gasket Change

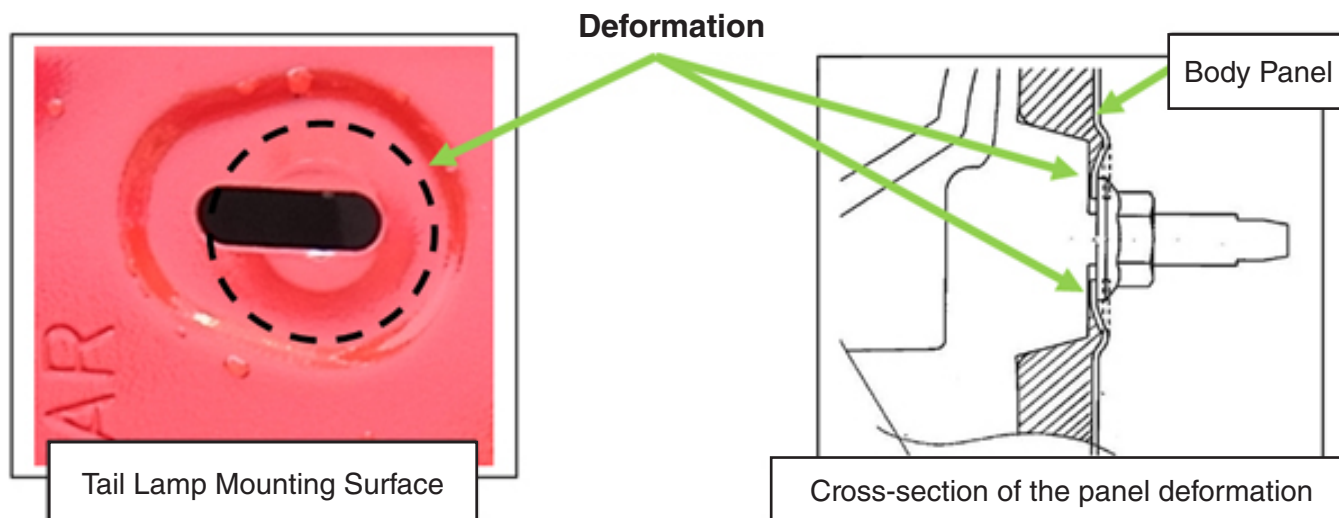
Due to a smaller diameter flange surface, the original retaining nuts may distort the rear body panel mounting and sealing surfaces for the combination lamps enough to allow moisture seepage past the seals into the combination lamps and possibly the trunk area. In addition, the thickness of the sealing gasket (packing) for the rear combination lamp has been increased from 5mm to 8mm.

Inspect the rear body panel in the retaining nut areas for any deformation of the metal as shown in the illustrations below.

If any deformation is found, CAREFULLY straighten the affected mounting area using a small body hammer and dolly.
