## SERVICE INFORMATION

**APPLICABILITY:** 2011MY Legacy, Outback, Forester, Impreza, WRX, & STI Models

**NUMBER:** 05-58-14

**SUBJECT:** Sound from Rear Suspension Upper Control Arm

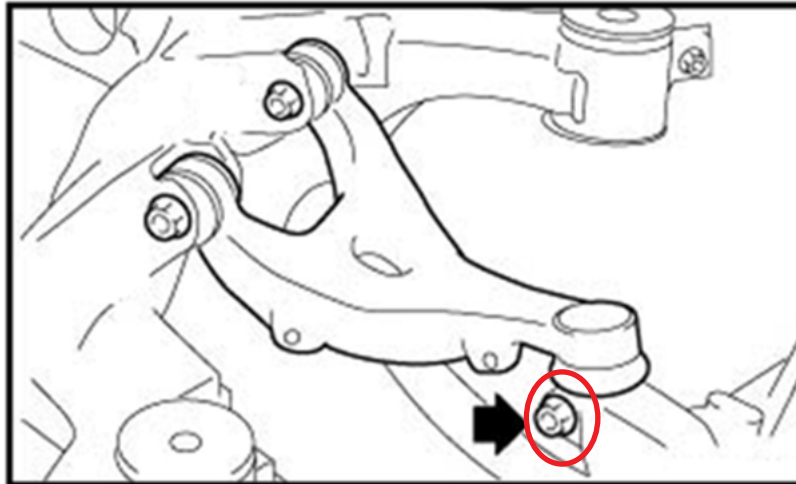
This bulletin provides a procedure for diagnosing and repairing a rattle-type rear suspension sound determined to be coming from the upper control arm ball joint. A revised torque specification for the ball joint retaining nut / bolt set is also included.

1. Once the condition has been confirmed, remove both rear tire and wheel assemblies for access to the suspension components as **BOTH** sides of the vehicle must be inspected.
2. Remove the nut and bolt securing the upper control arm ball joint to the bearing housing as indicated in the illustration above.
3. Rock the upper arm and the bearing housing as necessary to check for any looseness or free-play in the upper arm ball joint.
4. If any looseness in the ball joint is visible or felt, replace the upper arm assembly for that side of the vehicle following the procedure outlined in the applicable Service Manual.
5. **ALWAYS** install a **NEW** ball joint retaining nut and bolt set then torque to 90 Nm (66.4 ft. lbs.).
6. Repeat steps 2 through 5 for inspection / repair to the opposite side of the vehicle.
