NUMBER: 12-168-14

APPLICABILITY: 2013 BRZ SUBJECT: Appearance Imperfection of Inside Rear View Mirror

SERVICE BULLETIN

DATE: 03/31/14

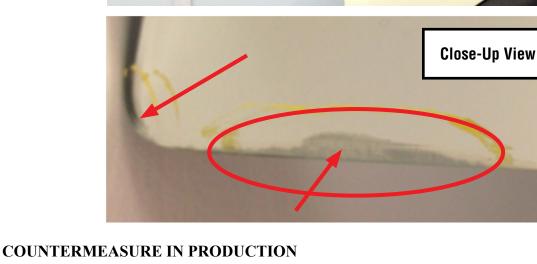
The countermeasure rear-view mirror assembly was incorporated into production on September 1, 2012 starting with VIN D* 603893.

This bulletin informs of how to repair a possible visual imperfection in the frameless rear-view mirror. A countermeasure mirror assembly is now available to address a customer concern of what

The part number for the countermeasure rear-view mirror assembly is 92039CA000.

Once the delamination of the mirror glass has been verified, replace the assembly with the countermeasure part following the procedure outlined in the applicable Service Manual.
