TECHNICAL SERVICE BULLETIN

Timberline - Differential Fluid Venting From The Rear Axle

22-2406

Ford 2021-2023 Explorer	Timberline
-----------------------------------	------------

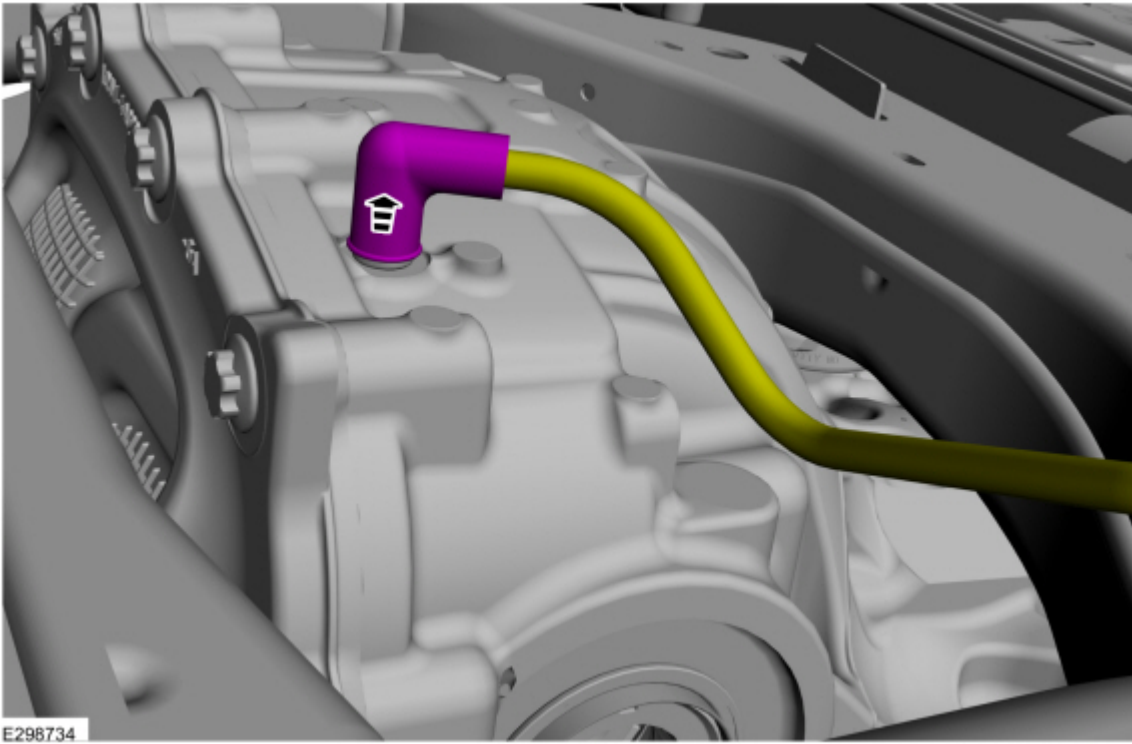
Figure 1

Issue: Some 2021-2023 Explorer Timberline vehicles may exhibit differential fluid venting from the differential fluid vent. The customer may notice differential fluid pooling below the vehicle, or saturating the wheel well liner. This may be due to the differential vent tube not having enough positive incline. To correct the condition, follow the Service Procedure to replace the differential vent tube.

1. Remove and discard the differential vent tube. Refer to Workshop Manual (WSM), Section 205-02.
2. Install the new differential vent tube. Make sure that the vent tube is routed correctly and maintains a positive slope on the curvature near the differential. (Figures 1-3)

NOTE: It may be beneficial to use a borescope to view the differential vent tube mounting and make sure the vent tube is fully seated and is sloping upward.
