TECHNICAL SERVICE BULLETIN Oil Pan Leaking - Built On Or Before 15-Aug-2019

This bulletin supersedes 19-2387.

This article supersedes TSB 19-2387 to update the Part List.

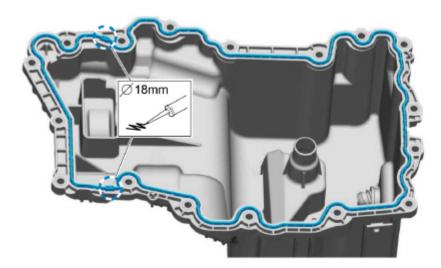
Figure 1

Issue: Some 2018-2019 Edge/Continental, 2018 MKX and 2019 Nautilus vehicles built on or before 1-Aug-2019 and 2018-2019 Fusion/MKZ vehicles built on or before 15-Aug-2019 equipped with a 2.7L EcoBoost or 3.0L EcoBoost engine may exhibit an oil leak from the engine oil pan RTV seal. To correct the condition, follow the Service Procedure steps to replace the oil pan with a new oil pan equipped with a press in place gasket.

- 1. Remove and discard the oil pan and oil pump seal. Refer to Workshop Manual (WSM), Section 303-01.
- 2. Clean and prepare the engine sealing surface. Refer to WSM, Section 303-00.
- 3. Install the new oil pump seal.
- **4.** Apply a 18 mm (0.708 in) bead of Motorcraft® High Performance Engine RTV Silicone to engine the front cover-tocylinder block joint areas on the oil pan. (Figure 1)

NOTE: The new oil pan does not require the use of Motorcraft® High Performance Engine RTV Silicone in any other location.
