**TECHNICAL SERVICE BULLETIN**  
**Buzz/Vibration/Rattle From Center Left Of Instrument Panel (IP) During Tip-In**

**23-2079**  
 13 March 2023

<b>Ford</b> 2022-2023 Explorer
-----------------------------------

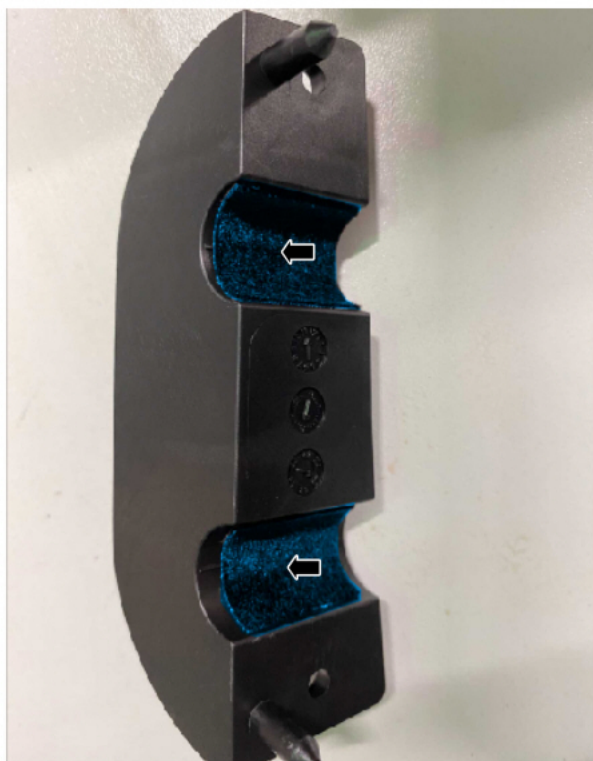
Figure 3

**Issue:** Some 2022-2023 Explorer vehicles may exhibit a buzz/vibration/rattle from the center left of the IP during tip-in when the vehicle is at operating temperature. This may be due to heater tube movement against the tube bracket. To correct the condition, follow the Service Procedure to apply flock tape to the heater tube bracket

(3). Apply flock tape from the Rotunda Squeak And Rattle Kit to the left heater tube bracket in the saddle area that clamps the heater tubes. (Figure 3)
