## SERVICE BULLETIN

**APPLICABILITY:** All Models Equipped with Harman Audio / Navigation Head Units **NUMBER:** 15-221-18R  
**SUBJECT:** Harman Audio / Infotainment: Harman Generation 3.0 and 3.1 Operating Tips **DATE:** 04/11/18  
**REVISED:** 03/28/23

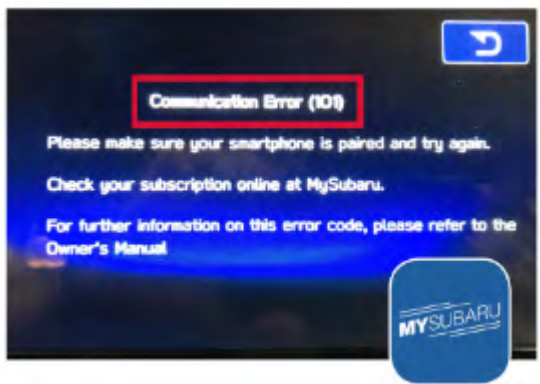
**CONDITION# 0.11** When selecting the MySubaru Application on the head unit, a Communication Error may occur that displays along with a specific code. In the example image below, the error code is 101:

**CAUSE:** Communication Errors can occur for many different reasons. For example, the issue causing the Communication Error could be that a Smartphone had not been paired to audio head unit.

**RECOMMENDATIONS:**

If a Communication Error message displays on the head unit screen, please use the chart below for descriptions on possible causes.

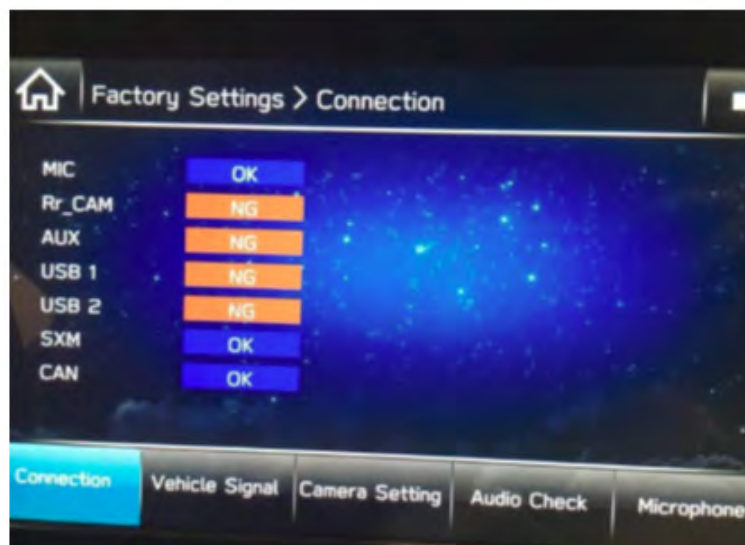
**CONDITION# 1.1 No backup camera after head unit replacement or battery disconnect (2016 Dec TechTIPS):**

**CAUSE:** Whenever the Audio / Navigation head unit requires removal on a 2017 Impreza, it is important the Service Manual procedure be followed. The Service Manual advises to disconnect the battery before servicing the audio unit. Failure to follow this instruction, can result in a customer concern of the backup camera becoming inoperative since the service. The reason, when connecting power to the unit, a self-check is performed. If the backup camera has not been connected yet, the unit assumes there is no back up camera and renders it inoperative.

Below is an image of what the screen will look like if a line check is performed before the issue is corrected:

**RECOMMENDATION:** A quick fix for this condition is to remove and reinstall the transit (PDI) fuse or remove and reinstall the negative battery terminal. The situation can be avoided completely by following the Service Manual and disconnecting the battery before starting the service.

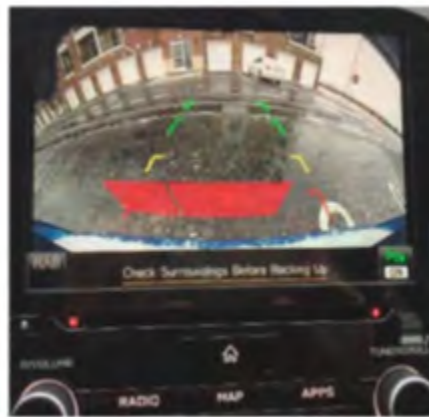
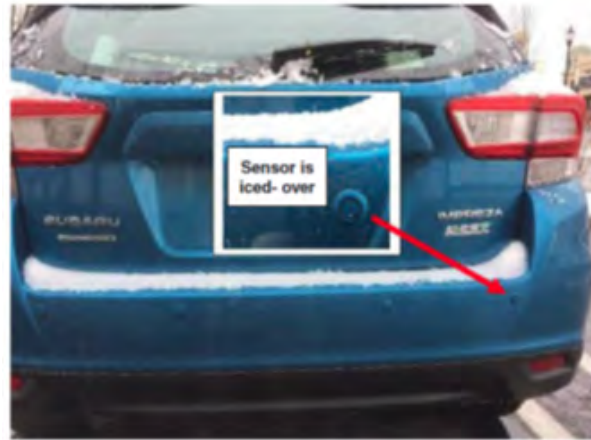
**CONDITION# 1.3** On vehicles equipped with reverse automatic braking (RAB), a red area appears in backup camera display:

**CAUSE:** If a customer states they see a red box or area in their backup camera display, the system is most likely operating as designed. Always perform a visual check of the sensors on the rear bumper first. If any of the sensors are covered over or obstructed by ice and / or snow, the RAB system may not function properly and the red area shown in the example photo below will most likely appear.

**RECOMMENDATION:** When this condition occurs, the RAB system is unable to properly differentiate between what really is an obstacle and what is not. In the image below, the sensor is iced over and the red area is displayed with no obstacle present. The Owner’s Manual provides a list of other potential causes for this condition to occur.

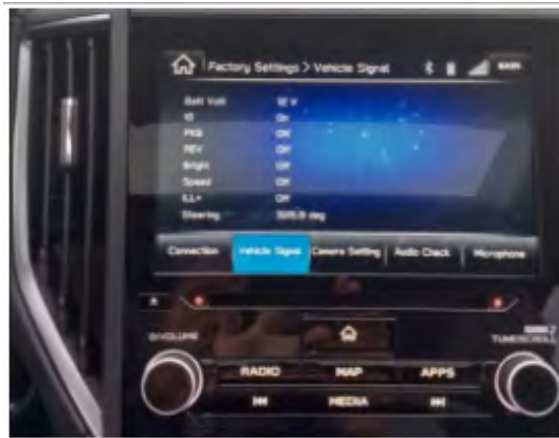
**CAUSE:** Park assist lines position is reflecting the steering angle. If the data is not supplied to the head unit from CAN bus or the data supplied is wrong, the lines position is not changing. Park assist lines display could be turned off via head unit setup.

The steering angle reading is shown on the photo below (“Steering 326.9 deg”).

**RECOMMENDATION:** Confirm the guide line settings and steering angle line data to determine the reason for concern.

Rotate the steering wheel to confirm the number is changing with the steering wheel rotating.

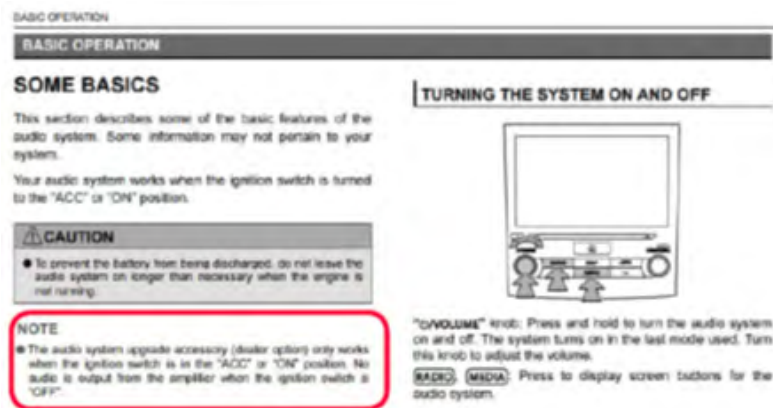
### **CONDITION# 3.1 Audio unit stays powered up after key off** (2017 Feb TechTIPS):

**CAUSE:** All the new 2017MY Impreza audio systems include a feature where the audio system stays powered for a period of time after the ignition is switched OFF. If the vehicle has been equipped with the accessory Rockford Fosgate audio amplifier, some confusion may arise when comparing audio

unit operation of one Impreza to another. Although the audio unit will continue to operate after the ignition is switched OFF on all models, the power supply for the accessory amplifier is switched off along with the ignition resulting in the loss of audio output. This may cause confusion for customers when seeing the audio unit appear to be operating but not hearing any audio output.

**RECOMMENDATION:** Be advised, this is a normal operating characteristic and no attempt should be made to repair or replace any of the system components. **This operating characteristic is also briefly described on pg. 118 of the Multimedia System guide contained in the Owner Information Kit as shown here.**

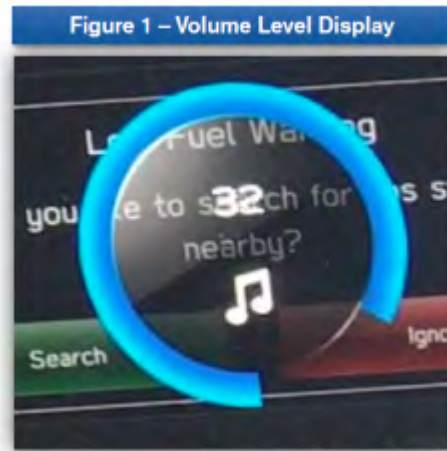
**CONDITION# 4.1 Audio Volume is turned to MAX when monitoring infotainment data monitor** (March 2017 TechTIPS):

**CAUSE:** If you are monitoring the Infotainment System Data Monitor and the volume level display (**Figure below**) appears showing the volume level increasing but the sound level remains the same, this is a normal operation of the Harman unit.

**RECOMMENDATION:** When a Technician accesses the Infotainment System Data Monitor, the unit enters “Diagnostic Mode” and the volume level will be displayed in this manner. No repairs should be performed to address this concern as it is a normal operating characteristic.

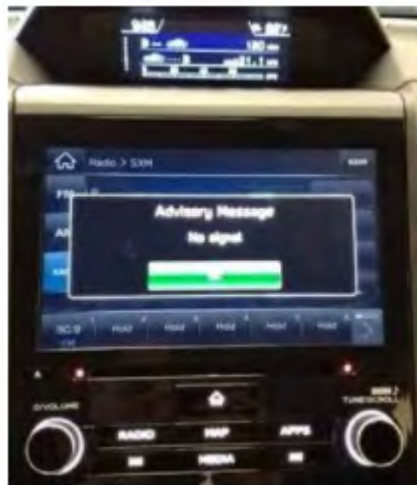
**CONDITION# 5.1** Harman Gen 3 Audio/ Navigation head unit shows an “Advisory Message- No Signal” notification on the display:

**CAUSE:** In areas of poor or no SXM coverage, the head unit will display the message as shown above. It is not a failure condition assuming SXM service is not available.

**RECOMMENDATION:** No action should be taken to correct this condition. **NOTE:** After Ver.3 (2.17.43.xx) software version update, the message ONLY pops up while displaying the SXM radio screen. On earlier software versions, it will pop up in FM/AM screen.

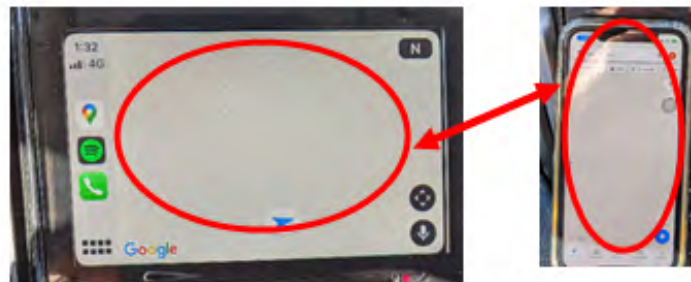
» No roads are displayed using Google Map, while running Apple CarPlay (Google Maps crashed on iPhone resulting in no roads to be displayed):

As you can see the head unit is projecting what iPhone is pushing to it and vehicle hardware replacement won't fix a concern with a crashing phone application. In cases like that we suggested frequent iPhone reboot or restart (especially after recent iOS update) or updating or reinstalling the application on the phone. Check the comments in iTunes store as this may be a known concern with the app.

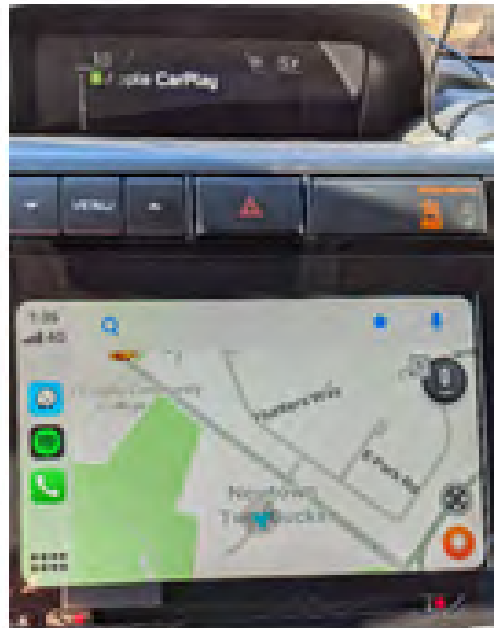
**CAUSE:** We have seen many reports of the Audio Output (radio, CD, USB etc.) being interrupted when the Apple CarPlay application is launched or a Navigation application (ex: Waze) or audio streaming application is (ex: TuneIn) is started from Apple CarPlay environment.

**RECOMMENDATION:** Please note this is a characteristic as the iPhone takes control. This may also occur when the phone is used for other purposes while CarPlay is active such as texting, replying to emails or other phone side actions.

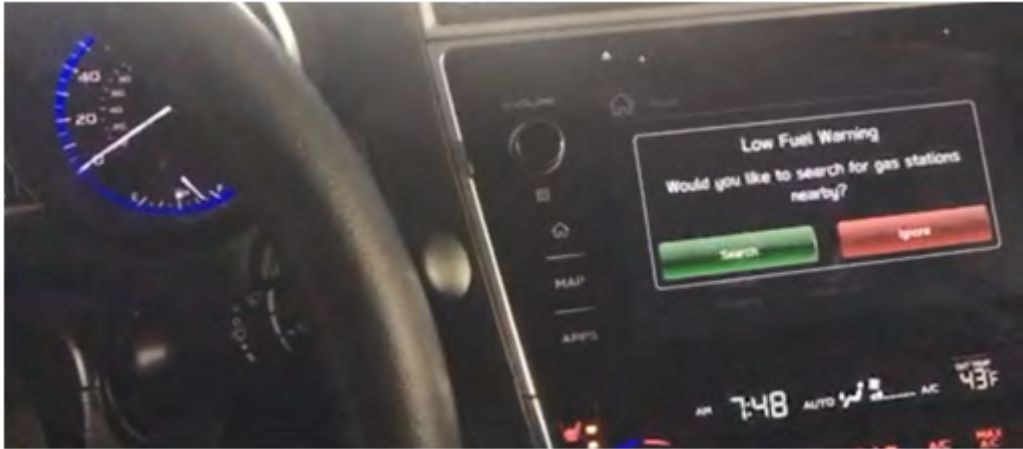
**CAUSE:** The head unit only displays fuel level information sent to it from the combination meter.

**RECOMMENDATION:** Confirm combination meter and sender functions are operating properly. Confirm the trip meter is reset following refueling. Confirm ignition key is not being left in the ON / RUN positions during refueling.
