SERVICE BULLETIN

APPLICABILITY: All Models Equipped with FA & FB Engines

NUMBER: 09-53-12R

SUBJECT: Judgment Standards for Water Pump Replacement

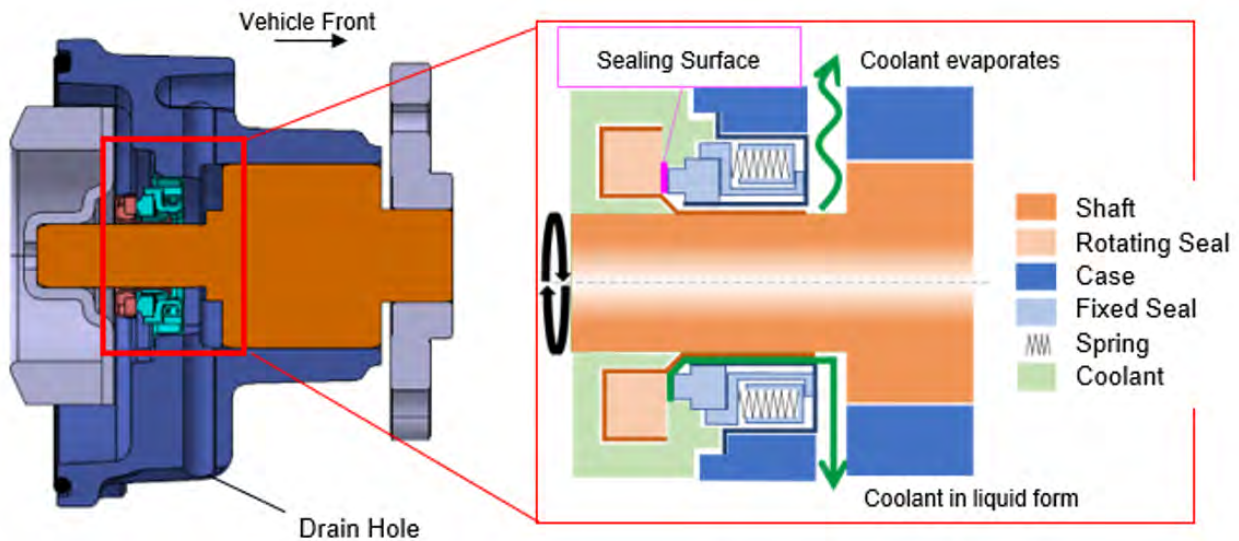
The mechanical type coolant seal used for engine water pumps equipped for FA/FB type engines has a mechanical seal that allows a small amount of coolant seepage/leakage through the drain hole at the initial stage of vehicles usage (up to 1800 miles) until the mechanical seal is well broken-in. Cases when low mileage vehicles exhibit a small amount of liquid coolant or dried coolant stain/residue on or around the water pump area including exhaust parts, or undercover, it is not defect of the water pump. If it is the case, it is not necessary to replace the water pump.

Section View of Water Pump and Mechanical Seal

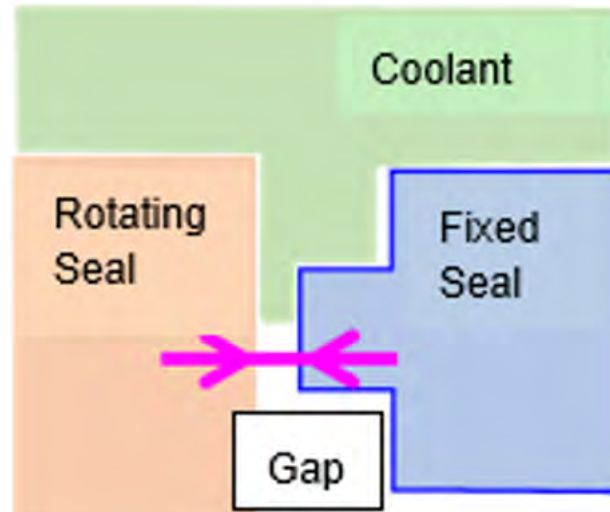
The sealing surface between the Rotating Seal and the Fixed Seal has slight gap. The sealing surface is lubricated by coolant to avoid the possible surface wear.

During the vehicles initial state of usage (up to 1800 miles), the sealing surface is not broken-in yet, allowing a small amount of coolant to exit through the drain hole. This will reduce after the sealing surface is broken in. This is a normal characteristic of the water pump.

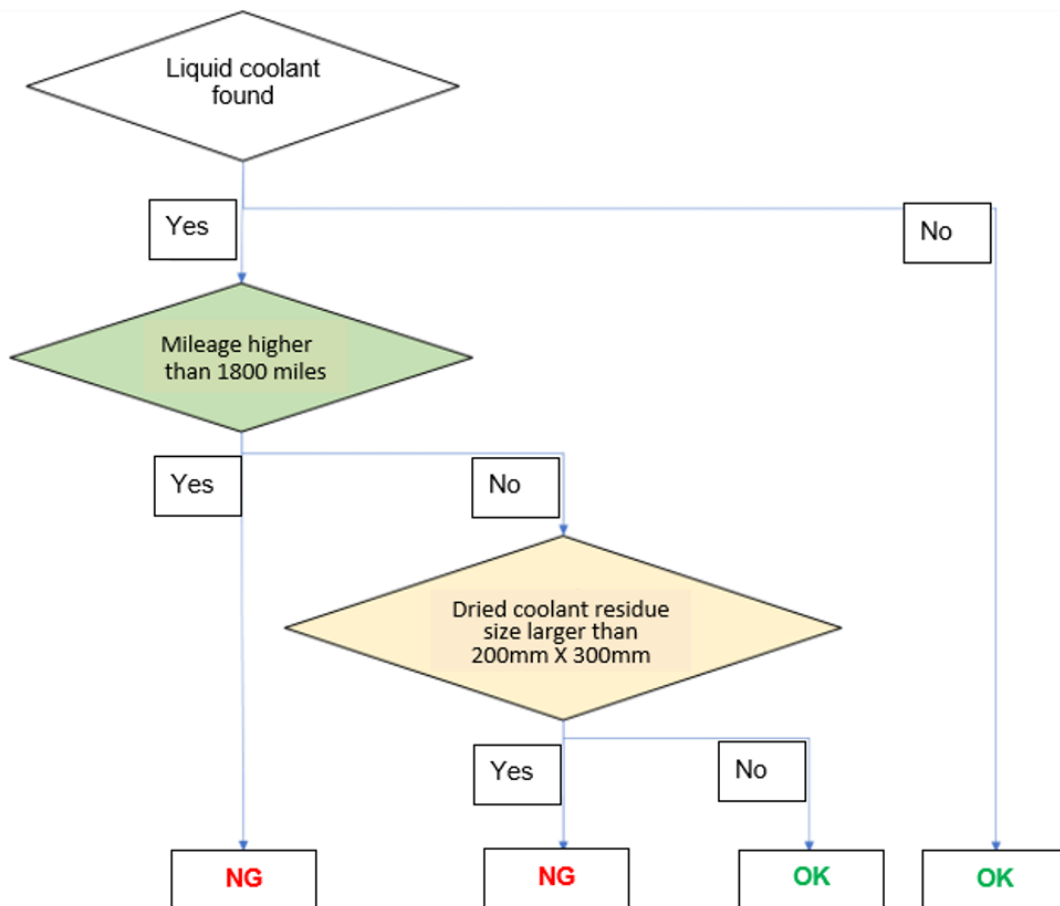
If liquid form coolant in still can be seen on vehicles with the mileage higher than 1800 miles, or the coolant leakage amount is a higher than normal amount (200mm X 300mm) with mileage less than 1800 miles, the water pump may need require replacement. See the inspection procedure outlined below to determine if water pump replacement is required.

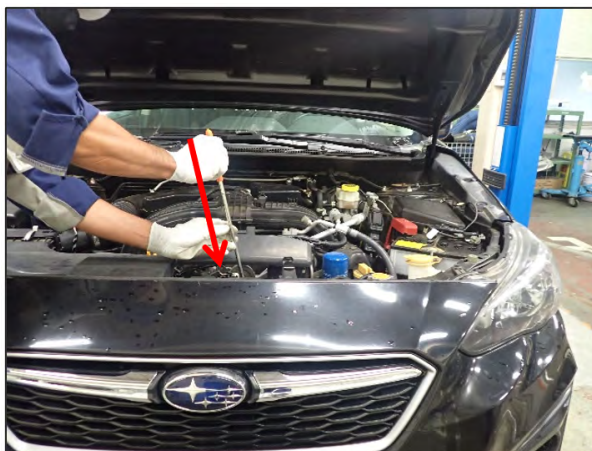
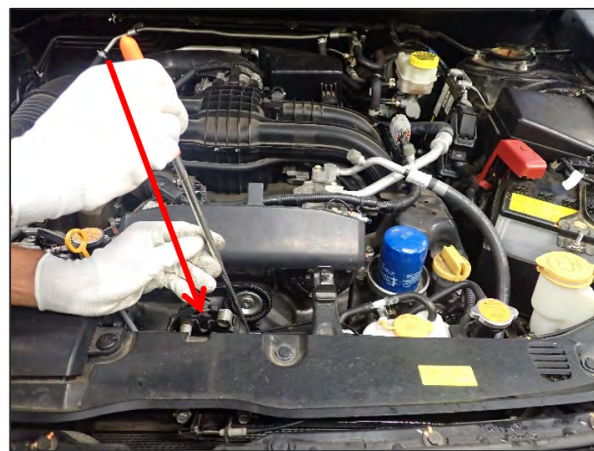
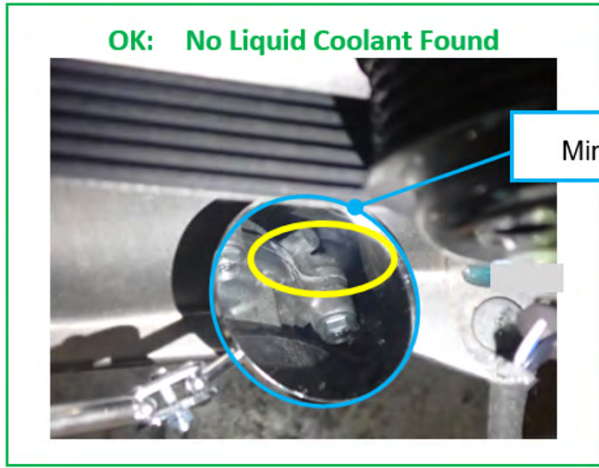
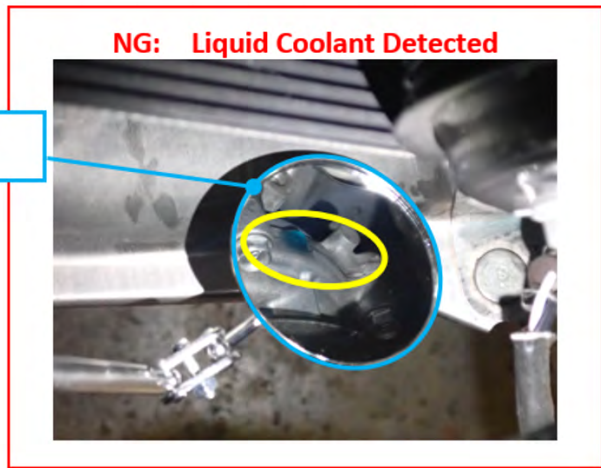
1: The water pump can be inspected front the top of the engine area with the aid of an inspection mirror. See the images below.

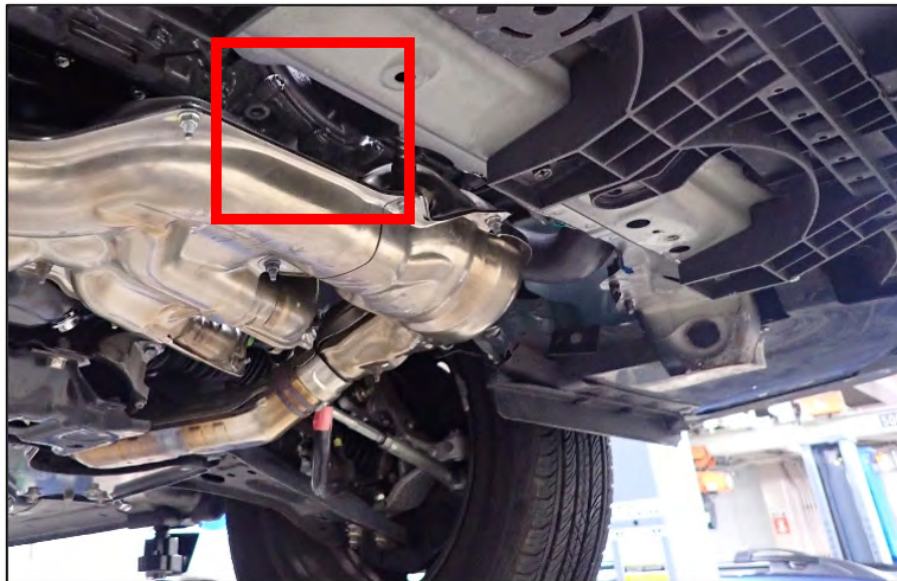
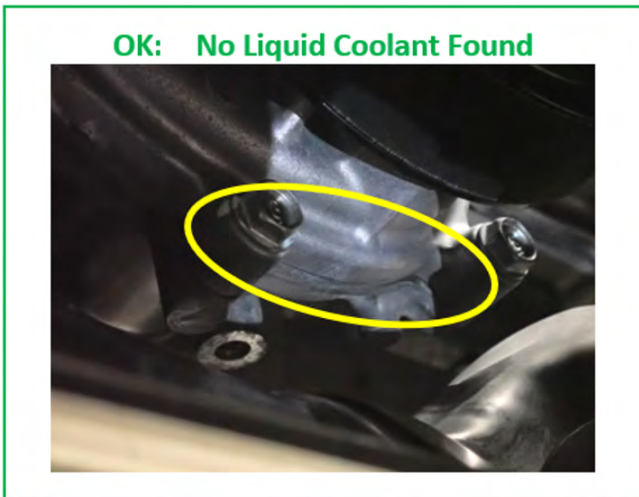
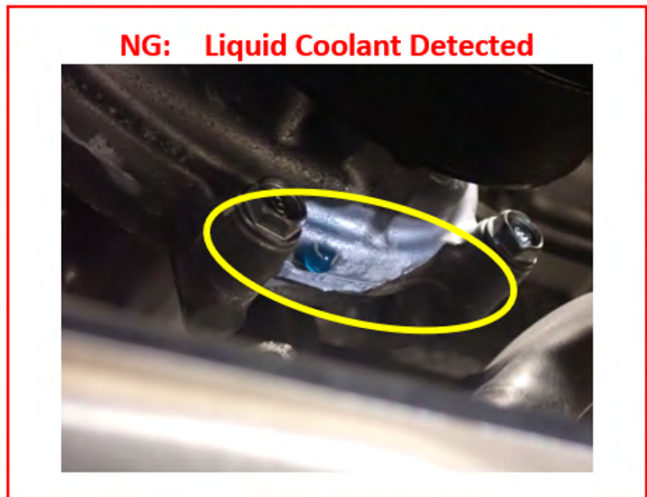
2: The water pump can be inspected from under the vehicle with the lower panel removed.

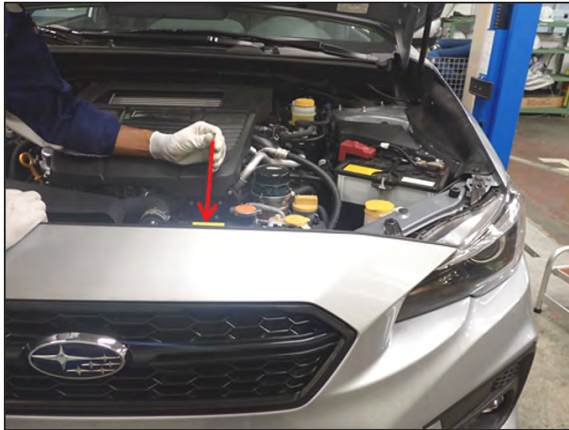
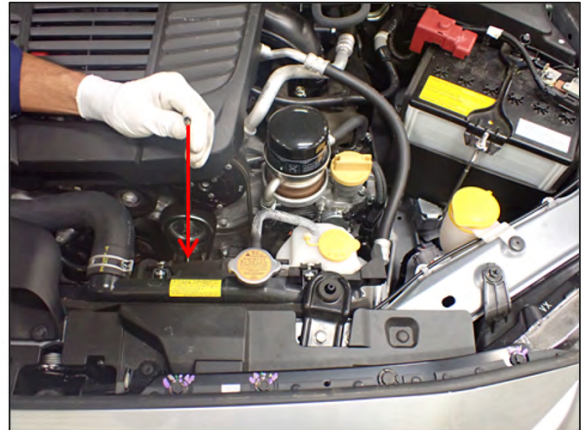
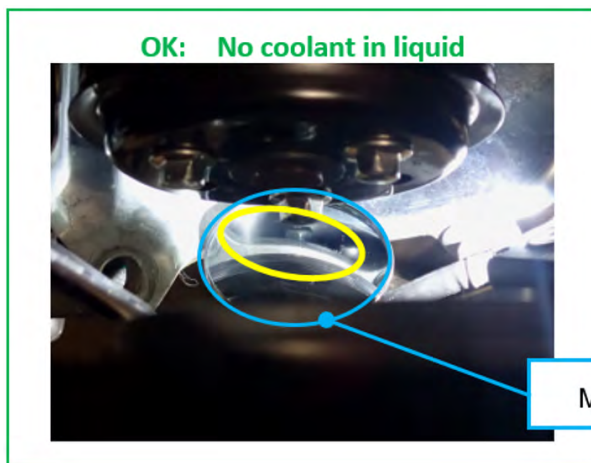
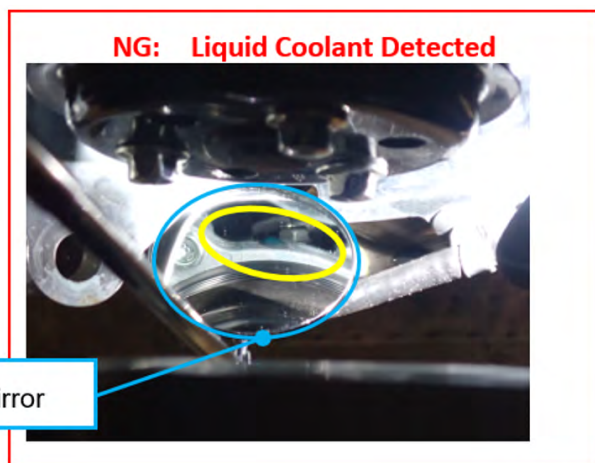
1: The water pump can be inspected front the top of the engine area with the aid of an inspection mirror. See the images below.

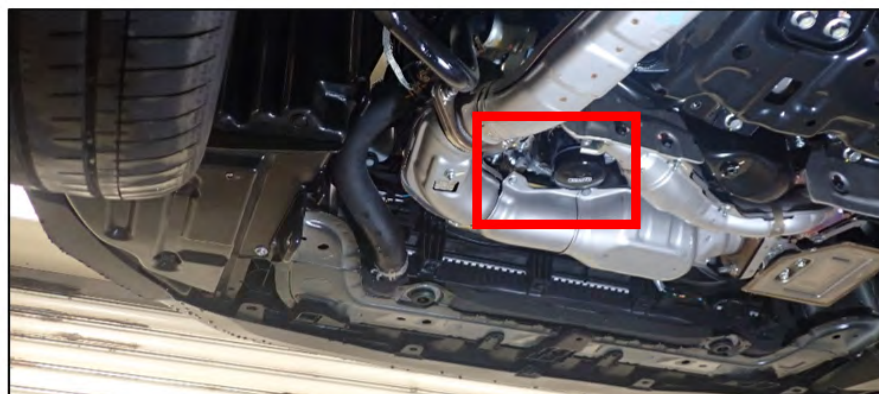
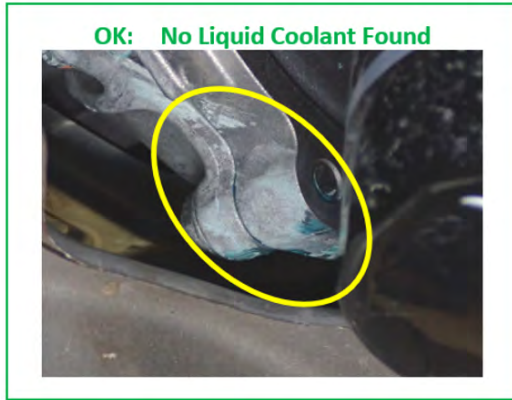
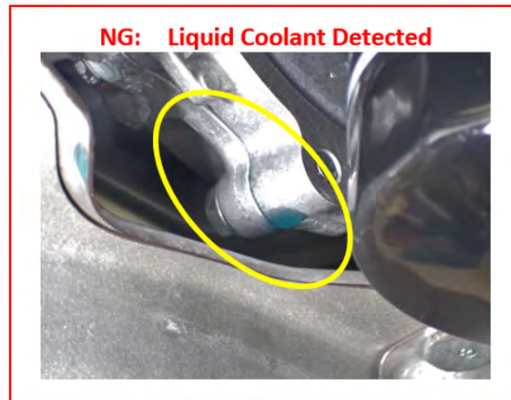
2: The water pump can be inspected from under the vehicle with the lower panel removed.

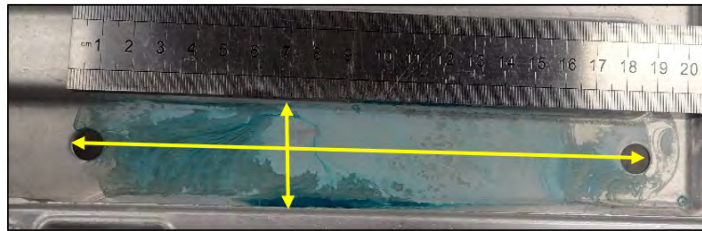
Inspect the area and measure the size of the dried coolant residue on the exhaust component or undercover. If the size of the residue is larger than **200mm X 300mm** in a rectangular form, the leakage is considered 9cc or higher requiring water pump replacement.

200mm X 300mm
in size is considered equivalent to 9cc leakage.

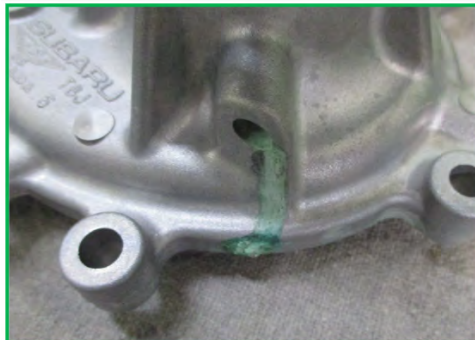
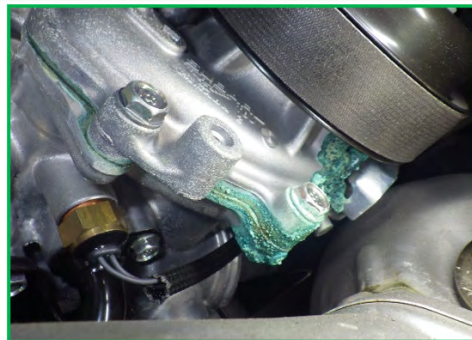
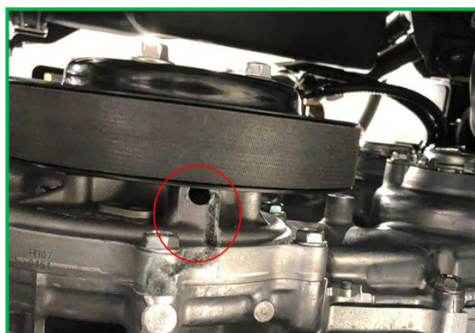
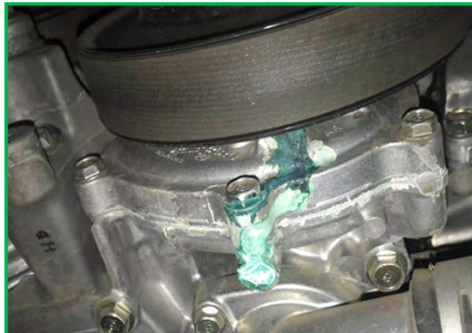
If coolant is dried and found to not be in liquid form, it is considered normal seepage through the drain hole. This would confirm the water pump replacement to be unnecessary. See the images below.
